BOLLIGER & MABILLARD

Bulletin No.:	2
Release Date:	June 1, 2007
Effective Date:	June 1, 2007
Supercedes:	
Issued by:	A. Pinizzotto
Checked by:	W. Bolliger
Page:	1 of 4

SAFETYALERT

Abstract of Issue:
Inspection of the safety harnesses weldments as per Detail of Issue.

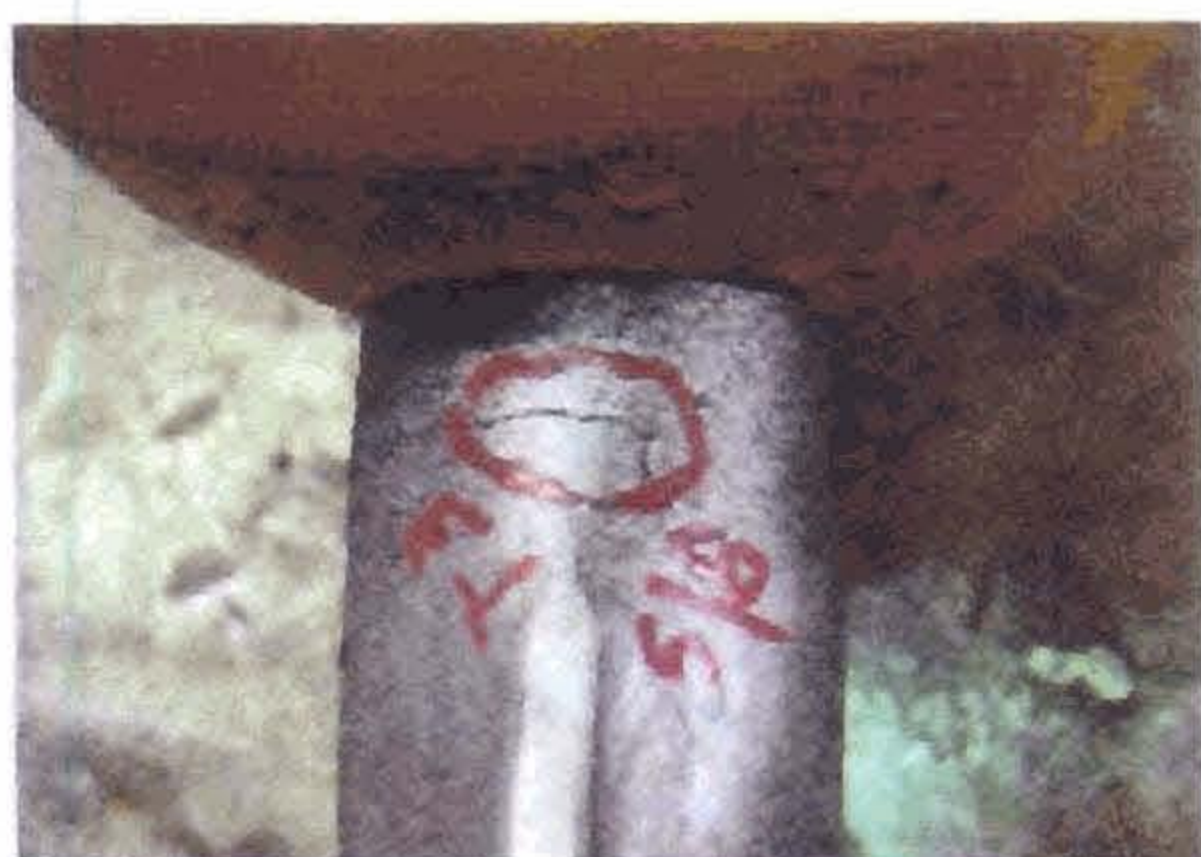
Reason for Release:
Cracks were discovered on several harnesses.

Indication found

⇒ harness can be repaired if the indication is smaller than 25 mm (1 inch) in length. Harness presenting larger indication must be rejected and replaced.
