Inverted Coaster BATMAN THE RIDE

Six Flags Great Adventure

LIST OF MANUFACTURER'S NOTICES

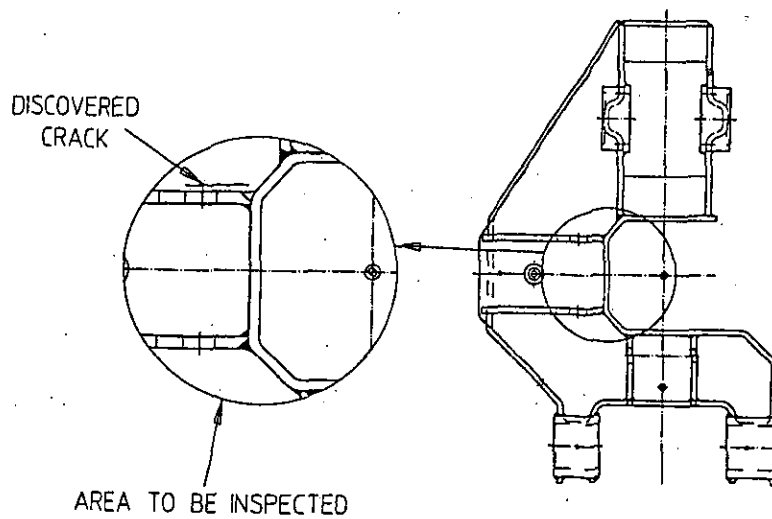
- 1) We draw your attention to the fact that cracks were found on one Inverted Coaster on five bogies in the area shown below.

- 2) Accordingly we ask you :
- a) to inspect with Magnaflux the area shown above
- before starting the new season
 - at mid season.

- b) to inspect visually once a week the area shown above. Dismantling of the side wheels is not necessary, except if visual inspection seem to indicate a crack.

- 3) Bolliger and Mabillard shall be informed of any crack. Ride shall not be operated if cracks are found in the bogies.
