Doppelmayr CTEC inc

SUBJECT: Bulletin No. SB-03-006

CHAIR NUMBER PLATES

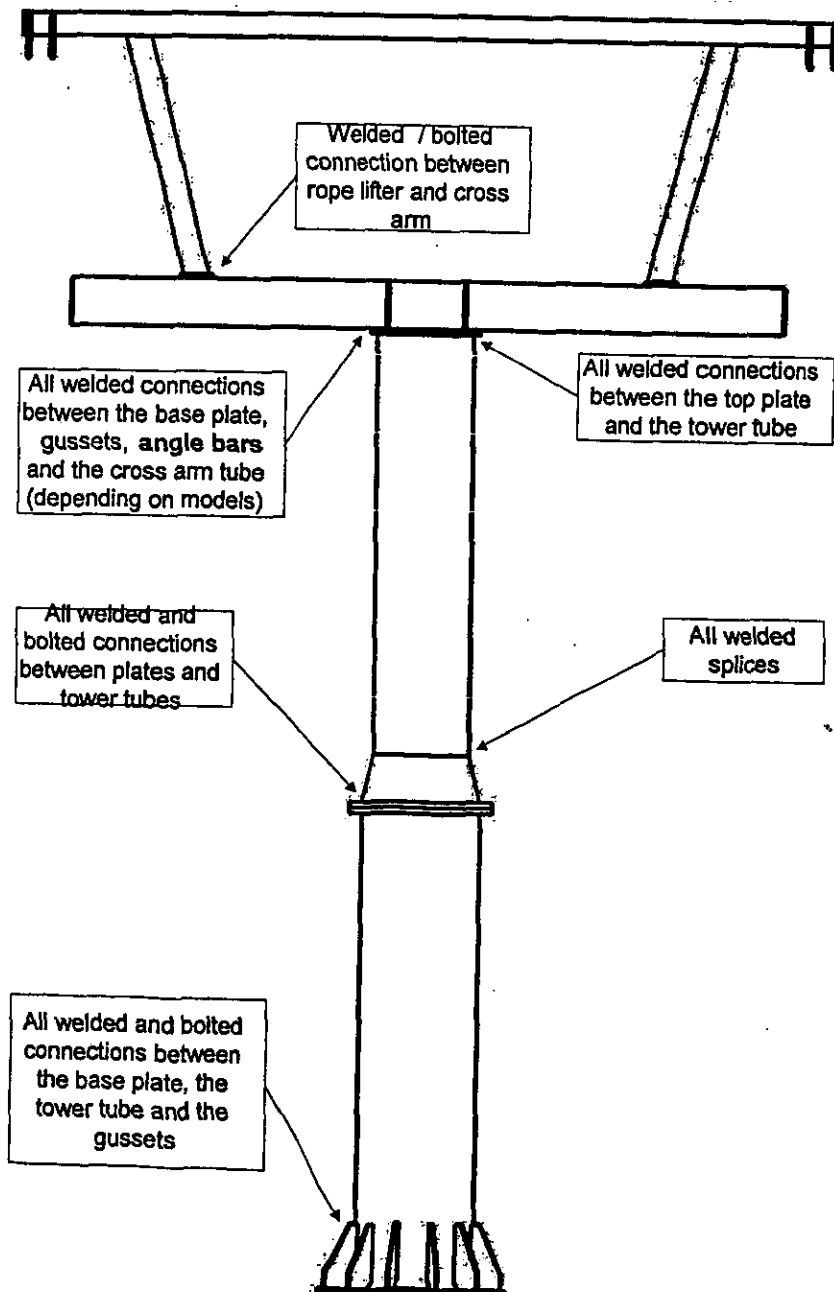
Fig. 1 Critical areas of towers and cross arms

Recently, cracking was observed in the cross arm of a negatively loaded tower. The crack started at the end of the angle gusset welded on the attachment plate and progressed into the cross arm tubing. It was also observed that the lift in question was (or had been) equipped with **urethane after-market sheave liners**.

Negative or combination loaded towers and adjacent towers are more susceptible to fatigue cracking due to unavoidable vibration and shock loading induced by grips passing under sheaves. Doppelmayr original equipment sheave liners are the product of many years of research and development, taking into account vibration damping, long life, electrical conductivity and other factors. **After-market sheave liners may not include these important features. DOPPELMAYR CTEC DOES NOT CONDONE THE USE OF AFTER-MARKET COMPONENTS, AND ACCEPTS NO RESPONSIBILITY FOR NEGATIVE CONSEQUENCES ARISING FROM THE USE OF SUCH PRODUCTS.**

- Ensure that periodic inspections by qualified personnel have been properly conducted as per Doppelmayr CTEC manuals and applicable local regulations.
- Ensure that inspections included the critical areas mentioned in this bulletin (see Figure 1). If not, perform a thorough visual inspection of all towers and cross arms and pay special attention to the critical areas shown in Figure 1.
- In case of doubt during visual inspection, perform a magnetic particle inspection of the suspect areas.
- **Replace any urethane or similar after-market liners installed on your line.**

- If you detect a crack during your inspection, contact your Doppelmayr CTEC representative for repair procedure or replacement. **Do not operate a lift with defective components.**

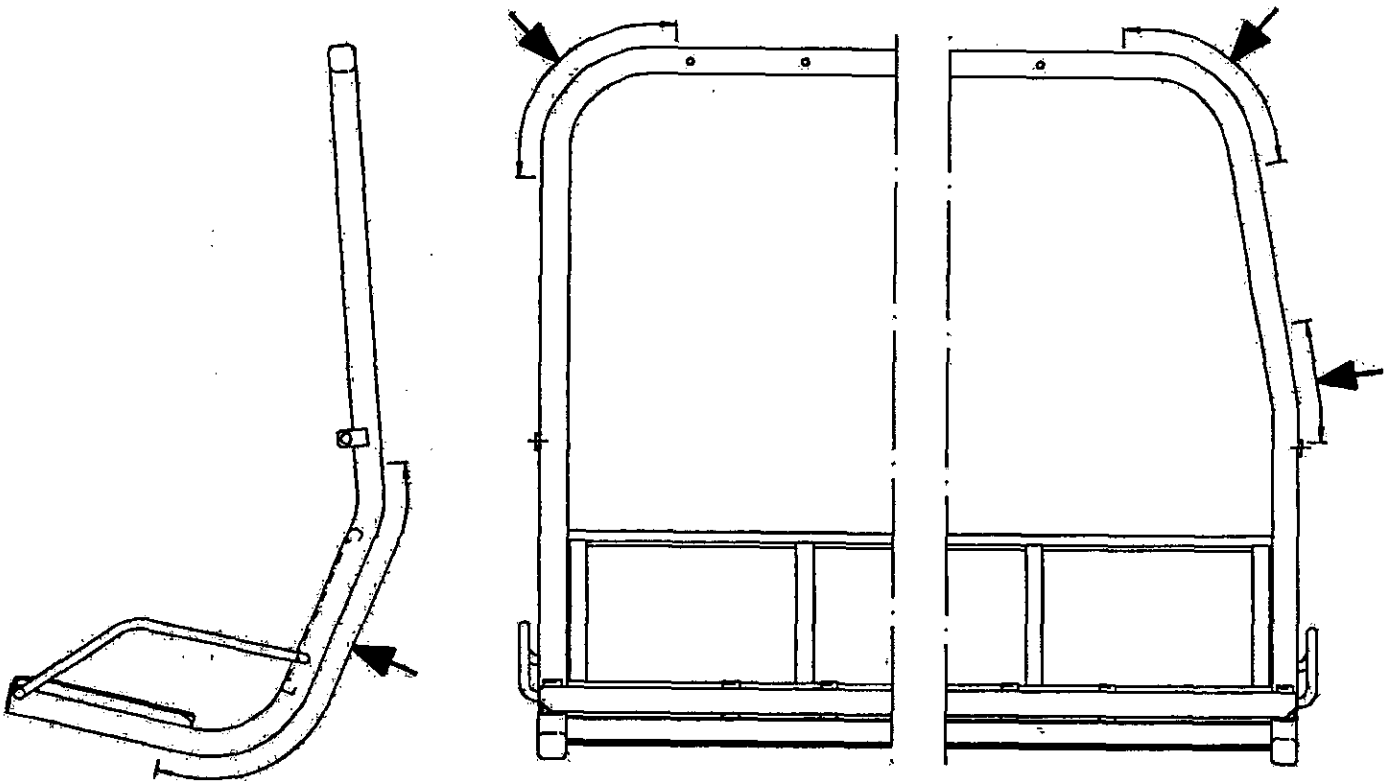
- Longitudinal cracks appear mainly in the bent area of the chair bail (see sketch below)
Pay particular attention to those areas when performing your periodic examinations.

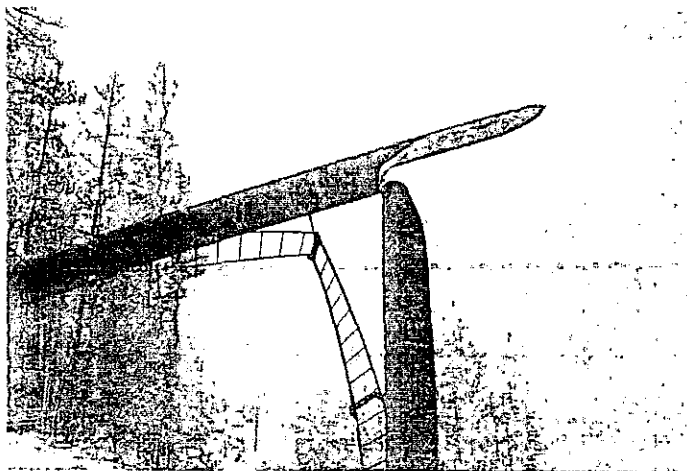
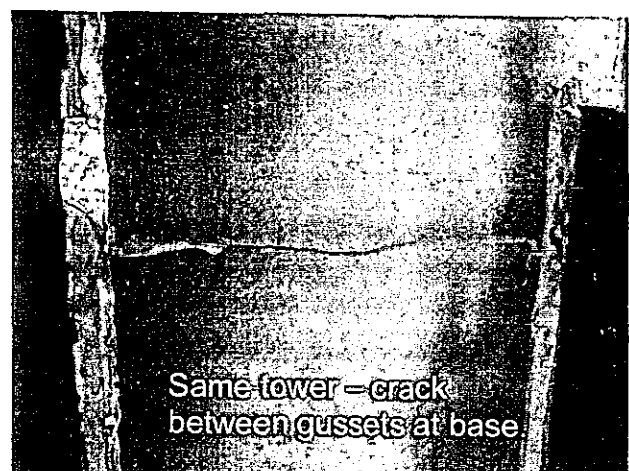
Tower: 6S/4S; 46' tall; 30' of 20" tube spliced to 16' of 16" tube. Ice filled to 30' position.

Weather conditions at failure:
Night; ~-5° F.; Wind ~ 57 mph.

Horizontal tower base crack 10-1/2" long, 14" up from base.

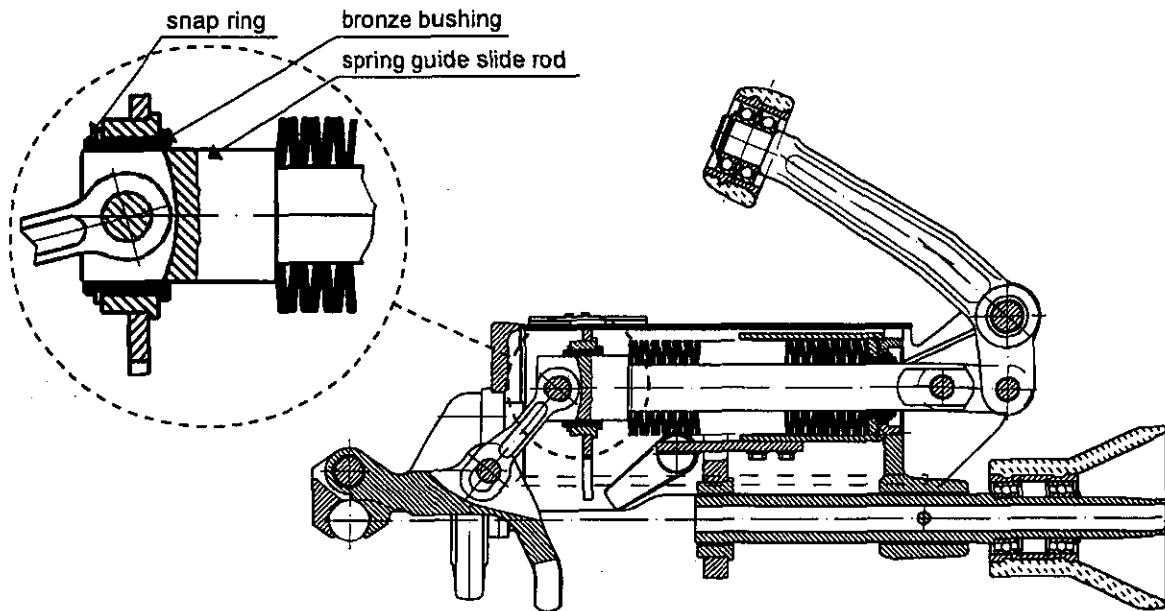
Because of current events we urgently recommend to pay special attention to the correct fastening of the bronze bushing of DS grips by means of the snap ring.

If the snap ring is not fitted correctly or missing, the bronze bushing may creep and as a result the grip may be blocked during the closing procedure!

Check if the snap ring sits properly, simply by turning it and checking the space between the ends of the snap ring.

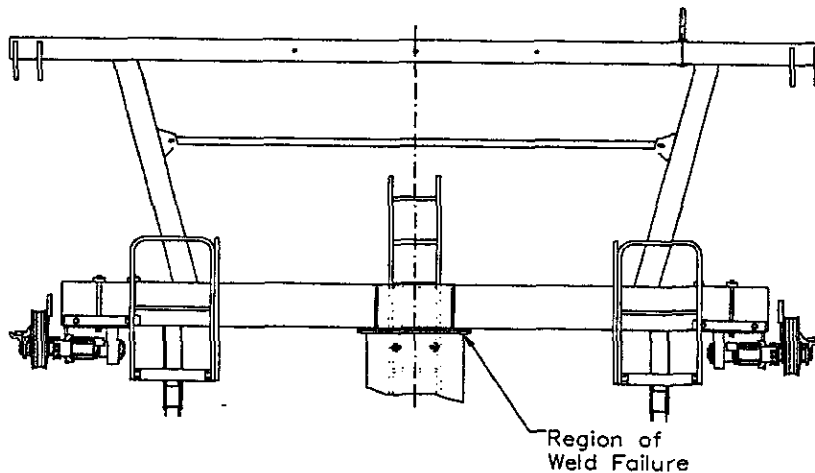
The following schematic depicts the location of the weld that failed.

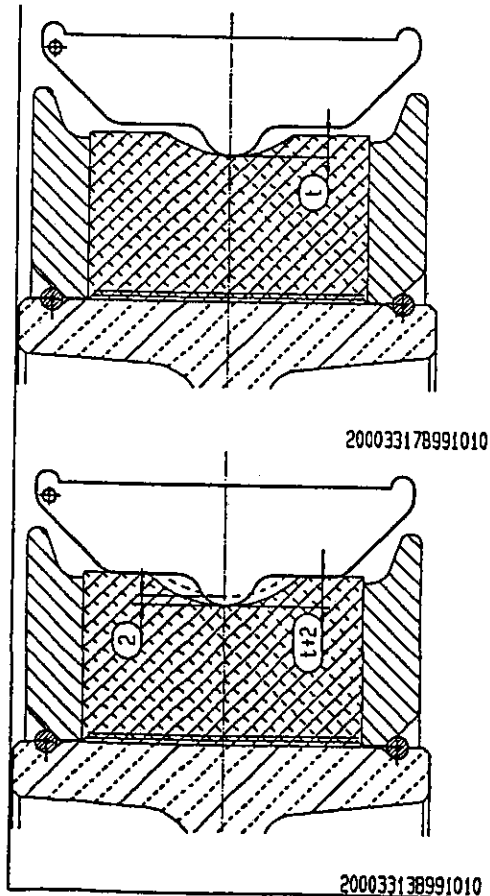
The template touches only the bottom of the groove.

If the rope groove is worn by 2 mm, the template will contact the sheave liner. The rubber liner must be replaced.

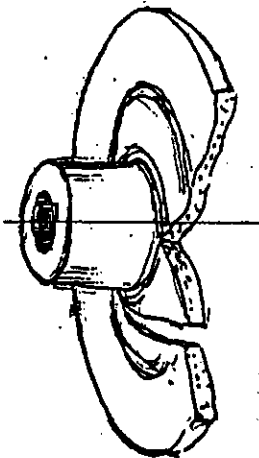
Upon cooling down and readjustment of the brake, operation was continued. Then, after approx. 30 minutes in operation, the brake disc suddenly broke.

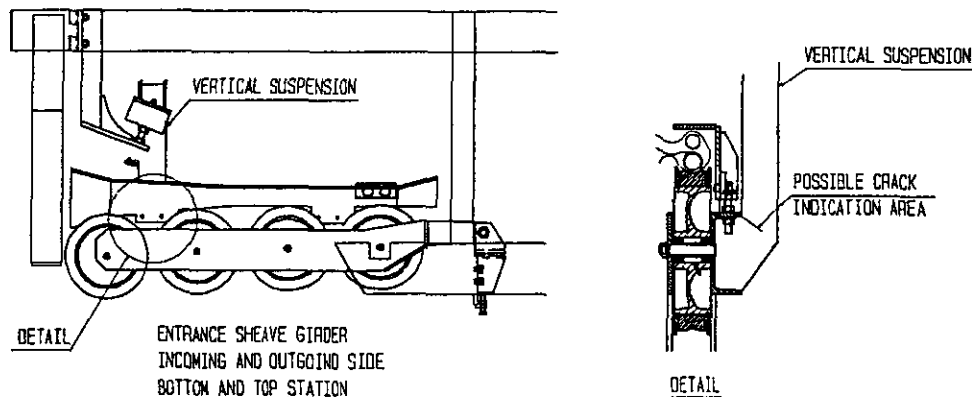
According to our files, entrance sheave assemblies of this type are installed on your lift. We would kindly ask you to check the critical area (see sketch) for possible cracks.
