# NAFLIC

TECHNICAL BULLETIN — AUGUST 2008

## 352. Octopus Centre Stub Shaft Defect

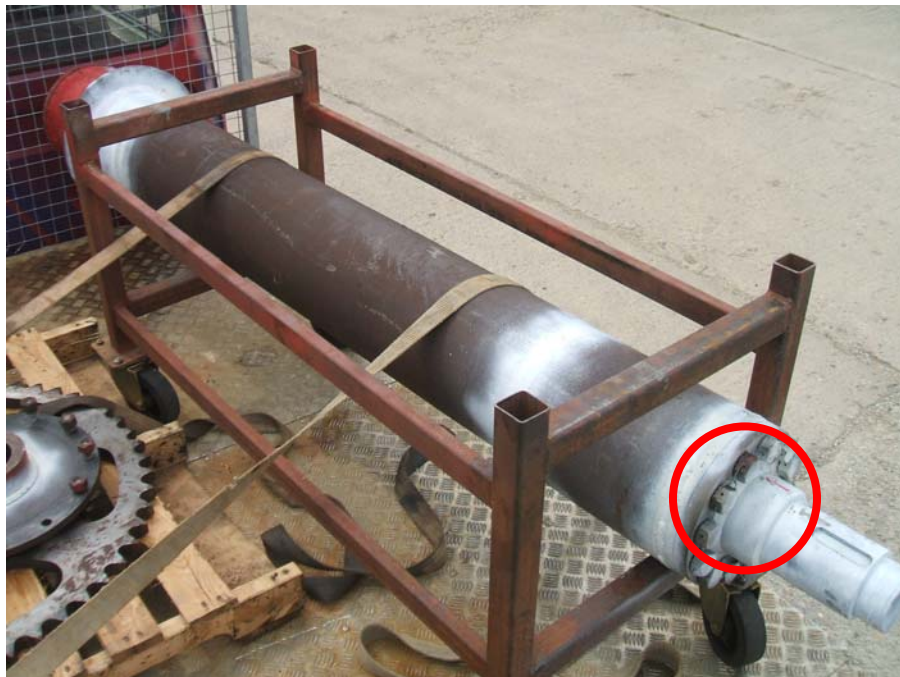
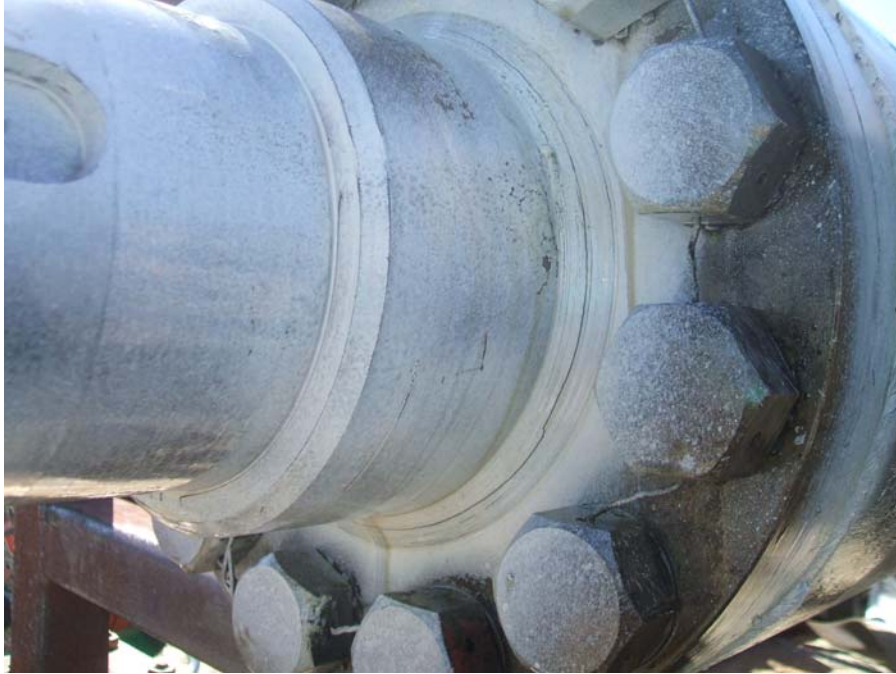
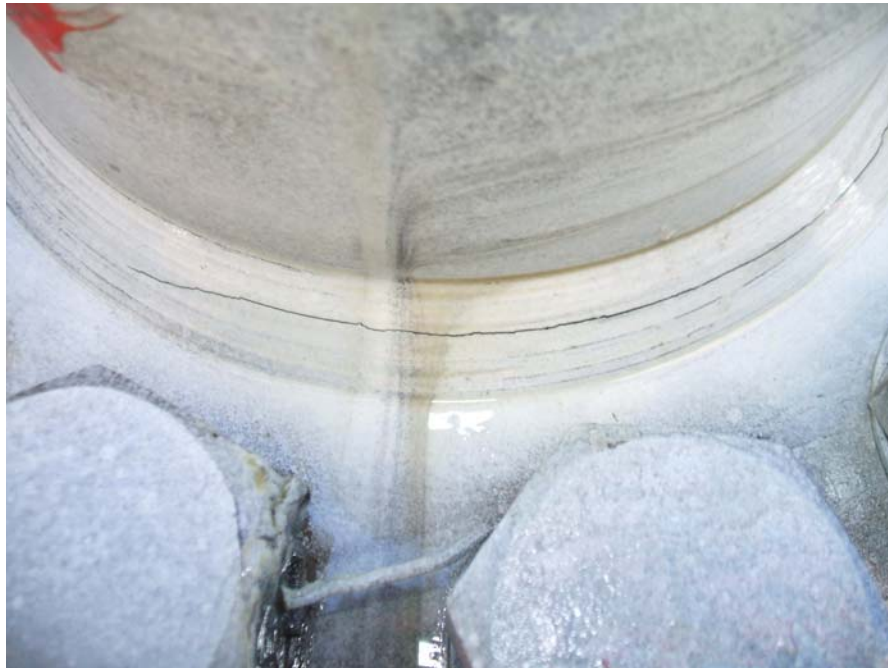
The committee has been informed of the following crack found on the centre stub shaft from a Hayes Fabrications Octopus ride. The shaft supports and aligns the inner and outer rotating poles of the ride centre.

This was the first time the shaft had been inspected since it was manufactured circa 1964. This demonstrates the importance of ensuring the shaft is disassembled from the ride in order to facilitate NDT. It was noted that the component was particularly difficult to remove from the device. Controllers and Registered Inspection bodies are reminded of the requirements of paragraph 137 in Fairgrounds and amusement parks Guidance on Safe Practice (HSG 175).
