**FIELD OPERATIONS DIRECTORATE
SPECIALIST GROUP - MECHANICAL**

**FINAL
REPORT**

Title: **Failure of a Crazy Frog Ride Radial Arm – Central Pier Blackpool**

Incident Site Central Pier Blackpool
Ride Owner RS Leisure Blackpool Limited

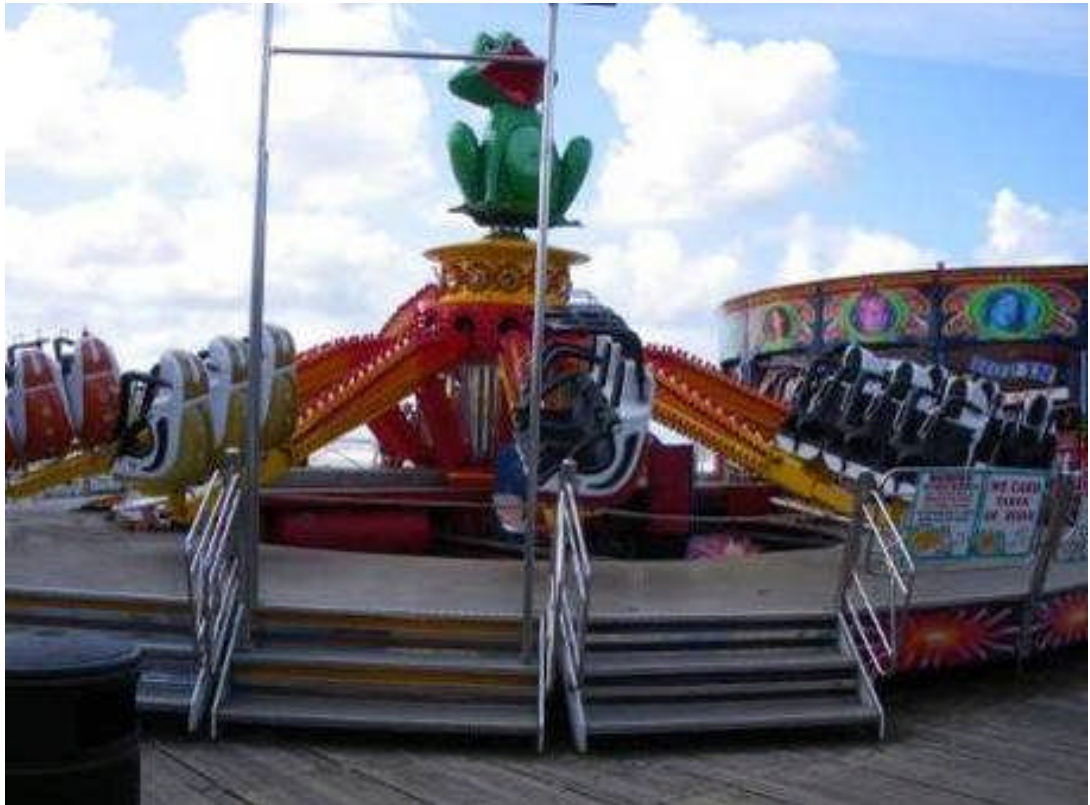
- 1.1 Although I have no first hand knowledge of the incident it is my understanding that on the evening of Wednesday 29th July 2009 a Crazy Frog II ride (see IMG1495), owned by RSBL Leisure Blackpool Limited (RSBL) had just started its ride sequence when one of the arms which supported the rides three seats collapsed catastrophically. At the time of the incident two members of the public were sitting in the seats and although one passenger was taken to hospital for precautionary x-rays, it is my understanding that no one was seriously injured as a result of the incident.

IMGP1495 – Crazy Frog Ride

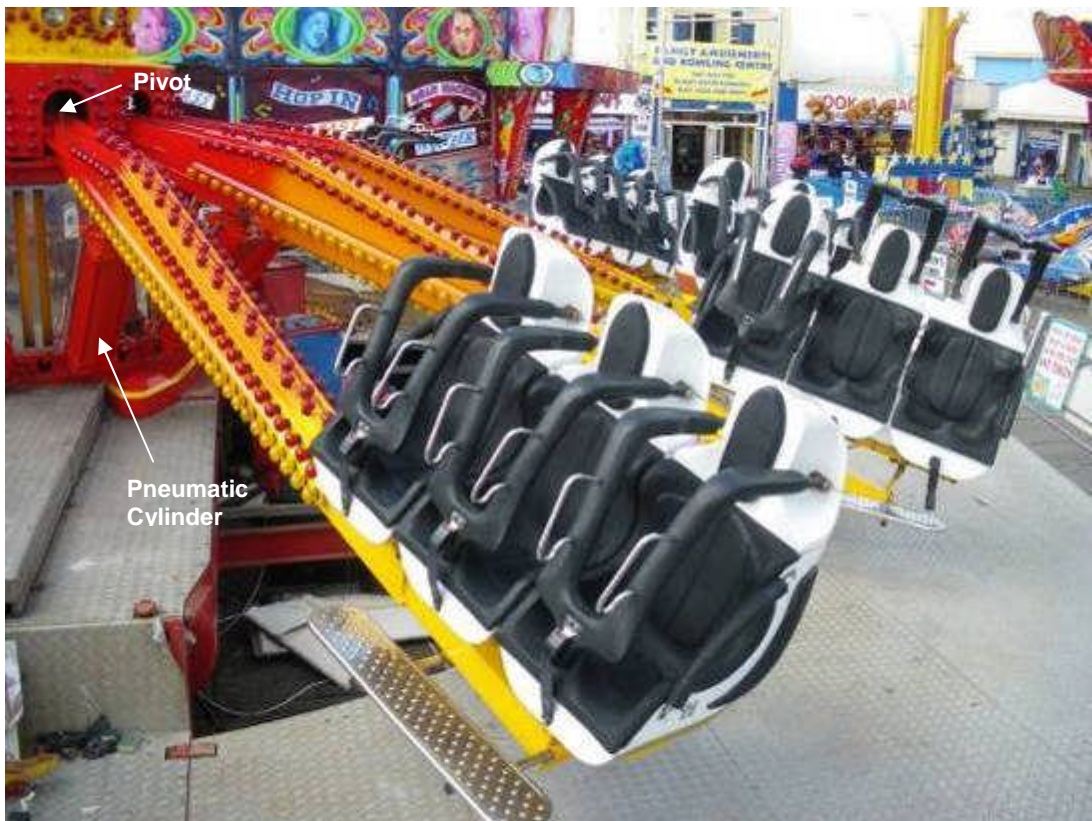
- 2.2 The ride had twelve radial arms approximately 5m long with three seats at the end of each arm (see photograph IMG1499).
- 2.3 Each radial arm was attached to the rotating central hub/carousel using a pivot connection, as shown in photograph IMG1568.

IMGP1499 – Ride Radial Arm

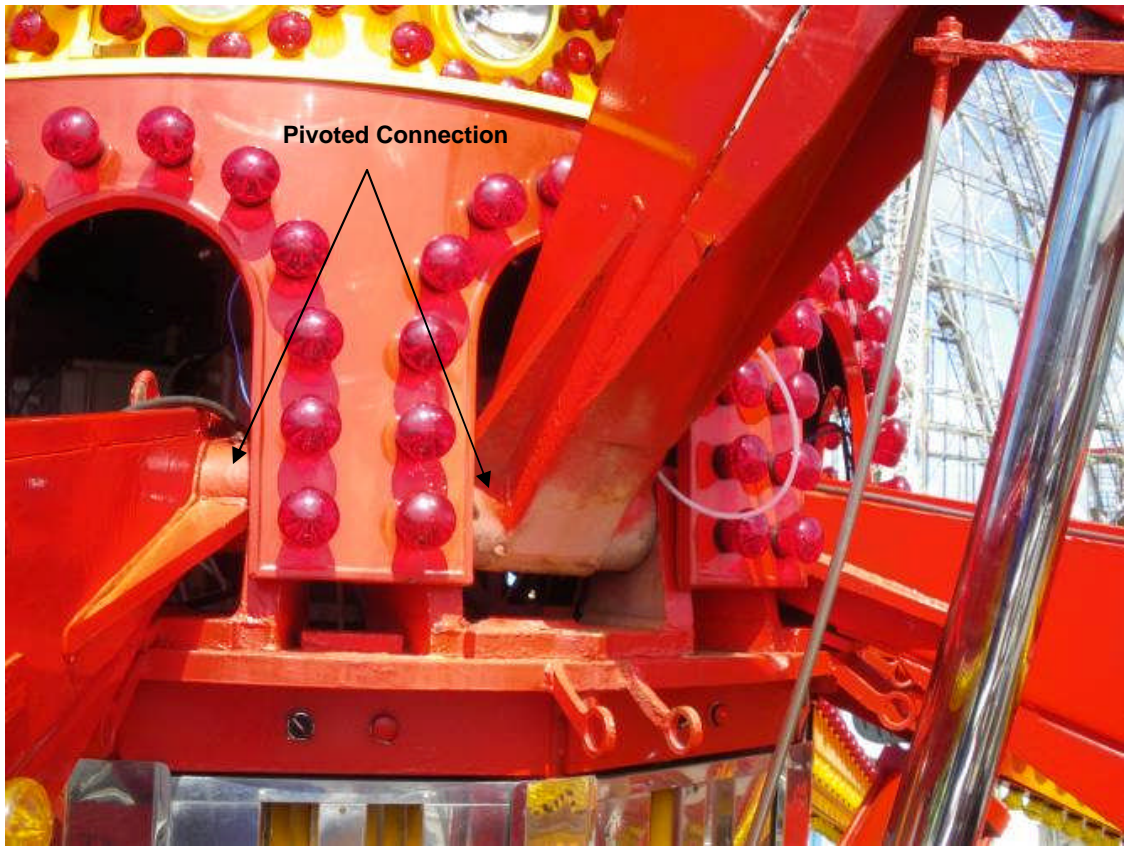
IMGP1568 – Radial Arm Pivoted Connection

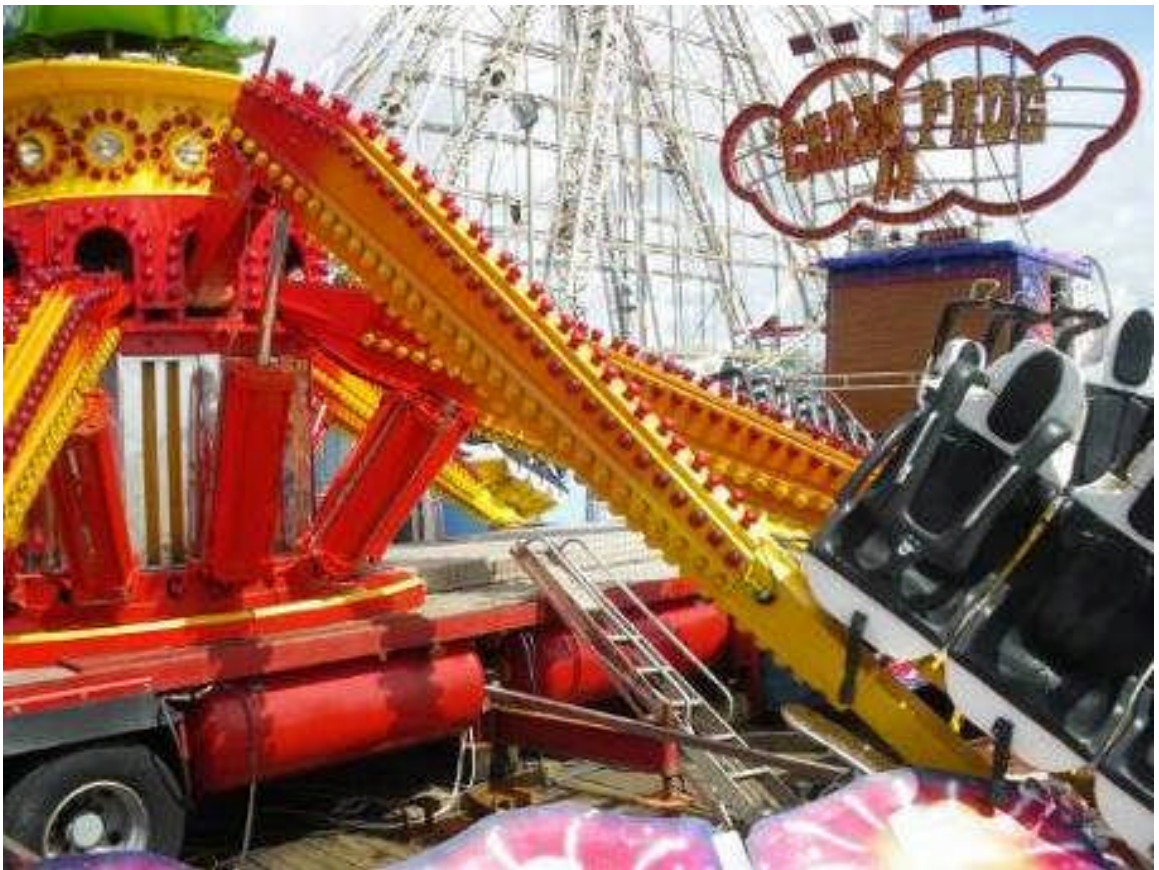
- 3.1 On arrival on site I observed that one of the arms, which I understand to be arm No.7, had failed catastrophically, as shown in photograph IMG1523.

IMGP1523 – Ride Control Console

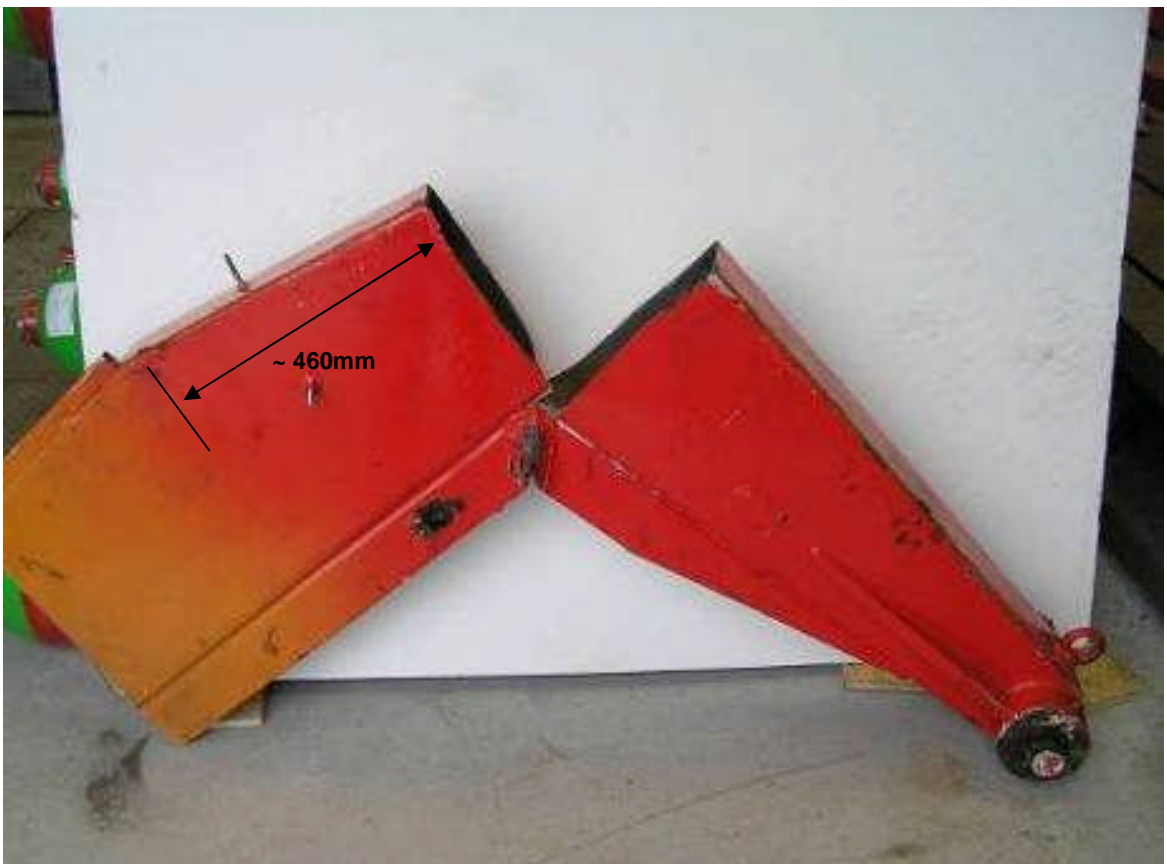
- The failure had occurred approximately 460mm from the widest section of the arm as shown in photograph as P8040173.
 - The arm was manufactured from a variable section channel with a top plate welded in position forming a box section. The box section had an upturned channel welded to the bottom of the arm acting as a lower stiffener. Additional strengthening plates were welded in the position where the pneumatic cylinder rod pinned connection was located, as shown in photograph IMG1566.

P8040173 – Failed Arm Photographed at HSL

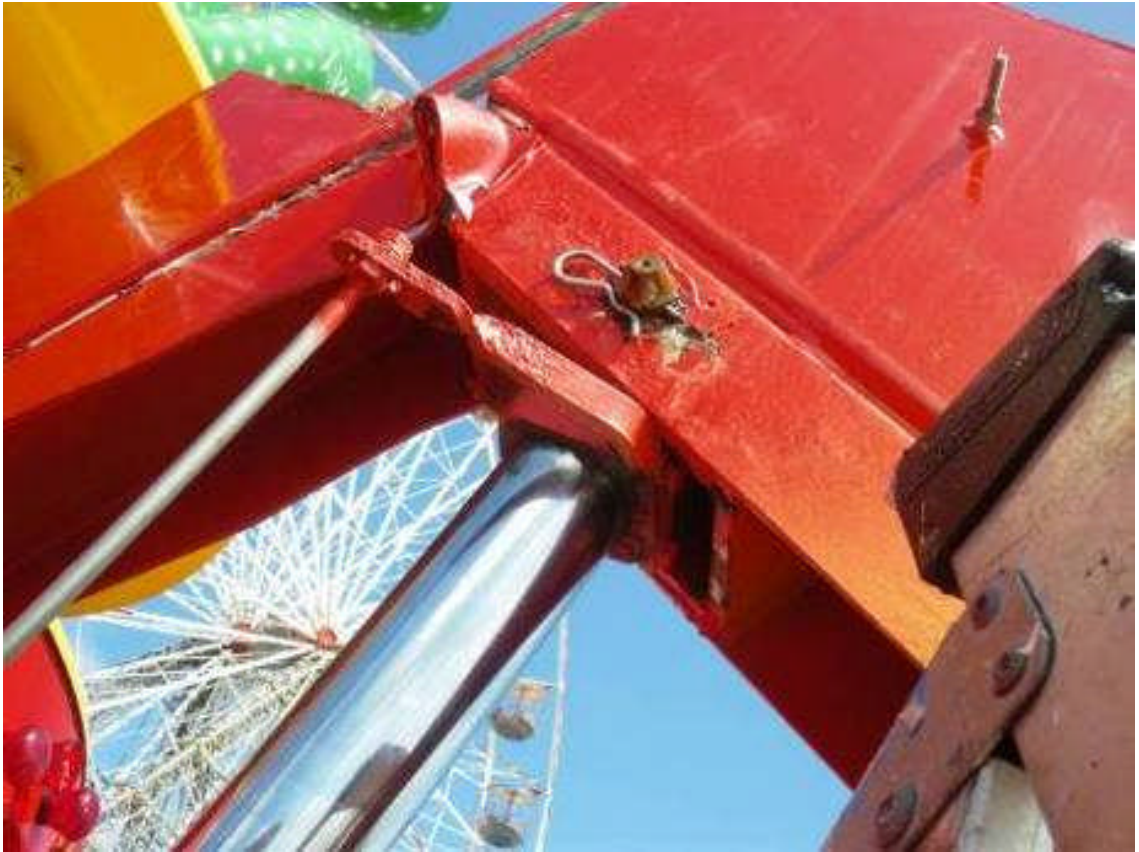
- The fabricated box section of the main arm had failed on three sides, as shown in photograph IMG1561. As the loaded arm failed it rotated forward about the lift cylinder pinned connection bending the remaining arm section and deforming the upturned channel (see photograph IMG1566).

IMGP1566 – Lower Stiffer and Lift Point Strengthening Plates

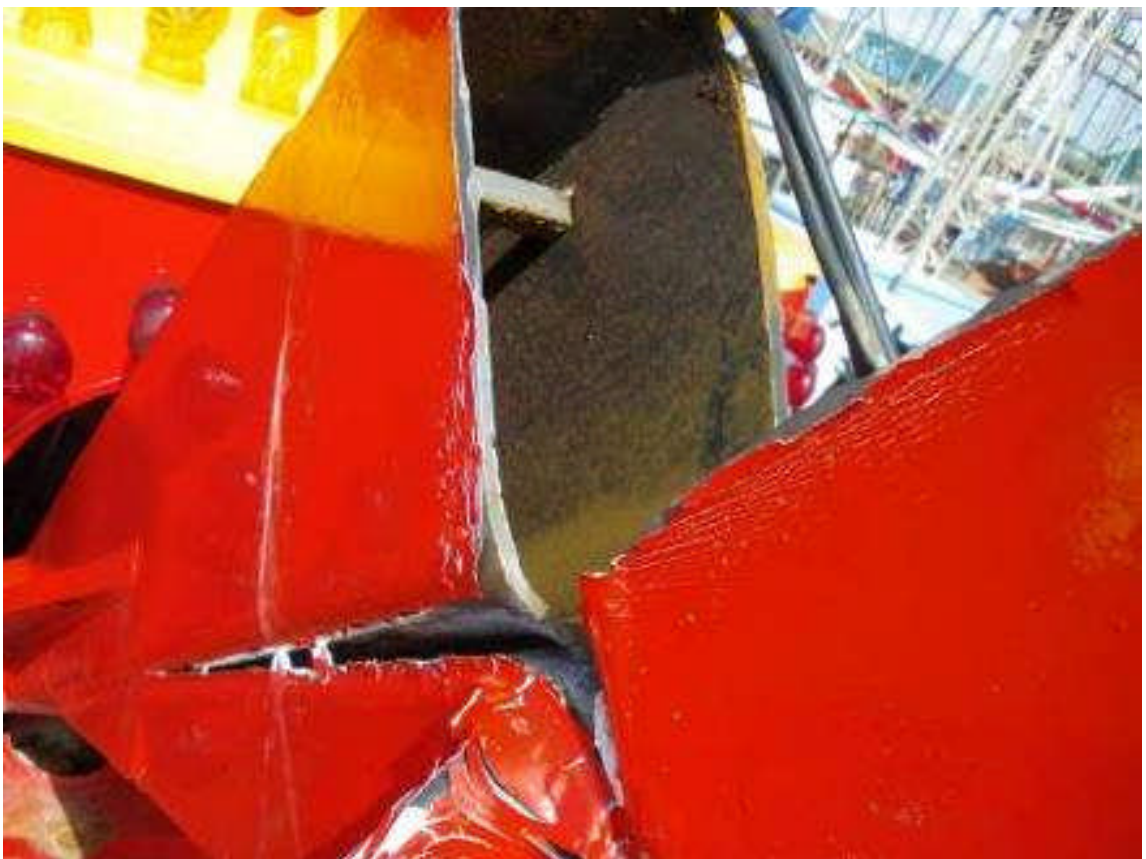
IMGP1561 – Failed Arm

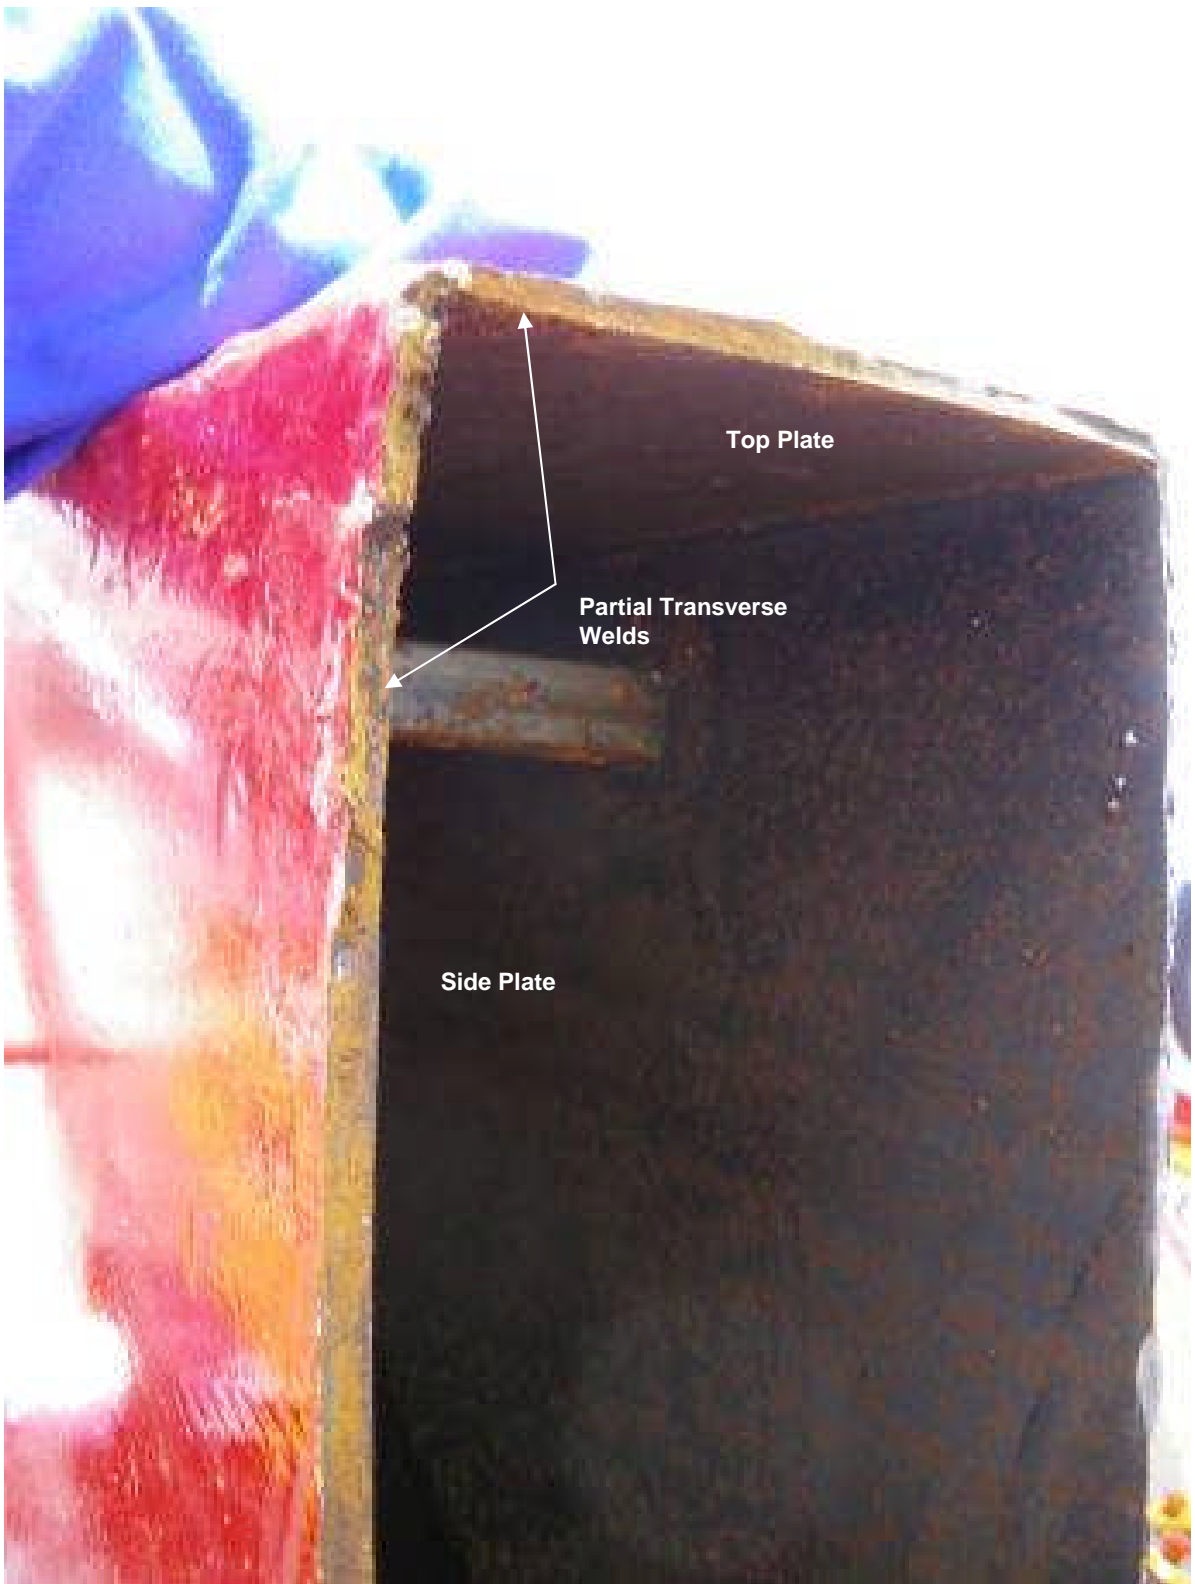
- On close examination there appeared to be a partial transverse weld at the upper right corner of the box section arm, as shown in photograph IMG1536.

IMGP1536 (Rotated Through 90°) – Partial Transverse Welds Observed on Site

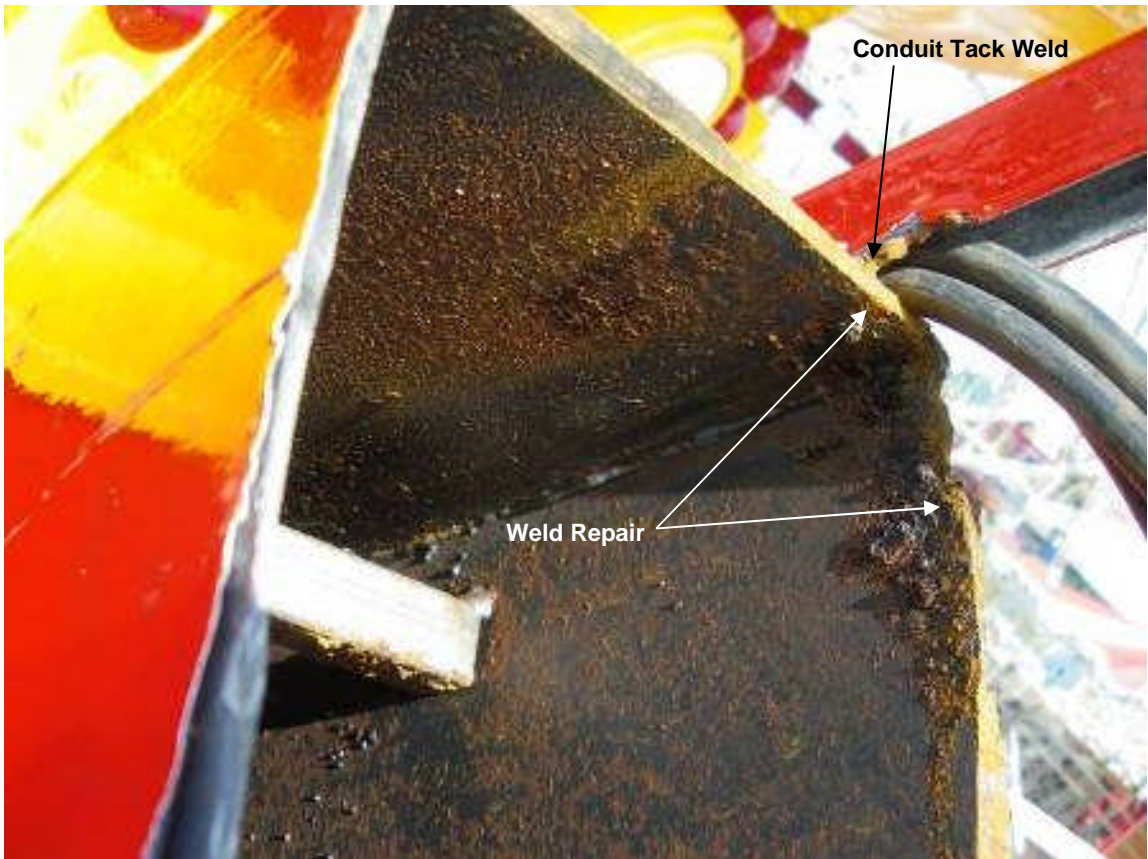
- I noted that the conduit had been tack welded in the area of the weld repair, as shown in photograph IMG1549.
 - During my examination I could not find any manufacturer's plates or serial numbers on the incident machine.

IMGP1549 – Tack Weld within the Weld Repair Zone

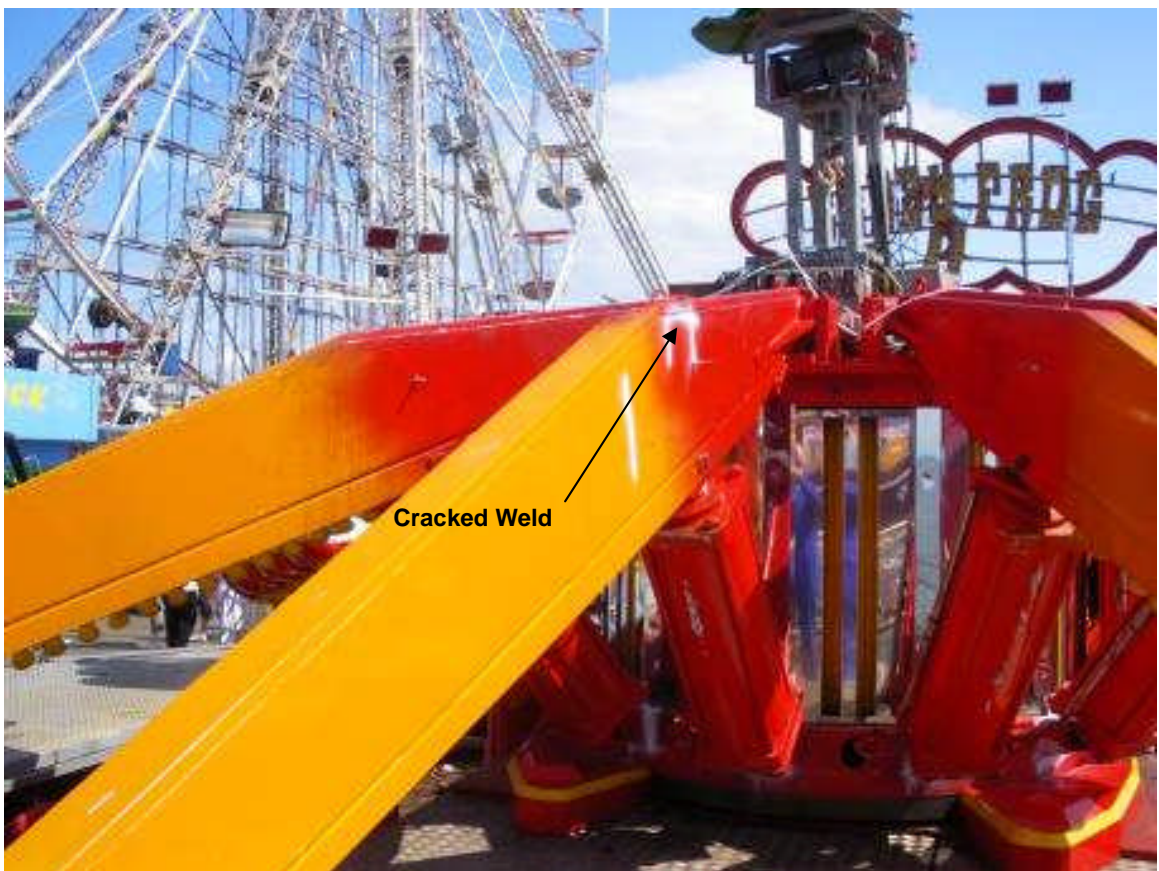
- 3.5 On the morning of Wednesday 5th August I was contacted by [REDACTED], during the telephone conversation he informed me that further cracks had been identified during the detailed Magnetic Particle Inspection (MPI) examination carried out by [REDACTED]. I therefore attended site later that morning to examine the cracks.
- 3.6 During my second visit to site I was shown two cracks as follows:
- Arm No.4 - The crack was approximately 150mm long and had been found along the top seam (i.e. Longitudinal) weld of arm, as shown in photograph IMG1603.

IMGP1603 – Crack in Weld Arm No.4

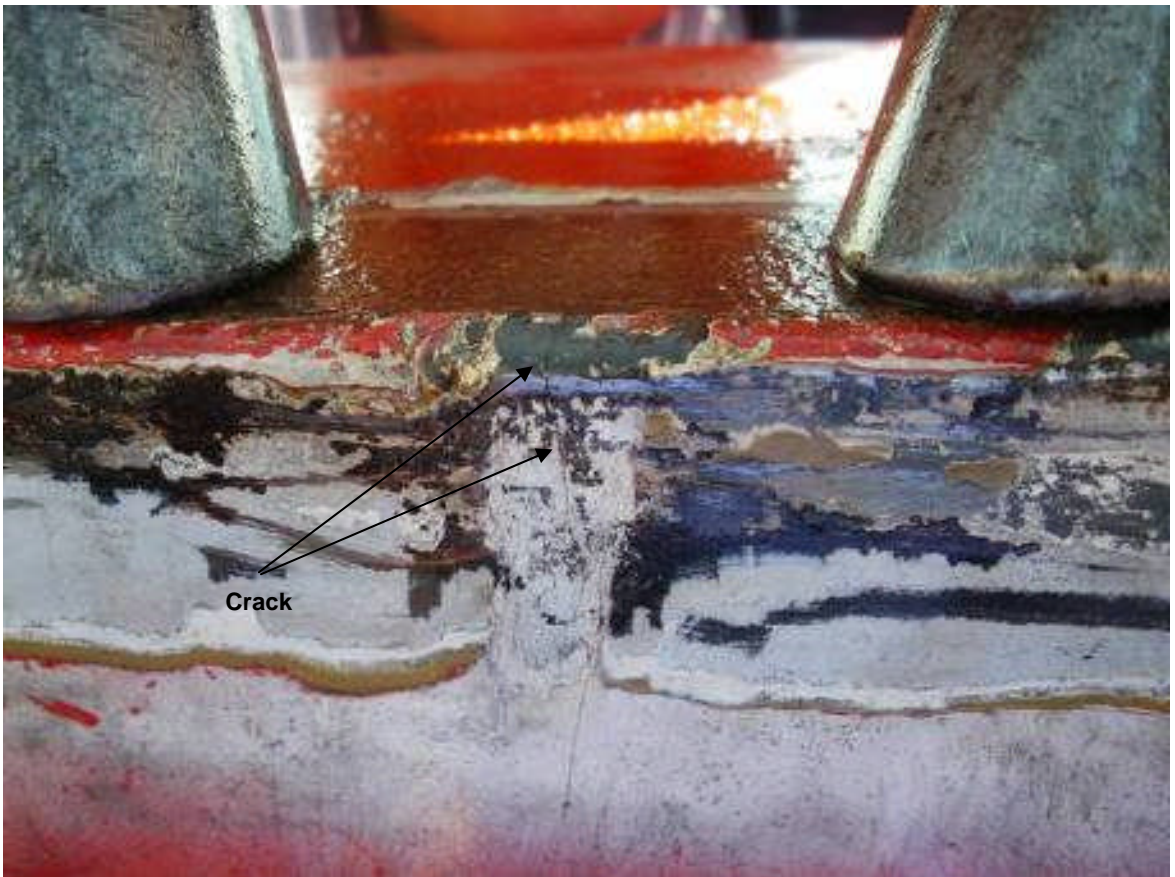
- Arm No.9 - The crack (see photograph IMG1610) was approximately 15mm long and had been found in the vertical channel and running across the weld in approximately the same position as the weld repair and subsequent catastrophic failure on Arm No.7.

IMGP1610 – Crack Identified On-site using Magnetic Particle Inspection

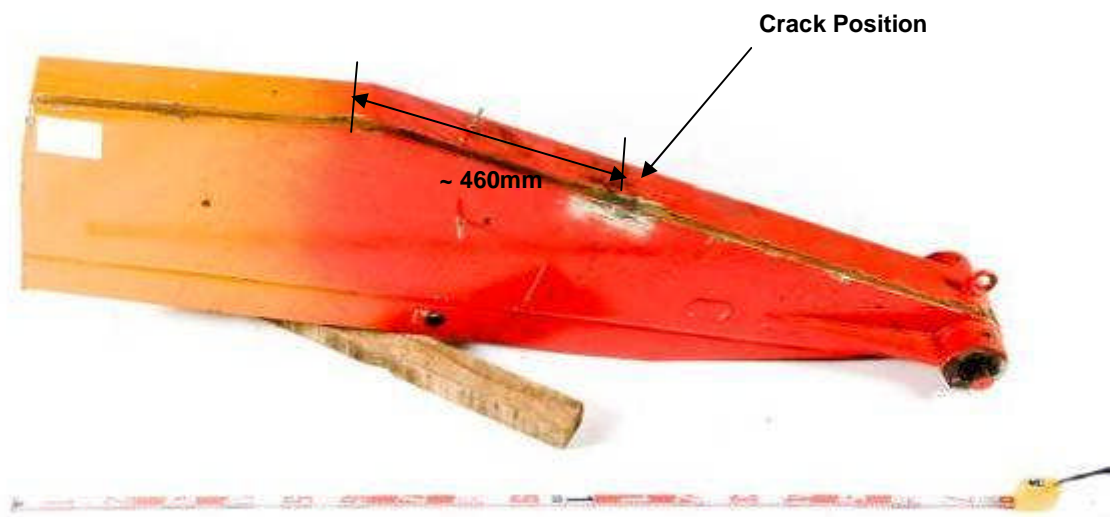
3.7 After the initial examination of the crack, on Arm No.9, [REDACTED] and [REDACTED] concluded that the arm could not be repaired and was to be scrapped. It was therefore agreed that the arm would be removed and cut up in exactly the same way as the catastrophically failed arm and the cracked section picked up and taken to HSL for a more detailed examination (see photograph 0908024_02).

0908024_02 – Arm with Crack

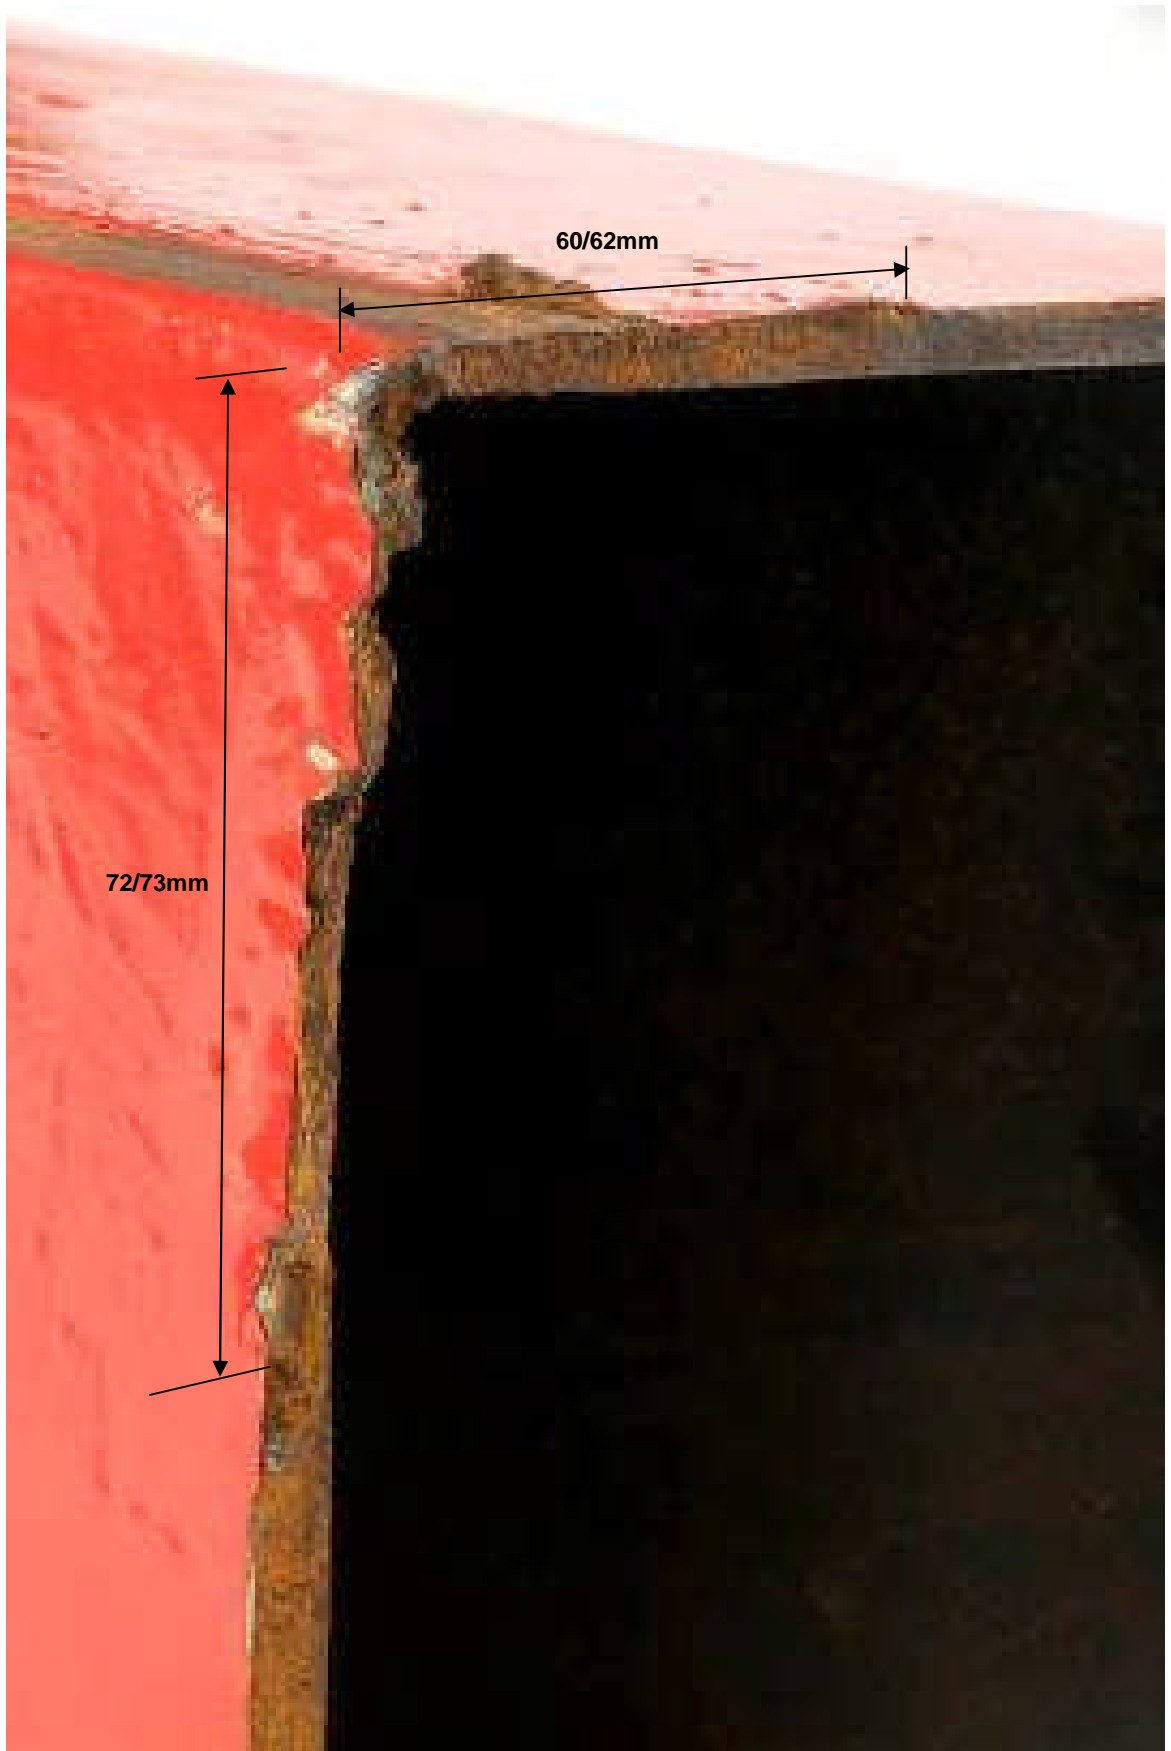
- *The weld runs were visible through the paint on the outer surfaces of the arm. The weld on the vertical side plate of the arm had been approximately 72-73mm long and that on the horizontal top plate of the arm had been approximately 60-62mm long.*

0908023_008 – Dimensions of Transverse Welds

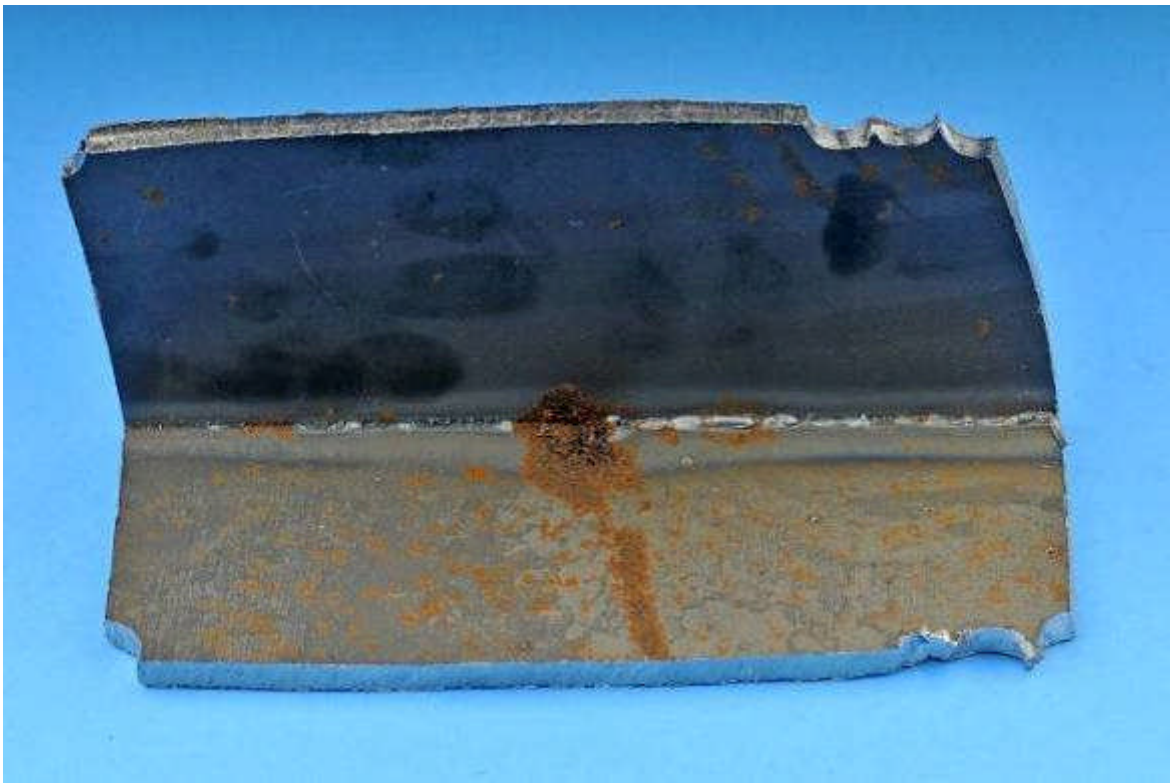
- After removal of the section of the arm around the crack-like indication the internal aspect of the fabrication weld could be seen. Once the corrosion build-up (see photograph Fig.05) had been removed, which itself showed that the crack was through thickness, it could be seen that there was a short weld bead extending from the underside of the top plate vertically downward. The weld bead internally was equivalent to the depth of the indicated crack found externally.

Fig.05 – Internal View of Cracked Arm

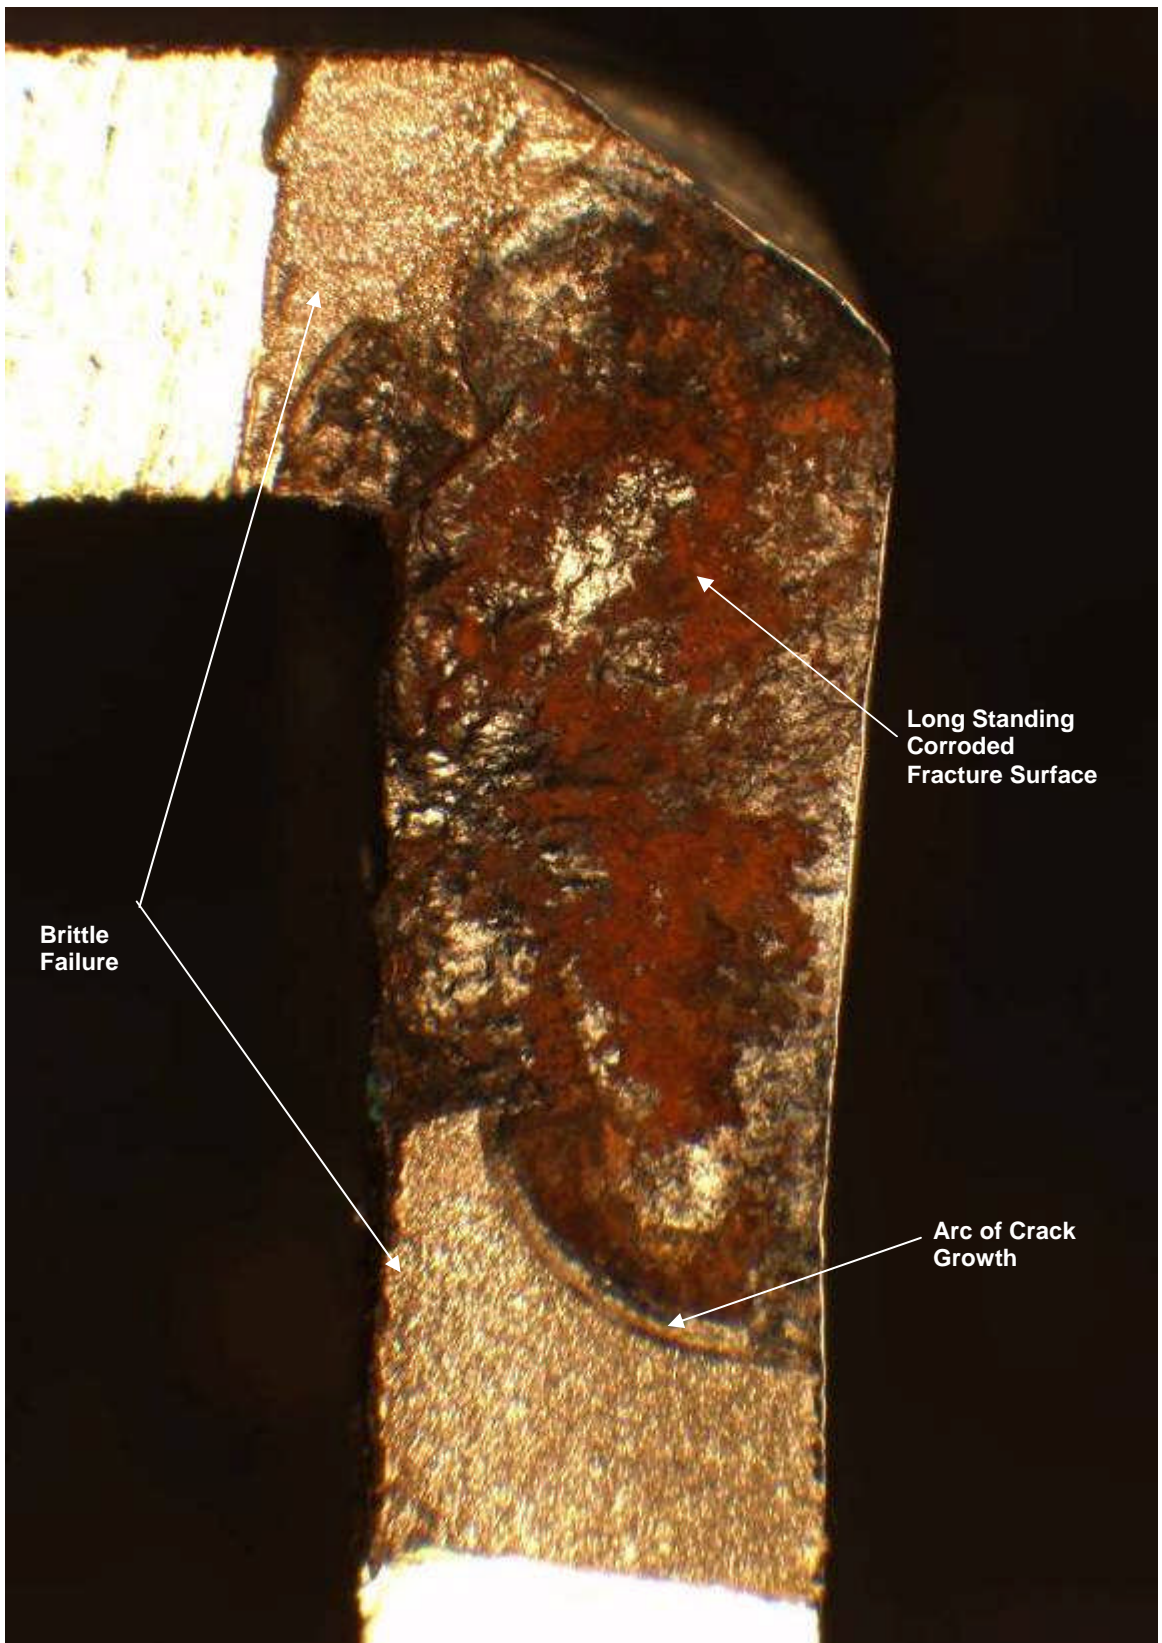
- The crack was opened at liquid nitrogen temperatures as shown in photograph Fig.10. This shows the long standing corroded defect, at the edges of which were smooth arcs of more recently produced fracture surface that suggested that the crack had been growing in size. Beyond these arcs of crack propagation the fracture transformed to the brittle fracture produced by the opening of the defect at liquid nitrogen temperatures.

Fig.10 – Opened Crack (Arm No.9)

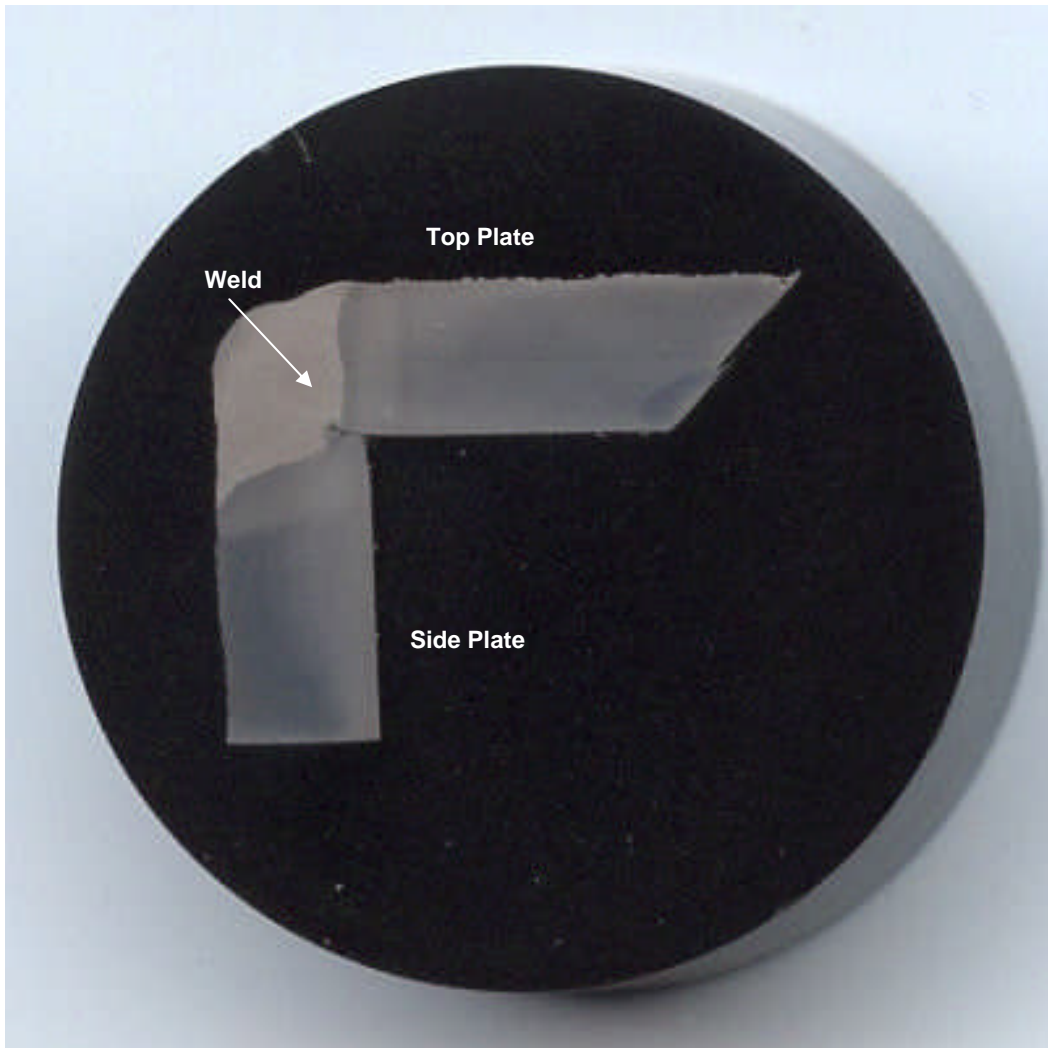
- The root of the longitudinal weld on this arm also exhibited varying depths of penetration (see photograph Fig.08) and the possibility of defects as annotated in photograph Fig.06. A section was taken through Defect 1 was taken and shown in photograph Fig.09. This section revealed a lap of weld metal at the internal surface with some lack of fusion. And from this there were some cracking propagating into the weld metal. The crack propagation appeared to be approximately 0.5mm into sound material. There was a similar lack of fusion at Defect 2 but this had not been

Fig.08 – Section Through Longitudinal Weld (Arm No.9)

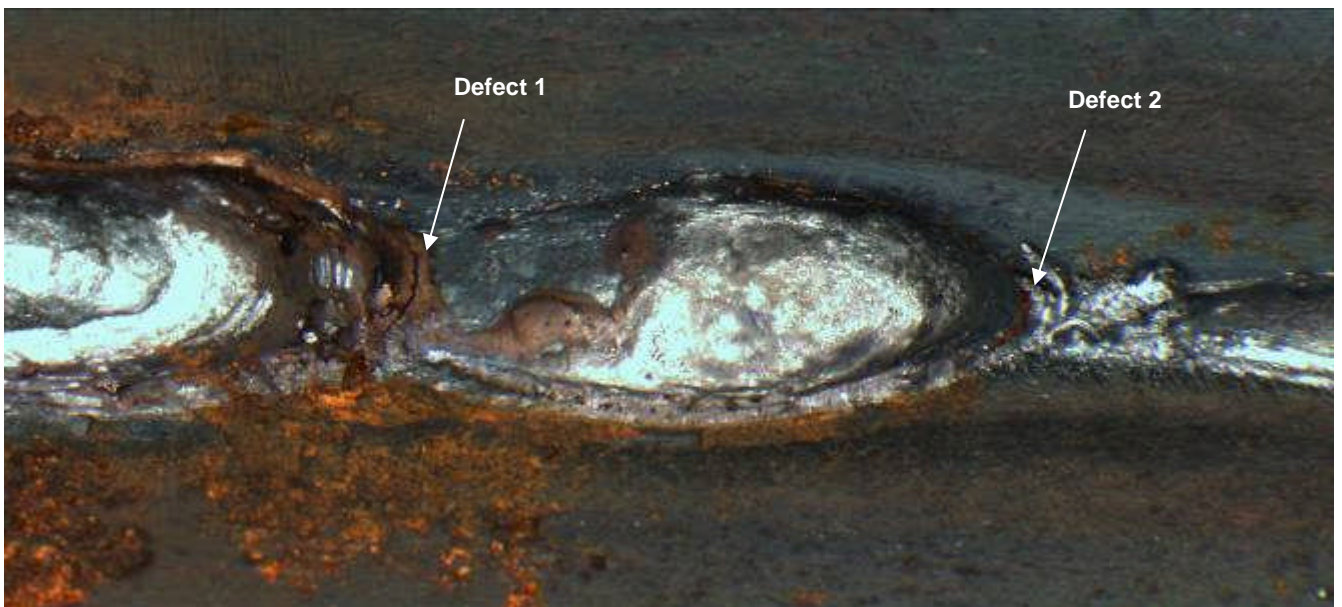
Fig.06 – Internal View of Weld Close to Crack (Arm No.9)

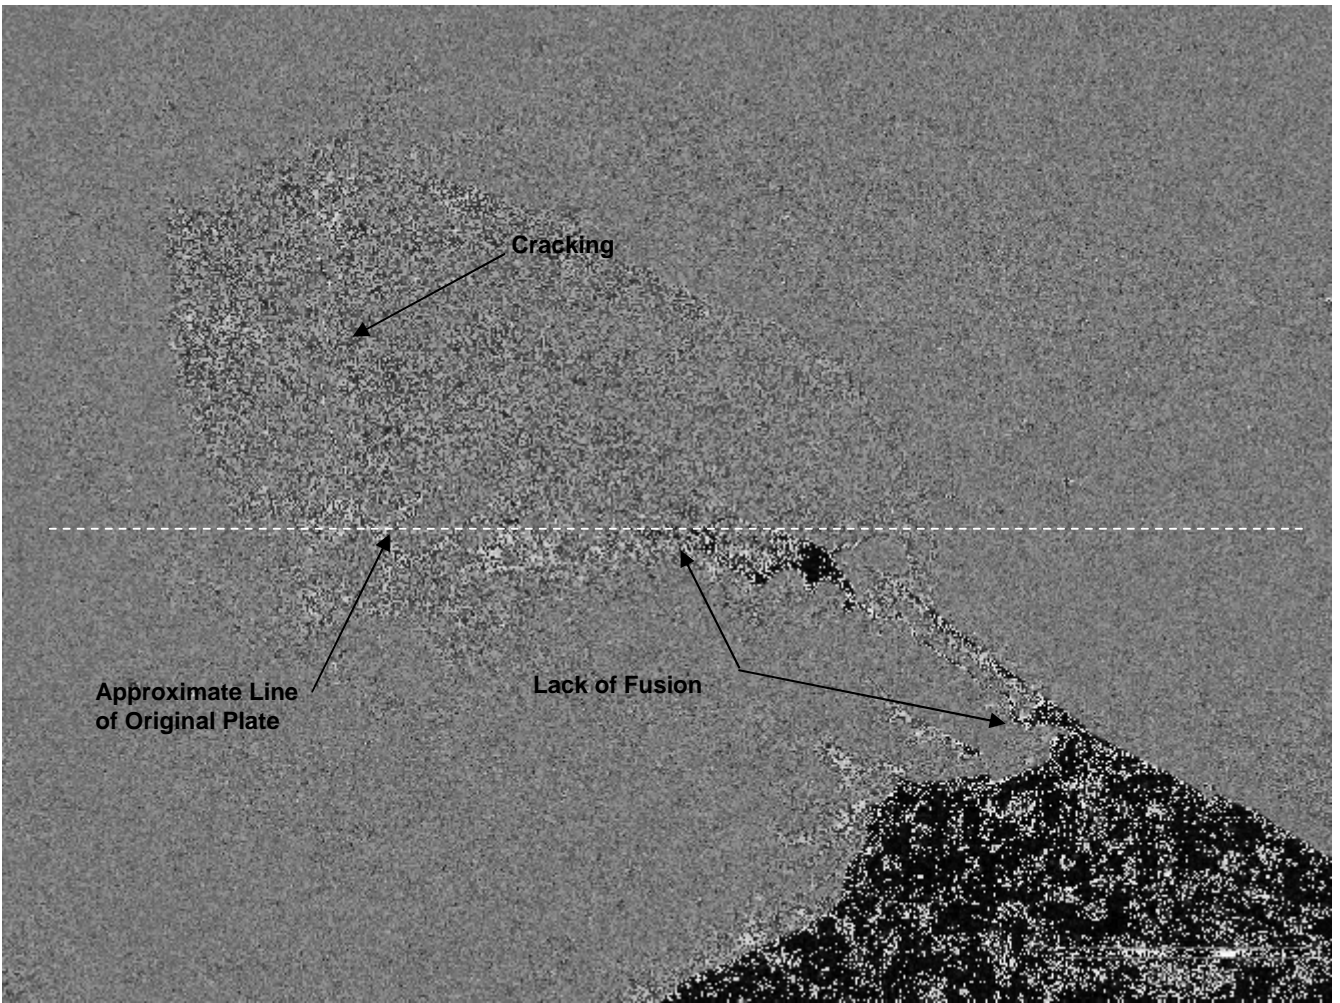
Fig.09 – Section Through Defect 1 (see Fig.06)
