OCTOPUS-SPIDER INSPECTION CHECK LIST

SWEEP SUPPORT ROD BULLETIN			
DRAWN BY: TMCQ	SCALE:	NO. REQ'D.:	MATERIAL:
DATE: 9-25-78	NEXT ASSY.:	BDS. NO.: 0-41-76	EFF. W/SN:
		SDD. BY NO.:	EFF. W/SN:

DATE: 3-30-74
 DRAWN BY: NEA
 SCALE: NONE
 NEXT ASSY:
 NO. REQ'D:
 MATERIAL:
 SDS NO.:
 SDD BY NO.:
 SPIDER
 BULLETIN O-39-74

Octo./Spider Sweep Support Rod Bulletin

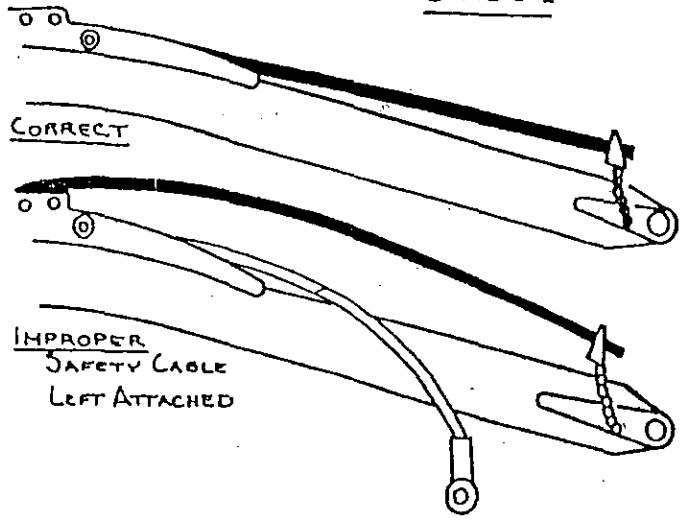
CAUSE 1

OPERATION OF THE SPIDER AMUSEMENT RIDE DEVICE WITH A BENT SWEEP SUPPORT ROD WILL CAUSE THE ROD TO BREAK AND WILL PERMIT A SWEEP TO FALL WITHOUT WARNING DURING OPERATION. ALL BENT OR DEFORMED RODS MUST BE REPLACED BEFORE OPERATION. FIELD REPAIRS ARE NOT RECOMMENDED OR AUTHORIZED BY THE FACTORY. THREE COMMON CAUSES OF ROD DEFORMATION OR BENDING ARE:

- 1) IMPROPER TRANSPORTING METHOD
IF, DURING TRANSPORTATION, THE SAFETY CABLE AND PIN ARE LEFT ATTACHED TO SWEEP, THE SUPPORT ROD WILL REST ON THE CABLE END AND WILL BEND OR DEFORM AT THAT POINT.
- 2) IMPROPER ASSEMBLY METHOD
IF, DURING ASSEMBLY, SWEEPS AND SWEEP RODS ARE NOT ASSEMBLED IN CONSECUTIVE SEQUENCE BEGINNING WITH FIRST SWEEP ATTACHED, A ROD MAY BE ATTACHED TO THE WRONG EAR ON THE ECCENTRIC HUB. UPON FURTHER ROTATION THE SWEEP ROD WILL BEND OR DEFORM AT ATTACHING POINT. DURING ASSEMBLY FROM TRAILER ECCENTRIC CRANK MUST BE POSITIONED PARALLEL TO REAR OF TRAILER POINTED LEFT (PASSENGER SIDE), ECCENTRIC CRANK IS NOT TO BE ROTATED DURING ASSEMBLY OF SWEEPS.
- 3) CARELESS DISASSEMBLY
IF, DURING DISASSEMBLY, SWEEP IS LIFTED BY HOIST BEYOND ROD DISCONNECT POINT FROM ECCENTRIC HUB ROD WILL LOCK AGAINST ECCENTRIC HUB ATTACHMENT AND WILL BEND OR DEFORM.

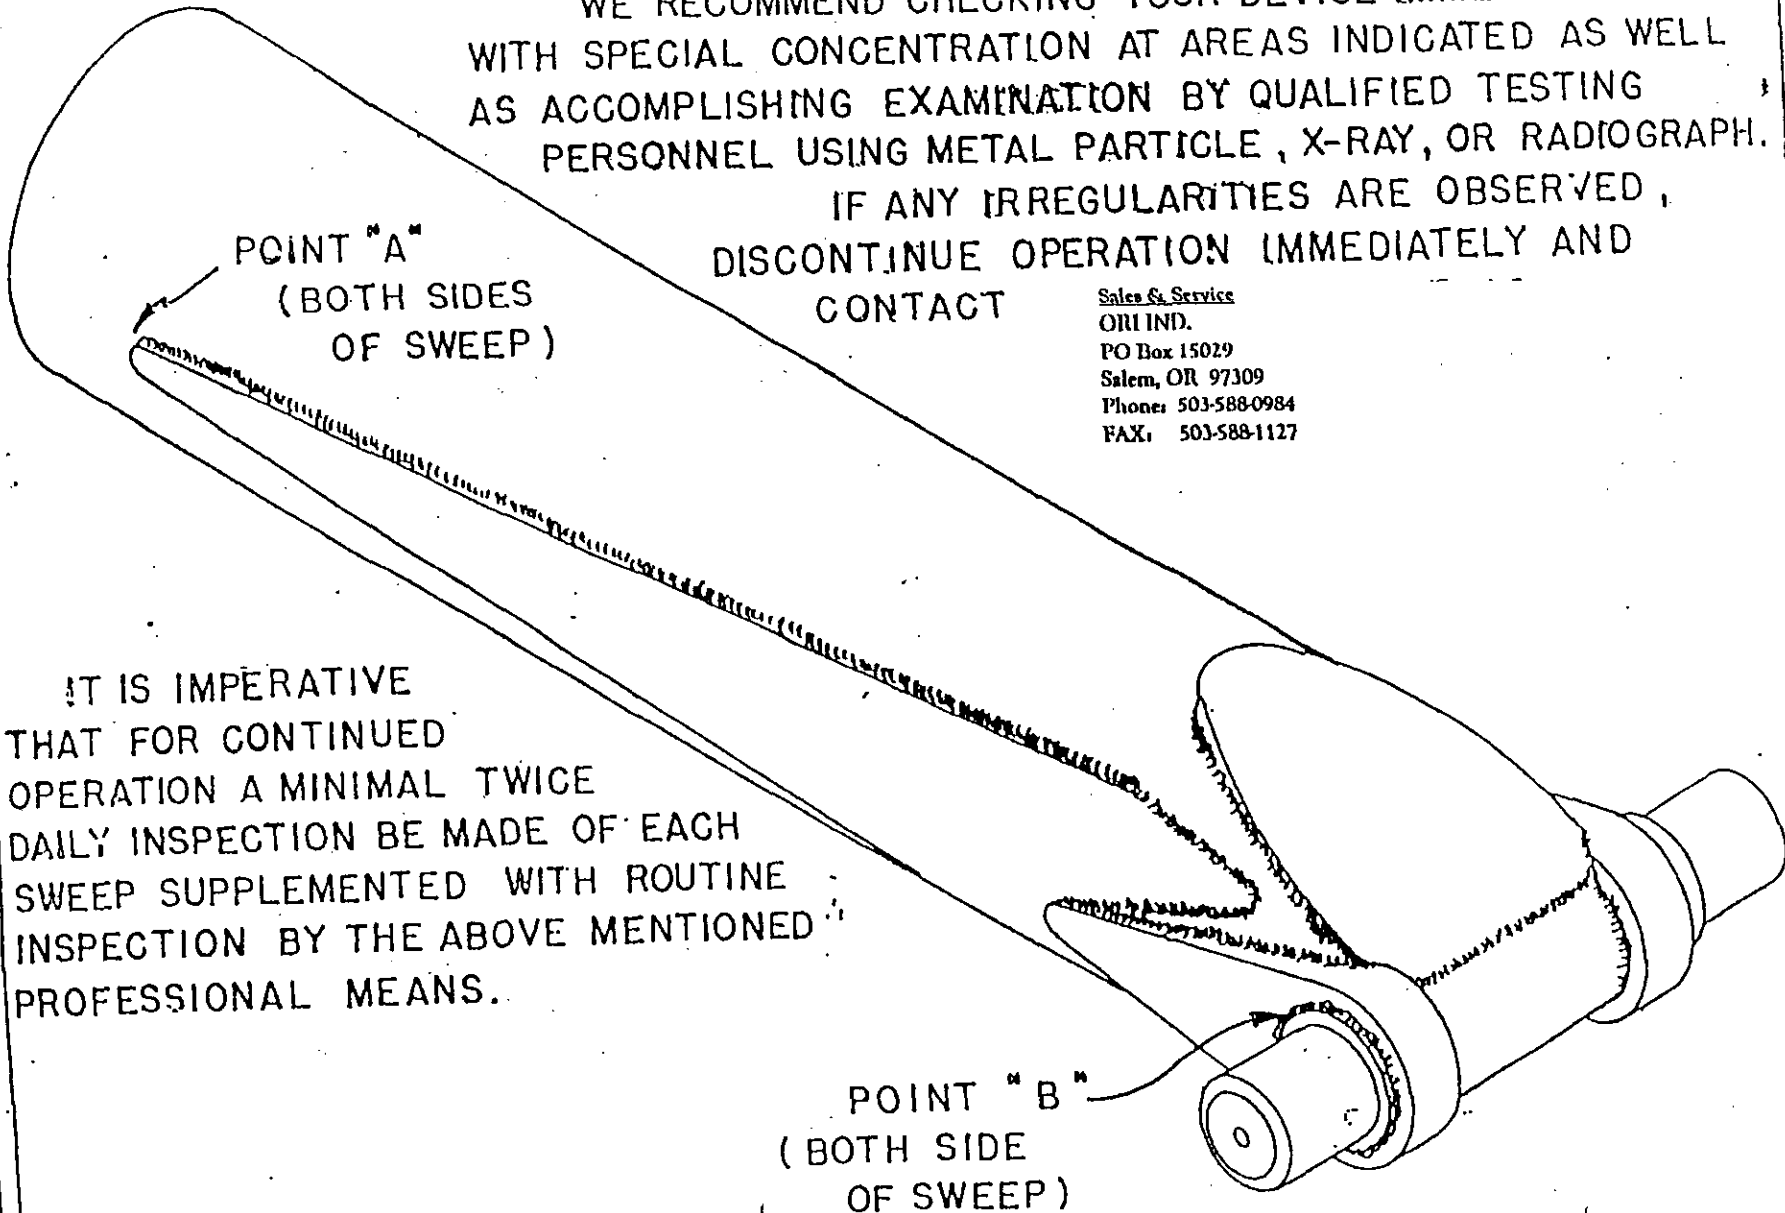
Drg. No. 0-45/10-7

WE HAVE BEEN ADVISED OF A CURVED SWEEP FAILURE WITH INDICATION OF ORIGINAL BREAKING AT POINT "A" AS SHOWN BELOW. ALSO, SOME HAIRLINE CRACKS HAVE BEEN REPORTED IN THE AREA OF ATTACHMENT OF THE SWEEP SPINDLE TO THE REINFORCING TEARDROP GUSSETS DESIGNATED AS POINT "B" BELOW.

WE RECOMMEND CHECKING YOUR DEVICE IMMEDIATELY WITH SPECIAL CONCENTRATION AT AREAS INDICATED AS WELL AS ACCOMPLISHING EXAMINATION BY QUALIFIED TESTING PERSONNEL USING METAL PARTICLE, X-RAY, OR RADIOGRAPH. IF ANY IRREGULARITIES ARE OBSERVED, DISCONTINUE OPERATION IMMEDIATELY AND CONTACT

IT IS IMPERATIVE THAT FOR CONTINUED OPERATION A MINIMAL TWICE DAILY INSPECTION BE MADE OF EACH SWEEP SUPPLEMENTED WITH ROUTINE INSPECTION BY THE ABOVE MENTIONED PROFESSIONAL MEANS.

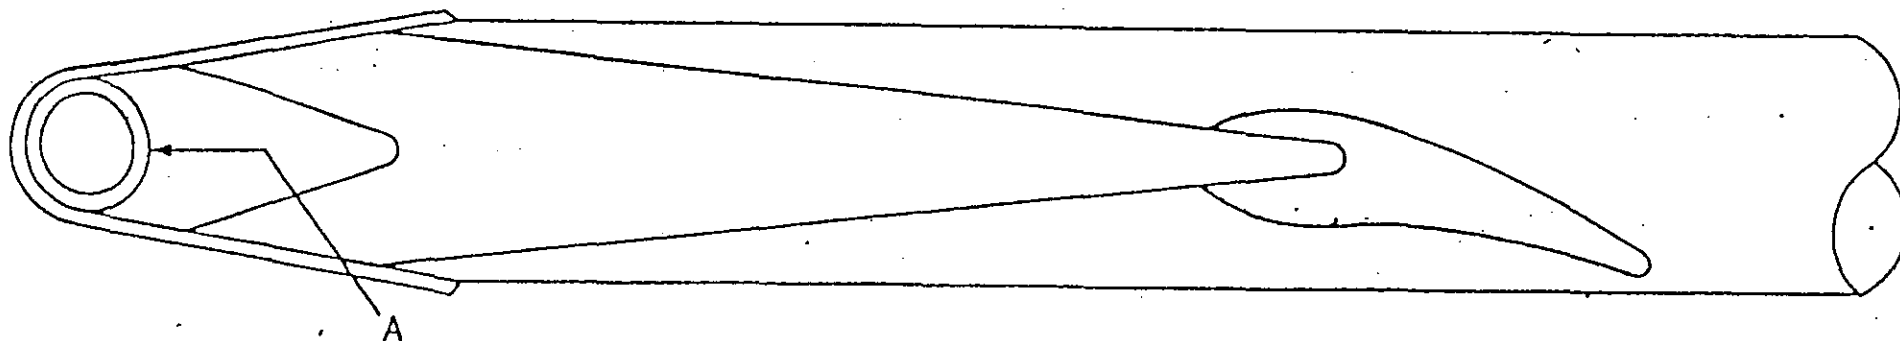
WE HAVE LEARNED OF A SWEEP FAILURE ON A SPIDER DEVICE
 MANUFACTURED BY EYERLY AIRCRAFT COMPANY.
 THE FAILURE OCCURED AT THE HINGE PIN WELDMENT. Note: Fig. "A"
 AS A PUBLIC SERVICE TO THE INDUSTRY, JVI IS ISSUING BULLETIN NO.8-88-1,
 RELATIVE TO THE EYERLY AIRCRAFT CO. 0-619 SWEEP WITH THE 16" HINGE PIN.
 IT IS ADVISED THAT YOU IMMEDIATELY INSPECT THE SWEEPS
 FOR FAILURE IN THIS AREA, (BOTH SIDES). IF CRACKING IS FOUND, NOTE LOCATION
 AND LENGTH, AND ADVISE ORI IND. @ (503) 588-0984 IMMEDIATELY

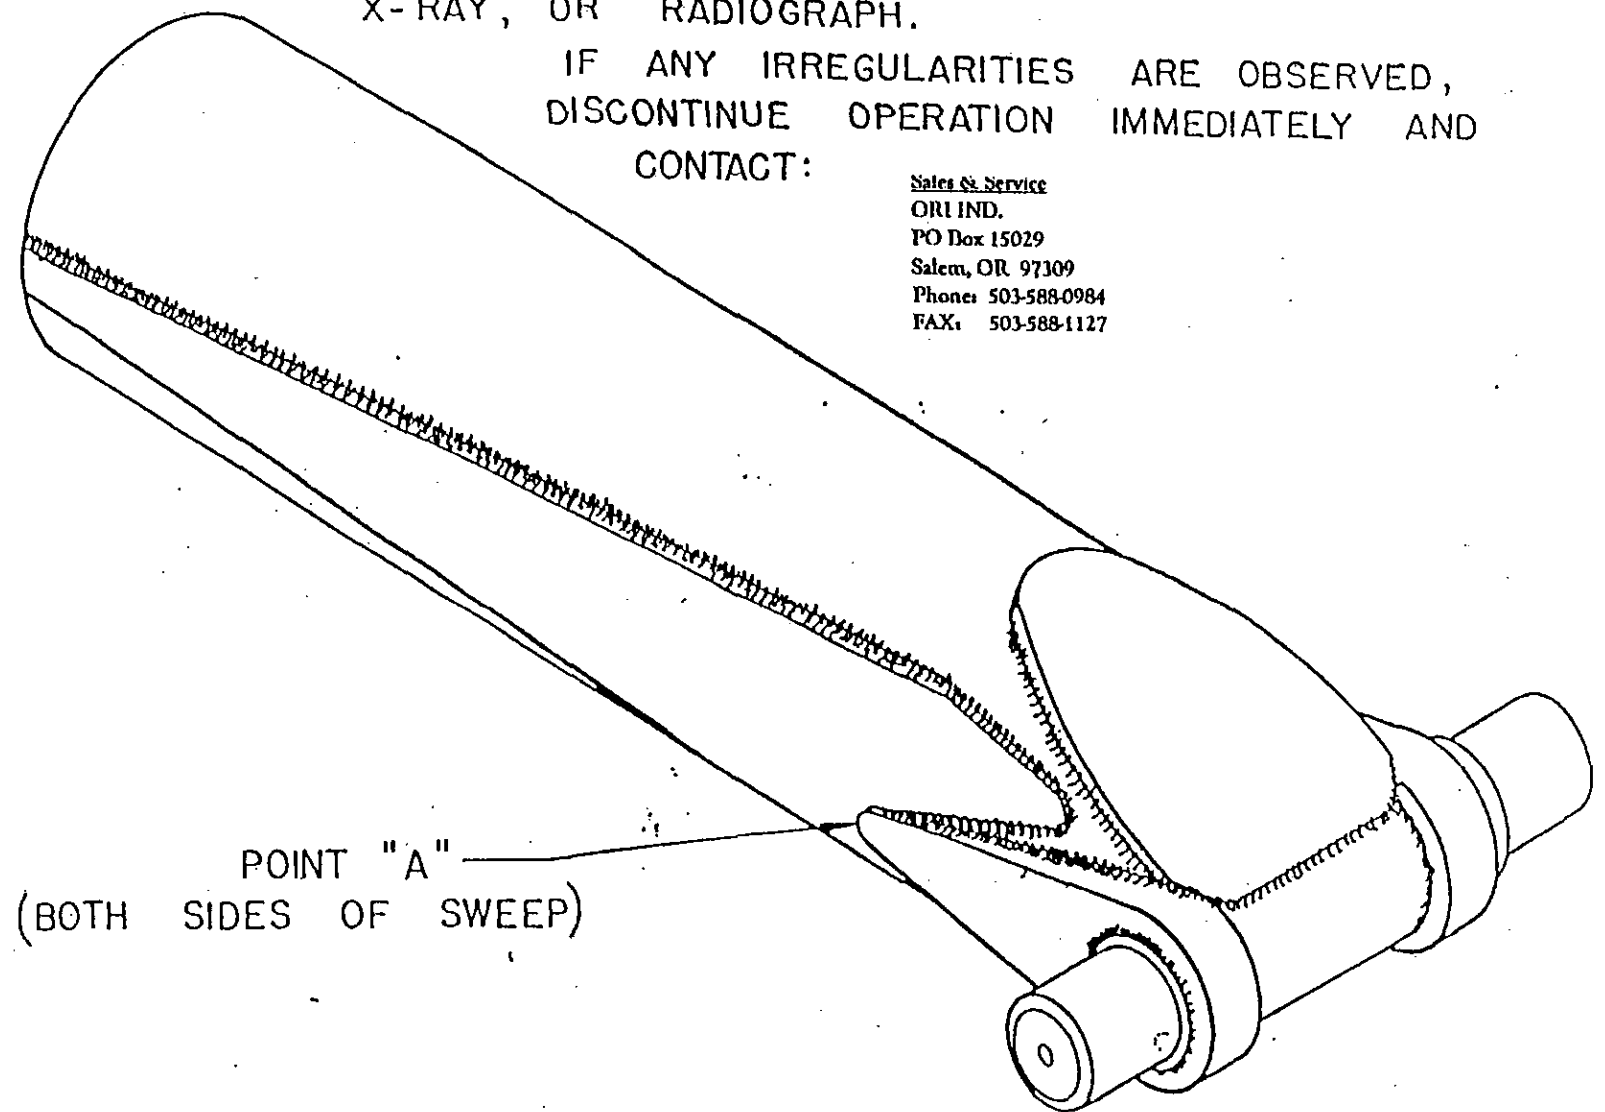
POINT "A"
(BOTH SIDES OF SWEEP)

WE HAVE BEEN ADVISED OF SOME THAIRLINE CRACKS IN THE WELDMENT OF THE SPINDLE REINFORCING TEARDROP GUSSET TO THE SWEEP TUBE, DESIGNATED AS POINT "A" BELOW.

WE RECOMMEND CHECKING YOUR DEVICE IMMEDIATELY WITH SPECIAL CONCENTRATION AT AREA INDICATED AS WELL AS ACCOMPLISHING EXAMINATION BY QUALIFIED TESTING PERSONNEL USING METAL PARTICLE, X-RAY, OR RADIOGRAPH.

IF ANY IRREGULARITIES ARE OBSERVED, DISCONTINUE OPERATION IMMEDIATELY AND CONTACT:

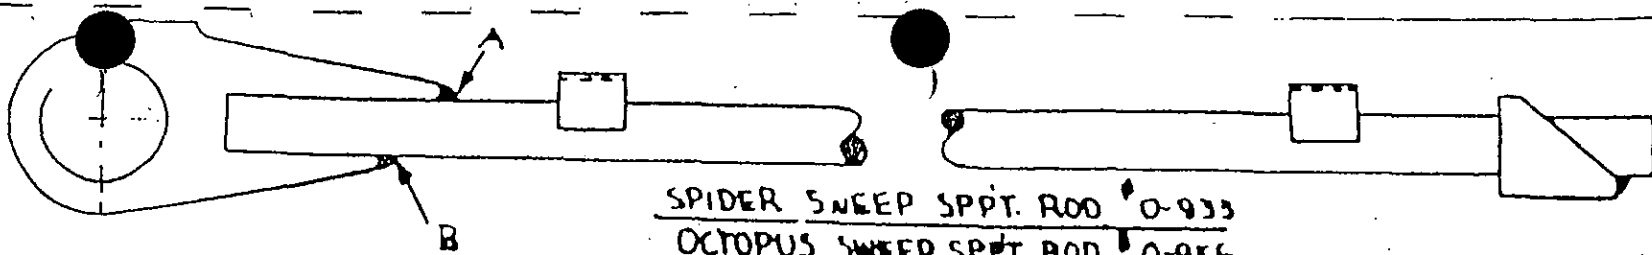
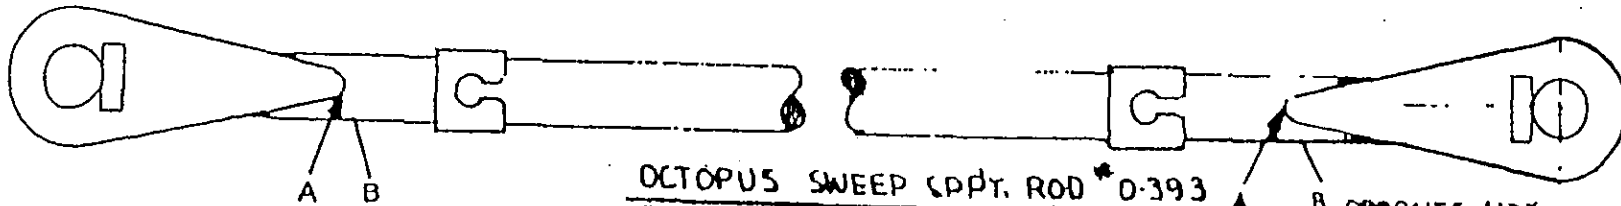
OPERATION OF THE SPIDER OR OCTOPUS AMUSEMENT RIDE WITH DEFECTIVE SWEEP SUPPORT RODS, (CRACKED, BENT OR OTHERWISE DEFORMED) WILL RESULT IN FAILURE OF THE ROD AND WILL PERMIT THE SWEEP TO FALL WITHOUT WARNING DURING OPERATION. ALL GREASE, GRIME AND DIRT SHOULD BE REMOVED FROM AREAS "A" AND "B" SHOWN, AND N.D.T. TESTED, USING MAGNETIC PARTICAL PROCESS. ALL CRACKED OR OTHERWISE DEFECTIVE RODS MUST BE REPLACED BEFORE OPERATION. FIELD REPAIRS ARE NOT RECOMMENDED. IT IS RECOMMENDED THAT A VISUAL CHECK BE MADE EACH SET-UP OR EVERY SEVEN DAYS, SPECIFICALLY IN AREA SHOWN.

ALL RODS SHOULD BE CHECKED EVERY 200 HOURS OF OPERATION USING THE ABOVE MAGNETIC PARTICAL METHOD. ANY DEFECTIVE ROD FOUND SHOULD BE REPLACED WITH A NEW FACTORY ROD ONLY.

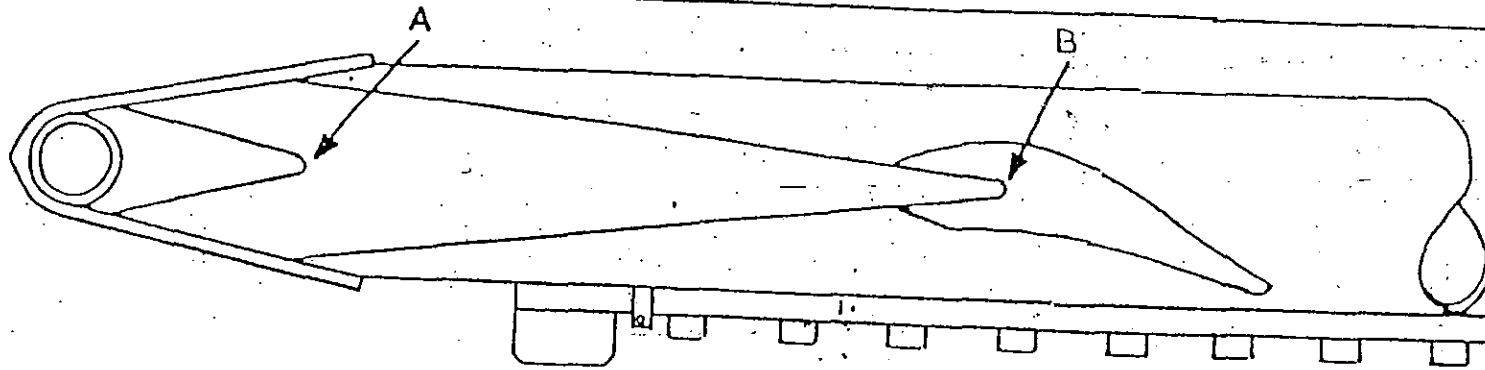
WE HAVE BEEN ADVISED OF SOME HAIRLINE CRACKS THAT HAVE DEVELOPED IN THE WELDMENTS AT POINTS 'A' AND 'B' (BOTH SIDES) OF THE SPIDER SWEEP, PART 0-619. IT IS IMPERATIVE THESE POINTS BE THOROUGHLY INSPECTED IMMEDIATELY UPON RECEIPT OF THIS BULLETIN. IT IS RECOMMENDED THE INSPECTION BE MADE BY QUALIFIED AND APPROVED TESTING PERSONNEL, EMPLOYING MAGNETIC PARTICLE, X-RAY, OR RADIOGRAPH PROCEDURES. IF THE INSPECTION REVEALS ANY IRREGULARITIES, OPERATION OF THE DEVICE SHOULD BE DISCONTINUED IMMEDIATELY. REPAIR IS TO BE DONE BY A QUALIFIED FACILITY KNOWLEDGEABLE IN APPROVED METHODS OF A.W.S. - A.S.M.E. STANDARDS.

IT IS RECOMMENDED THAT A VISUAL INSPECTION BE MADE AT EACH SET-UP OR EVERY SEVEN DAYS OF OPERATION, SPECIFICALLY IN AREAS NOTED.

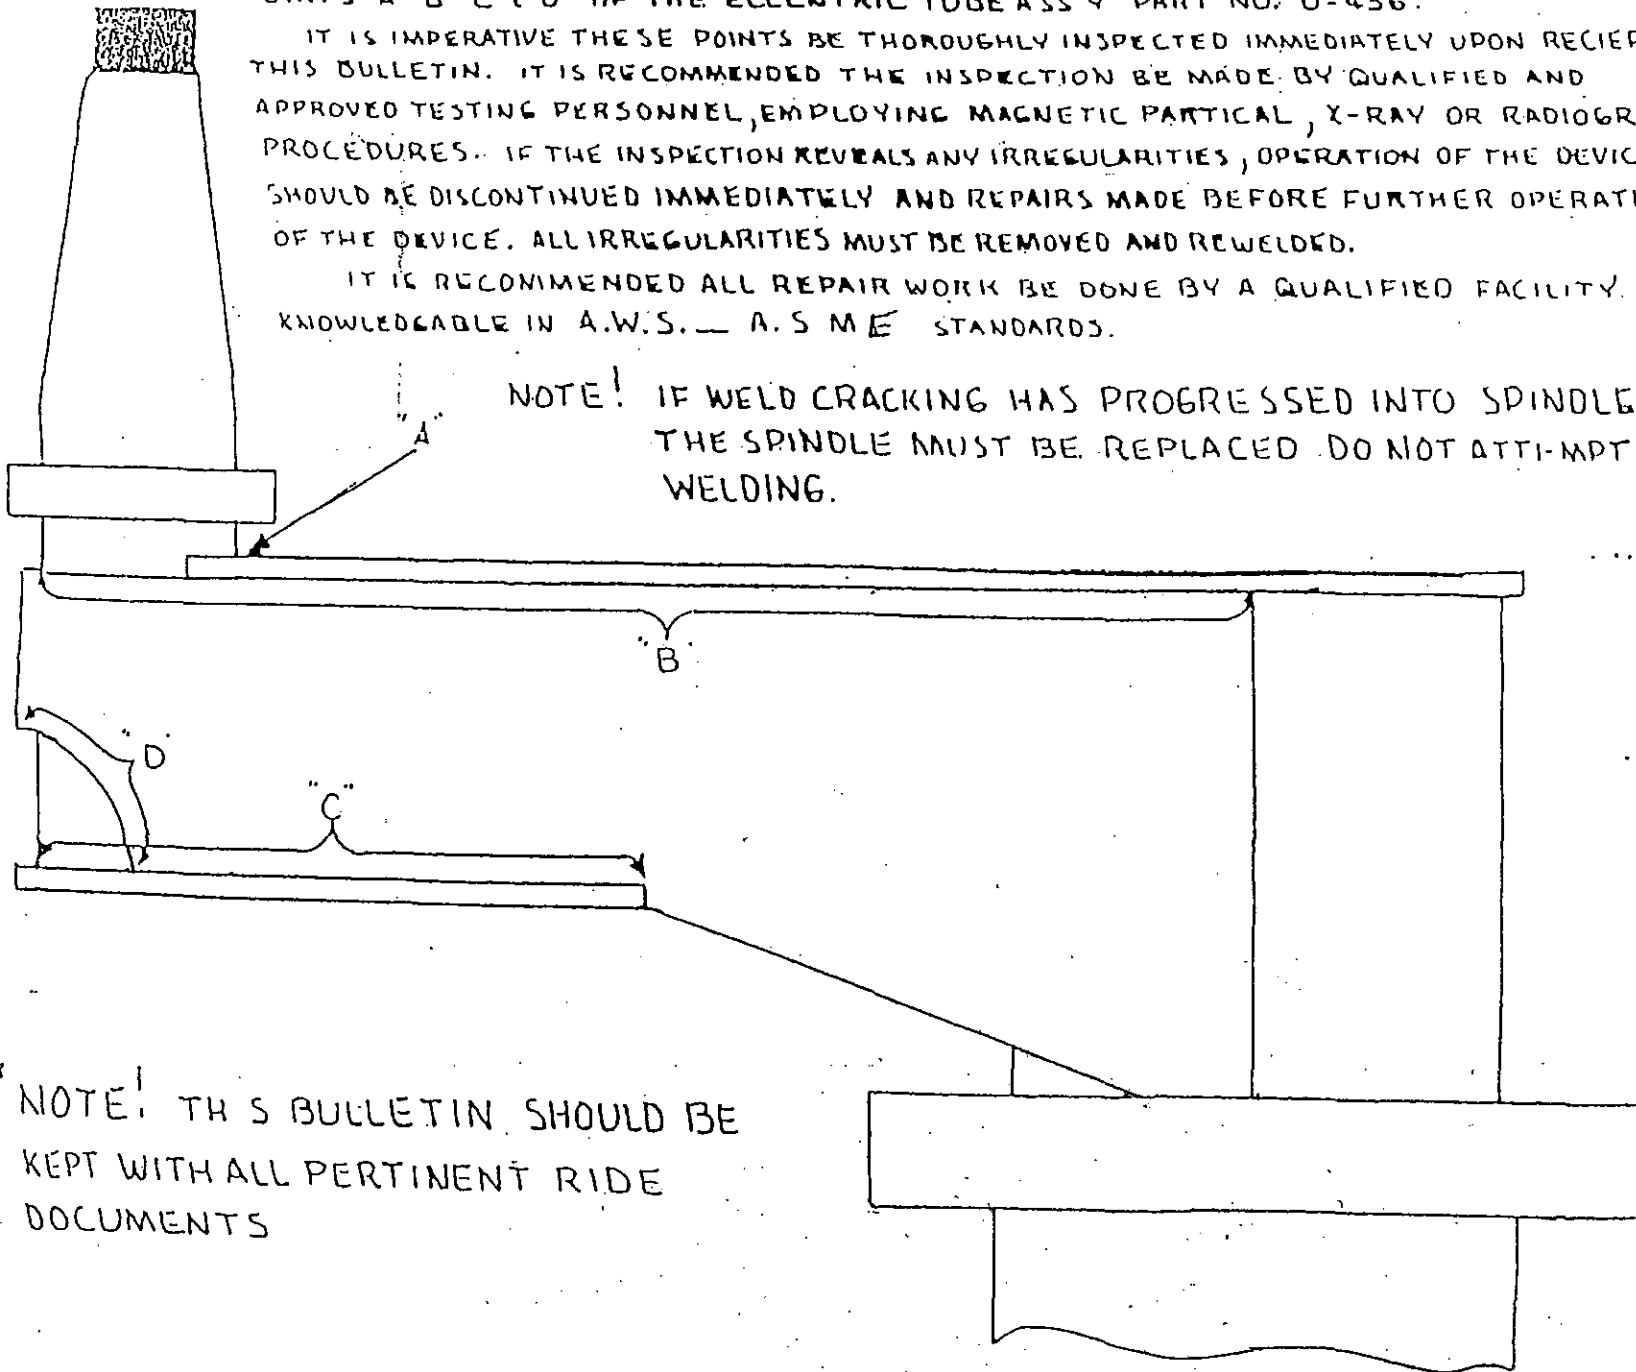
WE HAVE BEEN ADVISED OF SOME HAIRLINE CRACKS THAT HAVE DEVELOPED IN THE WELDMENTS AT POINTS "A B C & D" OF THE ECCENTRIC TUBE ASS'Y PART NO. 0-436.

IT IS IMPERATIVE THESE POINTS BE THOROUGHLY INSPECTED IMMEDIATELY UPON RECEIPT OF THIS BULLETIN. IT IS RECOMMENDED THE INSPECTION BE MADE BY QUALIFIED AND APPROVED TESTING PERSONNEL, EMPLOYING MAGNETIC PARTICAL, X-RAY OR RADIOGRAPH PROCEDURES. IF THE INSPECTION REVEALS ANY IRREGULARITIES, OPERATION OF THE DEVICE SHOULD BE DISCONTINUED IMMEDIATELY AND REPAIRS MADE BEFORE FURTHER OPERATION OF THE DEVICE. ALL IRREGULARITIES MUST BE REMOVED AND REWELDED.

IT IS RECOMMENDED ALL REPAIR WORK BE DONE BY A QUALIFIED FACILITY KNOWLEDGABLE IN A.W.S. — A. S. M. E. STANDARDS.

NOTE! IF WELD CRACKING HAS PROGRESSED INTO SPINDLE, THE SPINDLE MUST BE REPLACED. DO NOT ATTEMPT WELDING.

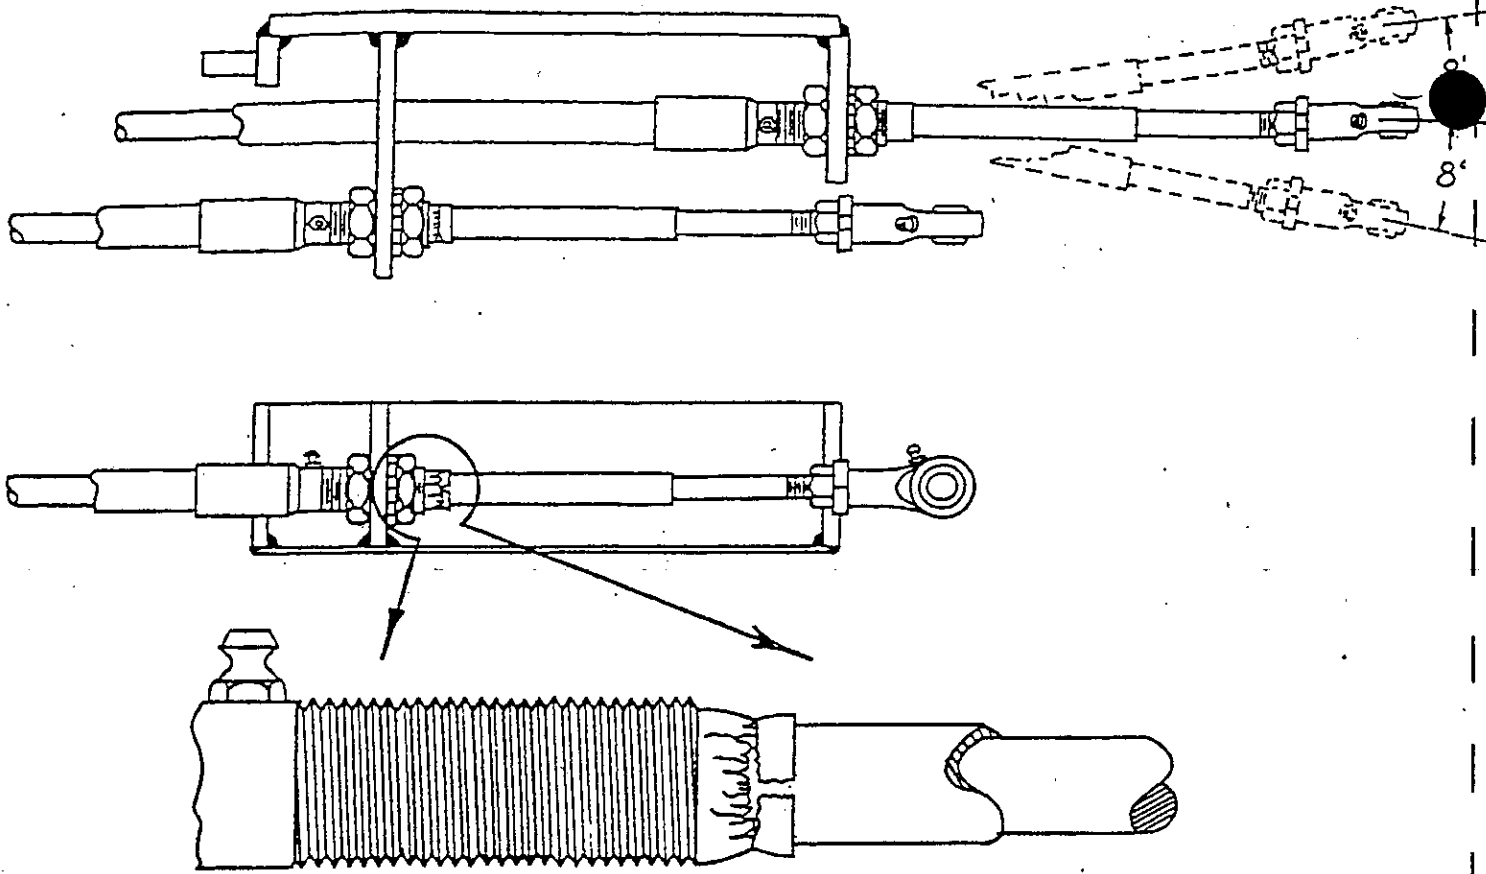
Some operators have swiveled the control cable rods beyond the recommended maximum 8° angle when removing from the clutch and brake control levers. Too much cable travel between "brake on" and "clutch engaged" will also exceed the recommended maximum 8° angle at the control stand. Either condition will result in failure at the cable swivel joint.

Please examine your cables for failures and notify us of the type of failure, short or long cable, and which end. Damaged cables should be replaced although they will still operate if the stroke is maintained within the 4" limit.

Kits to eliminate failures will soon be available.

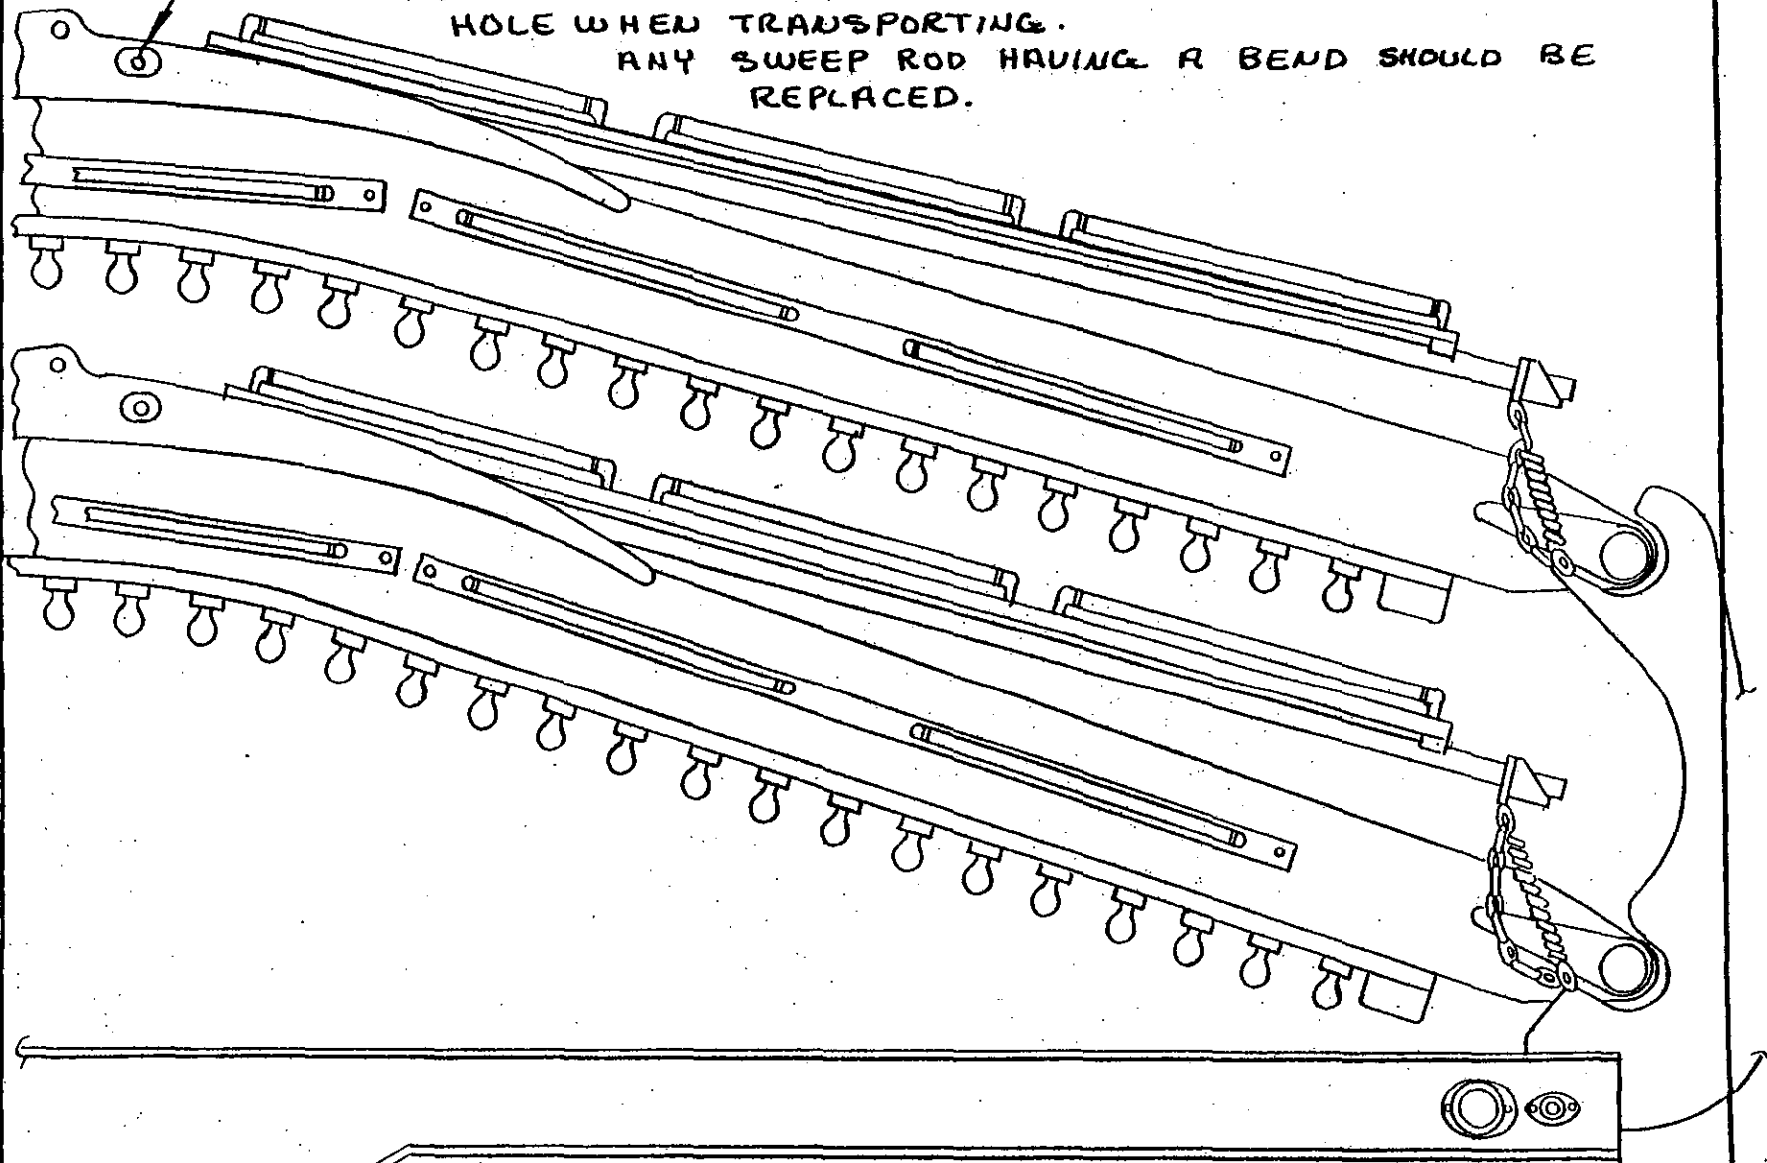
SAFETY CABLE PIN (O-626) TRANSPORTING BULLETIN

IT HAS BEEN BROUGHT TO OUR ATTENTION THAT THE O-626 SAFETY CABLE PIN IS BEING LEFT IN THE SWEEP WHEN TRANSPORTING. THIS CAUSES SWEEP RODS TO BEND WHICH CREATES EXCESS STRESSES AT THE EAR WELD ATTACHING POINT CAUSING POSSIBLE FATIGUE FAILURES DURING RIDE OPERATION.

UNDER NO CIRCUMSTANCE SHOULD THIS PIN BE LEFT IN ITS HOLE WHEN TRANSPORTING.

ANY SWEEP ROD HAVING A BEND SHOULD BE REPLACED.

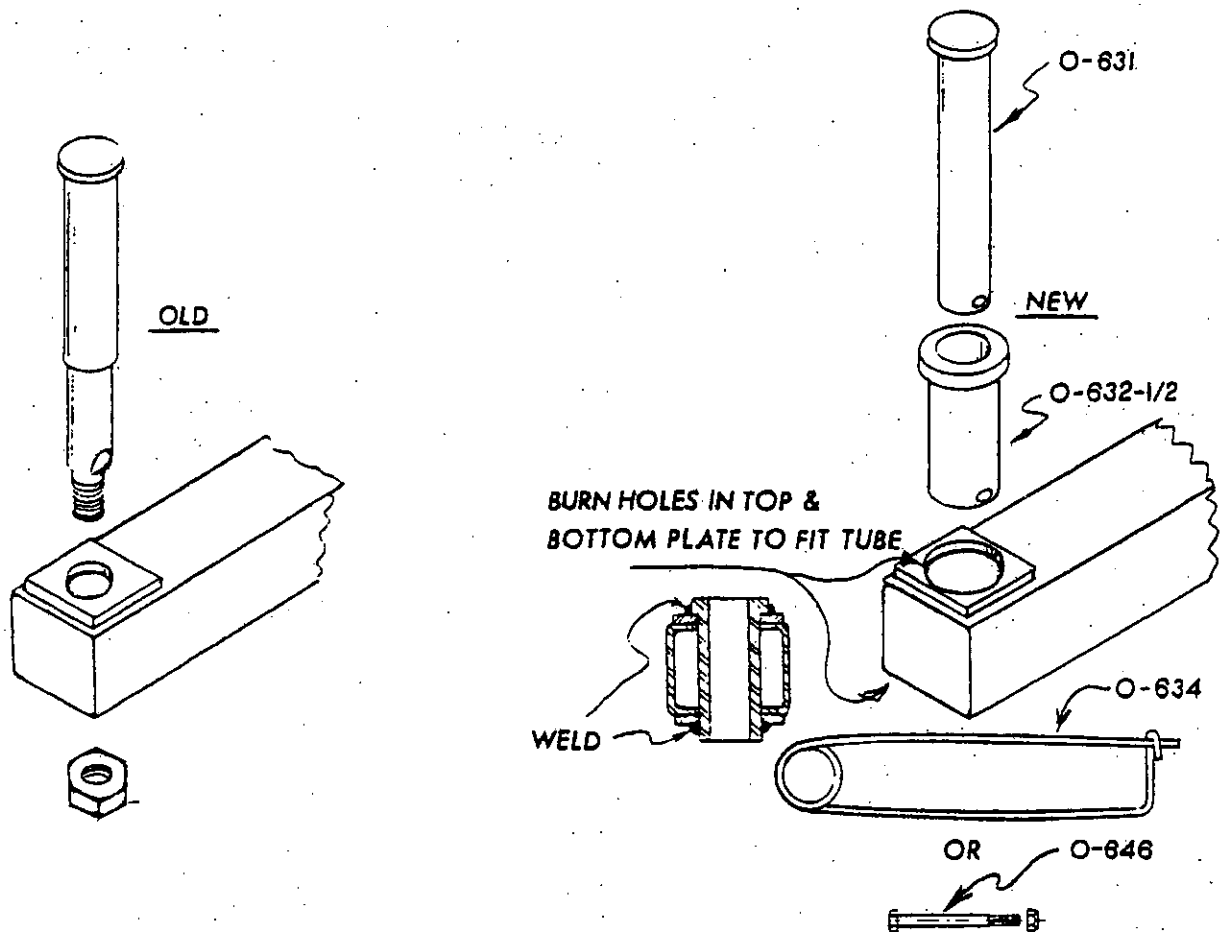
Car Spindles. Poor maintenance and improper operating practices have caused spindle failures and resulting injuries to passengers. We recommend replacement of your Car Spindles and modification of the sweep spindle securing area as illustrated below.

Car Spindle, Part No. O-631 and Car Support Tube, Part No. O-632-1/2 will be furnished at [redacted] per set for one car mounting. In addition, Car Spindle Lock Pin, Part No. O-634 will be furnished at [redacted] each or Car Spindle Lock Bolt and Nut, Part No. O-646 at [redacted] each. See reverse side of this Bulletin for installation instructions. No car modifications are required. Material will be forwarded upon receipt of proper shipping instructions.
