Doppelmayr CTEC inc

SUBJECT: Bulletin No. SB-03-006

CHAIR NUMBER PLATES

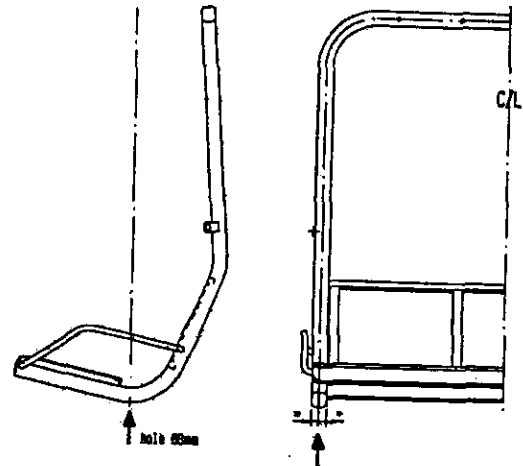
Recently, a case of severe corrosion has been found in a few chair bails of a triple chairlift in service since 1980. The corrosion went trough the bottom wall of the square tube of the chair bail at the lowest point of the chair (when installed on the cable). The corrosion appeared to the inspector as a small rust point and have been confirmed with a hammer (went trough).

We have observed that those chairs didn't have draining holes at the bottom of the chair bail, and that there was a lack of inside galvanized coating.

If you find a lack of draining holes, or blocked holes, at the bottom of a carrier with square tubes, please proceed to the next steps;

- Drill a 8 mm diameter draining hole at each side of the bottom of the chair bail as per figure beside.
- Once the hole is done, or unblocked, check the thickness of the remaining material, which should not reach the minimum value stated in table 1.

Thickness can be measured with a caliper or a depth gage trough the hole. In case of doubt, accurate thickness measurement is also possible by mean of an ultrasonic thickness gage.

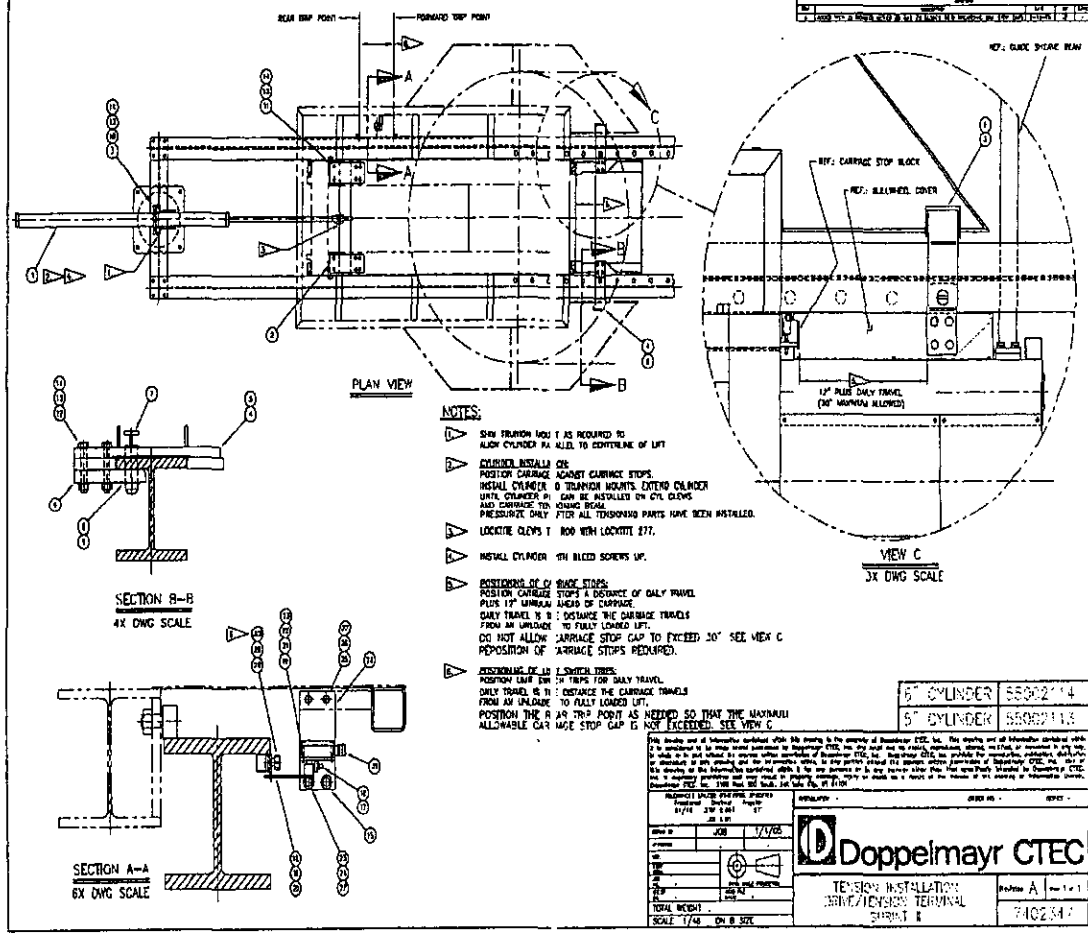
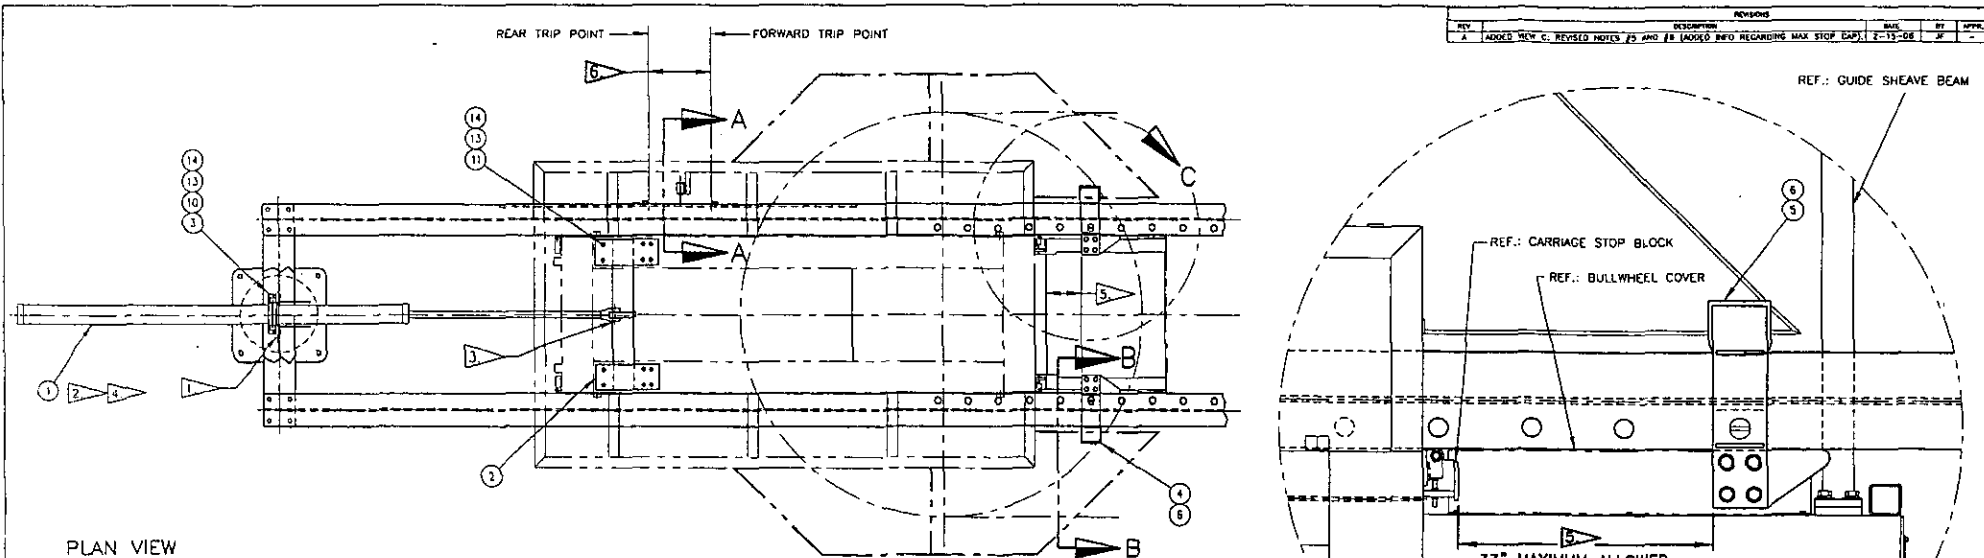
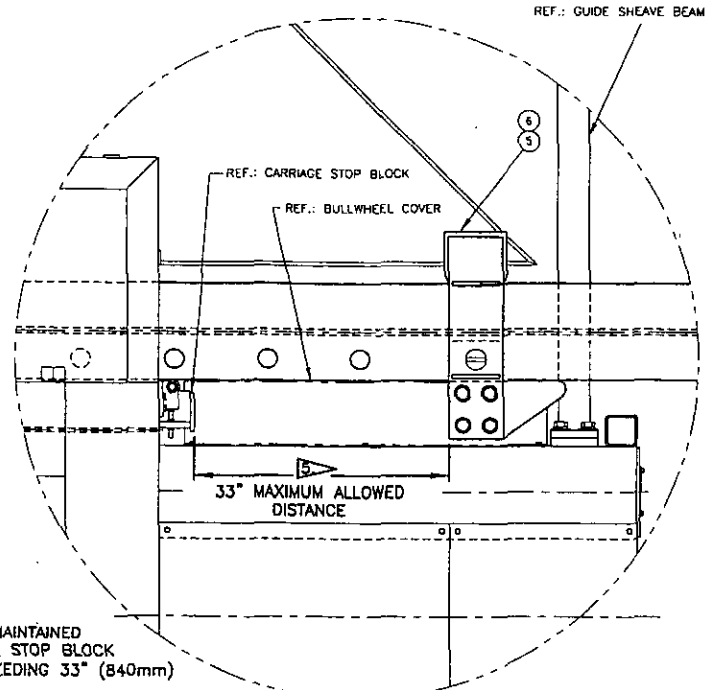
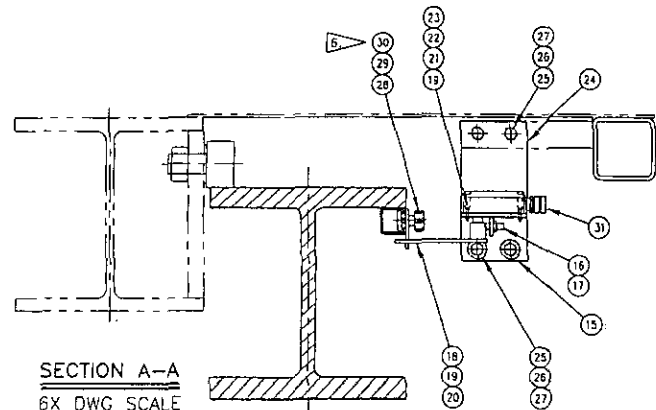
5 **POSITIONING OF CARRIAGE STOPS:**
POSITION CARRIAGE STOPS A DISTANCE OF DAILY TRAVEL PLUS 12" MINIMUM AHEAD OF CARRIAGE. DAILY TRAVEL IS THE DISTANCE THE CARRIAGE TRAVELS FROM AN UNLOADED TO FULLY LOADED LIFT. THE POSITION OF THE CARRIAGE STOPS MUST BE MAINTAINED TO PREVENT THE DISTANCE BETWEEN THE CARRIAGE STOP BLOCK AND CARRIAGE STOP (TYP BOTH SIDES) FROM EXCEEDING 33" (840mm) SEE VIEW C

6 **POSITIONING OF LIMIT SWITCH TRIPS:**
POSITION LIMIT SWITCH TRIPS FOR DAILY TRAVEL. DAILY TRAVEL IS THE DISTANCE THE CARRIAGE TRAVELS FROM AN UNLOADED TO FULLY LOADED LIFT. THE POSITION OF THE LIMIT SWITCH REAR TRIP POINT MUST BE MAINTAINED TO PREVENT THE DISTANCE BETWEEN THE CARRIAGE STOP BLOCK AND CARRIAGE STOP (TYP BOTH SIDES) FROM EXCEEDING 33" (840mm), INCLUDING ALLOWANCE FOR DAILY CARRIAGE TRAVEL. SEE VIEW C

See enlarged detail View C and Notes #5 & #6 on drawing 7402347 Rev. A attached

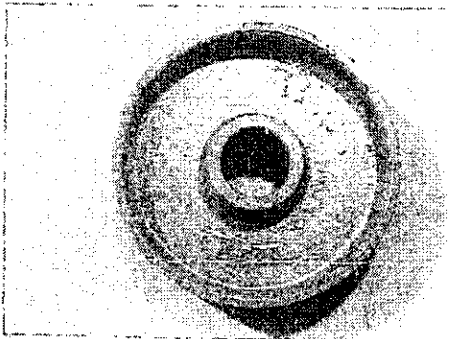
- This problem affects the **320 steel hubs used for drop sheaves**.
- **Only model 320 steel hubs (id. CCC12155) with the letter P320 on one side and no production date on the other side are affected (see picture 1 below).**
- 320 steel hubs **with production date** appearing on one side (see picture 2) **do not seem to be affected**.

Picture 1.
320 drop sheave hub with marking P320 on one side

Check all 320 drop sheaves with steel hubs for the snap ring gap (see picture 3 and following sketch). All sheaves showing improper mounting dimensions (snap ring gap and position) shall be removed from service.

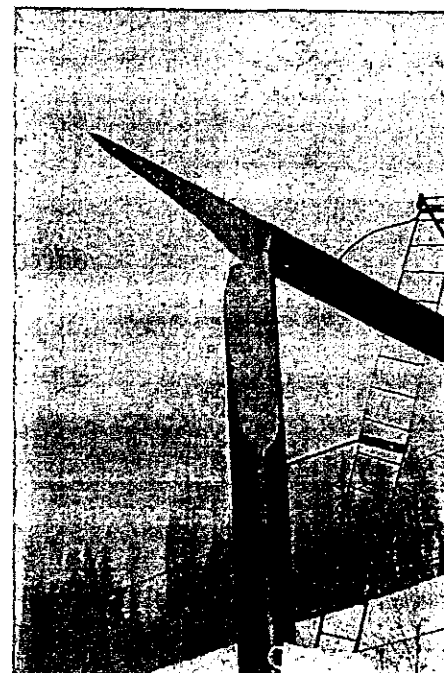
Haul rope was trapped on both HS & LS assemblies.

Horizontal tower base crack 10-1/2" long, 14" up from base.

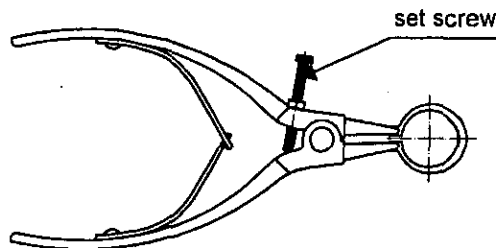
If the snap ring is not fitted correctly or missing, the bronze bushing may creep and as a result the grip may be blocked during the closing procedure!

This means that the grip leaves the station without being completely closed!

When fitting the snap ring, make sure that it will not be over-tensioned by excessive opening. Therefore it is advisable to use adjustable circlip pliers with a set screw.

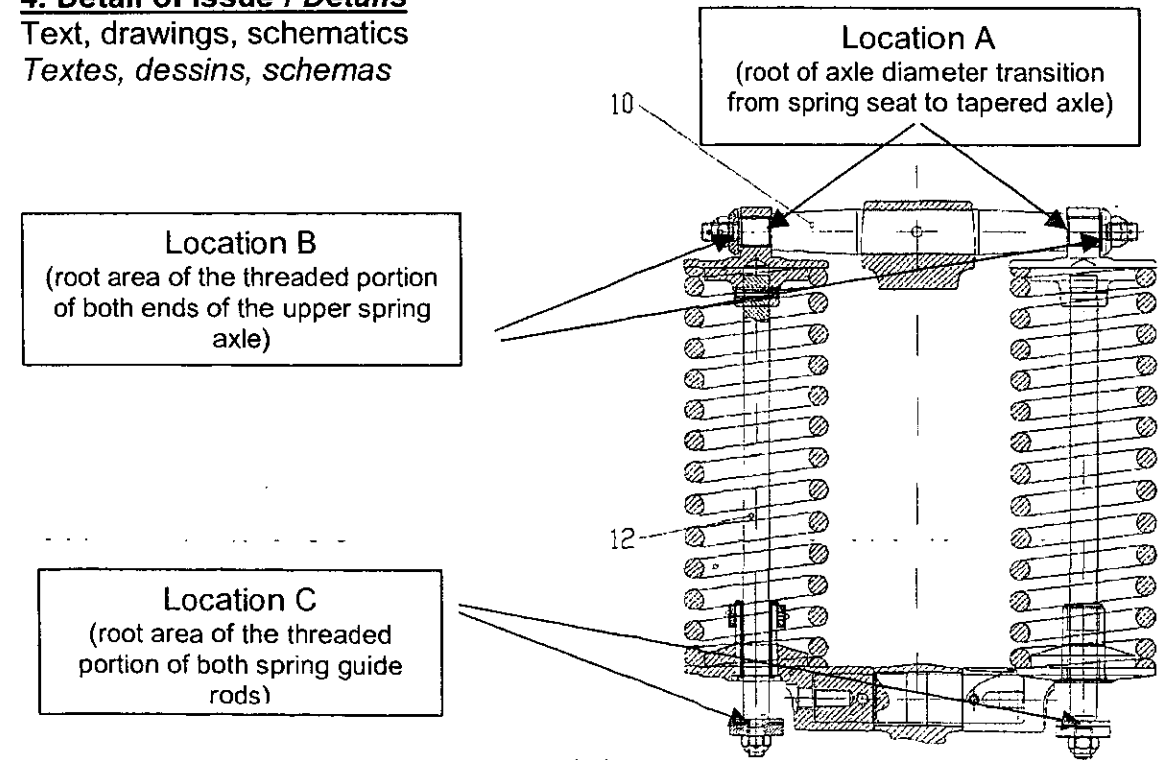
- During routine NDT inspection, care should be taken to inspect the affected areas with the assistance of wet fluorescent magnetic particles. See Locations A, B, & C on the accompanying drawing.
- Indications noted in Location A (Item 10 – upper spring axle) are cause for immediate rejection of the component. No rework of material in Location A is allowed.
- Indications noted in Location B (Item 10 – upper spring axle) have been determined to be non-critical and need only to be documented in the grip inspection record. No rework of material in Location B is required.
- Indications noted in Location C (Item 12 - spring guide rod) must be removed. Garaventa has authorized the reworking of material in Location C to a minimum diameter of 12.5 mm. Indications remaining in Location C once the minimum diameter of 12.5 mm has been reached are cause for rejection of the component.

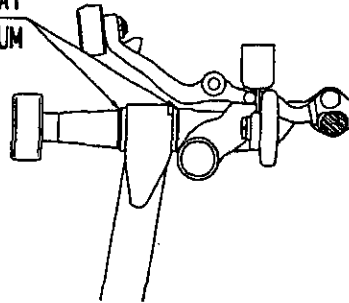
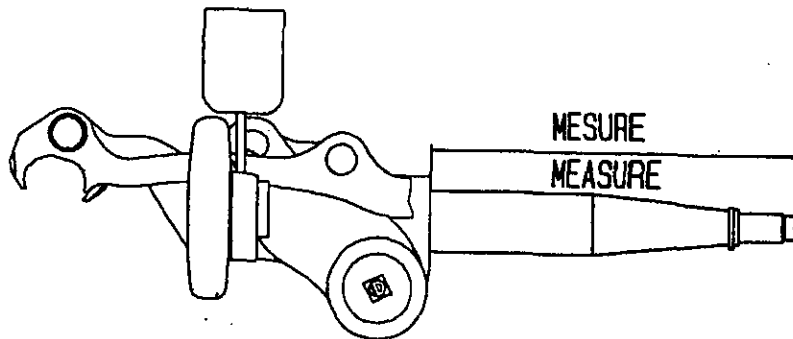
MOVEMENT OF HANGER AXLE ON DT GRIPS

On a few installations in North America (mainly in regions with high humidity and strong temperature fluctuations) there has been isolated cases where movement of the hanger axle in the fixed jaw has been detected due to condensation building in the bore of the fixed jaw.

The cavity behind the axle may collect water until the cavity is full. This could take several years. Once the cavity is full, with freezing conditions, micro movement may occur. Once movement has occurred, the enlarged cavity will fill with additional water and with freezing conditions, may cause further micro movements.

JEU LATERAL
LATERAL PLAY
3 mm MAXIMUM

Please report any movement to your Doppelmayr CTEC Service Representative. Do not attempt to pull hanger axle from fixed jaw by yourself as a specific procedure with specialized tooling with high forces (6 to 8 tons) is required or irreparable damage may occur.

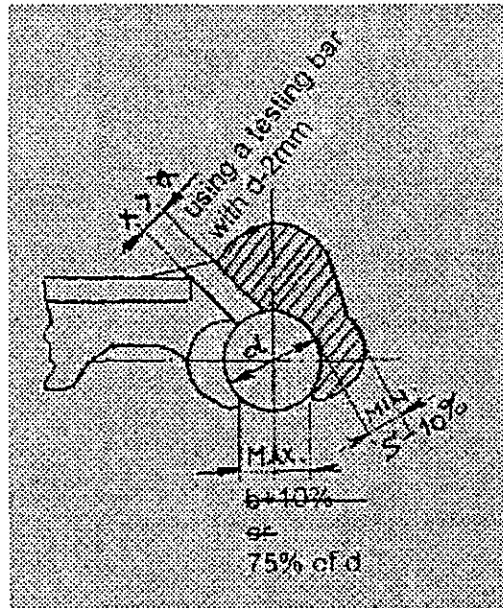
This sketch concerning the distance between the 2 grip jaw tips had two criteria included:

- ◇ Please delete:
"b + 10% or".
- ◇ The following line remains unchanged:
"b max. = 75% of d".

- 1.3 Distance between the tips of the two grip jaws:
The distance "b" between the two grip jaws should be max. 75% of the rope diameter.

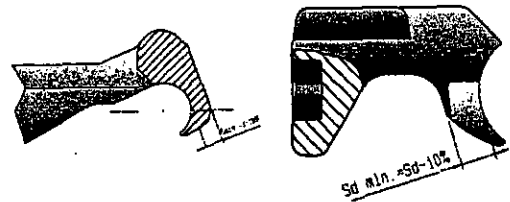
1.1 Thickness of grip jaw:

A 10% reduction in the thickness of the grip jaw compared to the required value stated on the drawing is acceptable.

$$S_{\min} = S - 10\%$$

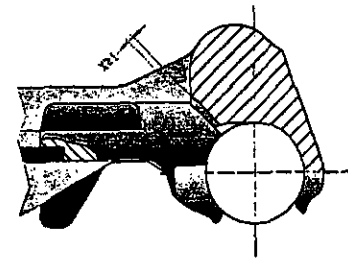
1.2 Grip capability:

Wear on the grip jaws and/or in the grip mouth can lead to the grip jaws blocking each other ($x = 0$) before sufficient grip force is applied to the rope. The distance X between the grip jaw and the main body of the grip shall never fall below 1 mm.

Clearance too small if $X < 1 \text{ mm}$

Grip capability shall also be assessed at least once a year when installed on the haul rope, as wire rope diameter reduction directly affects the grip capability.

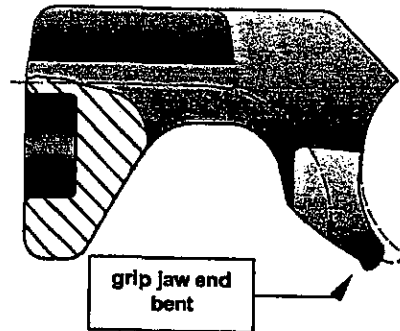
1.5 Bent thrust jaw:

Particularly in the case of surface lifts if a (high) torque is continually applied when tightening the grip (where there is contact between rope strands).

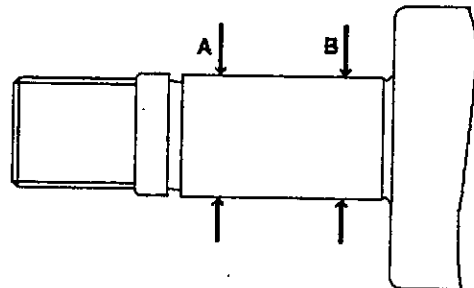
1.6 Play between grip shaft and hanger head bushing:

The clearance between the grip shaft and the bushing can be partly compensated by fitting new bushings. If the grip shaft is worn beyond the following criteria, the grip shall be replaced.

**A or B are located at the center of bushing working surface*

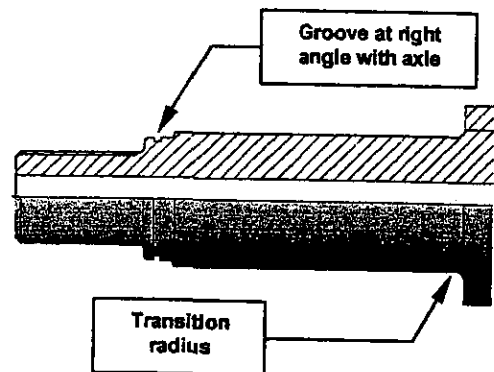
1.7 Shape of snap ring groove:

The outer contact surface for the snap ring in particular must be even and at right angles to the axis of the grip shaft. There shall be no evidence of snap ring coming out of the groove.

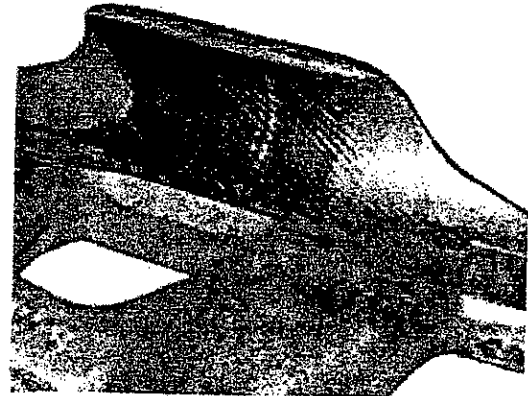
2.2 Rope channel shows inadmissible imprints of wires and (in particular) strands:

Heavy imprints are a problem if it is no longer possible to even them out without reducing the thickness of the grip jaws below acceptable limits.

Permitted
Slight imprint from wires

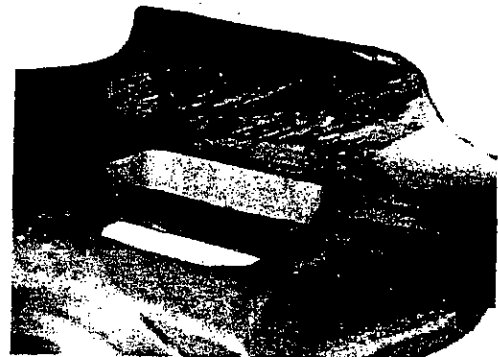
Not permitted
Pronounced imprint from strands

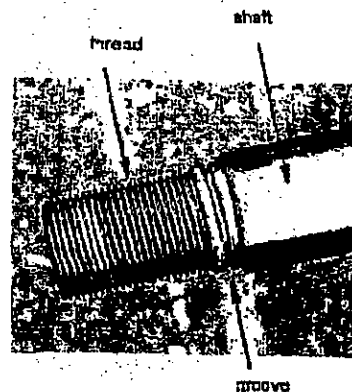
2.5 Damaged thread in/on grip shaft:

The thread is responsible for generating the grip force exerted on the rope. If the thread is damaged, stiff or has too much play, repair or replacement is necessary.

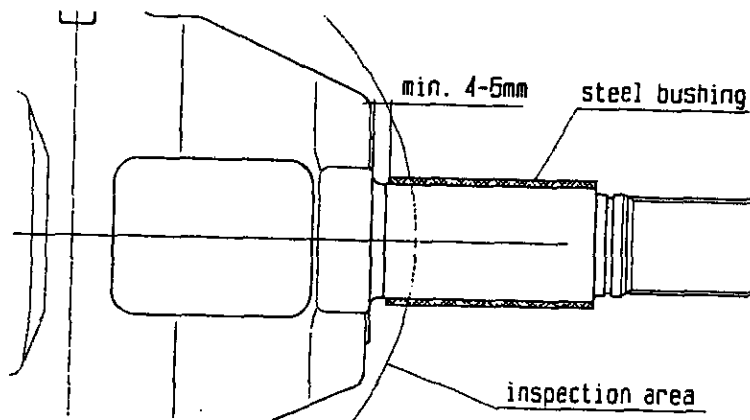
If a sleeve was added to increase the shaft diameter, the gap between the sleeve (steel bushing) and the grip shoulder (see graph) must be at least 4 to 5 mm.
Otherwise, it is not possible to perform a valid MT-inspection in this area!

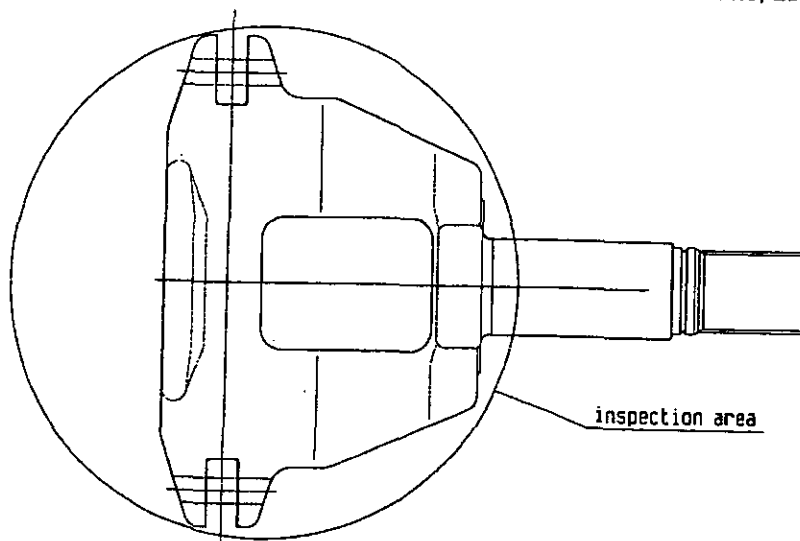
- Magnetic particle inspection is **mandatory** in **critical areas**.
For critical areas see graph below.
- Magnetic particle inspection is **mandatory** on **unacceptable visual indications**, as per D3.1.2.

Unacceptable indications may be removed by grinding under following conditions:

- Maximum depth of grinding: 5% of thickness, max. 3 mm
- Diameter of grinding exceeds 25 times depth
- Grinding must be smooth (surface finish minimum N6 to ISO 1302) and free of nicks.
- Local hardening and hardening cracks due to grinding must be avoided!

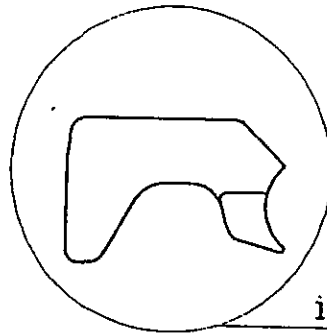
inspection area

Magnetic particle inspection is **mandatory** on the **whole surface** of the moveable jaw.

Unacceptable indications may be removed by grinding under following conditions:

- Maximum depth of grinding: 5% of thickness, max. 3 mm
- Diameter of grinding exceeds 25 times depth
- Grinding must be smooth (surface finish minimum N6 to ISO 1302) and free of nicks.
- Local hardening and hardening cracks due to grinding must be avoided!

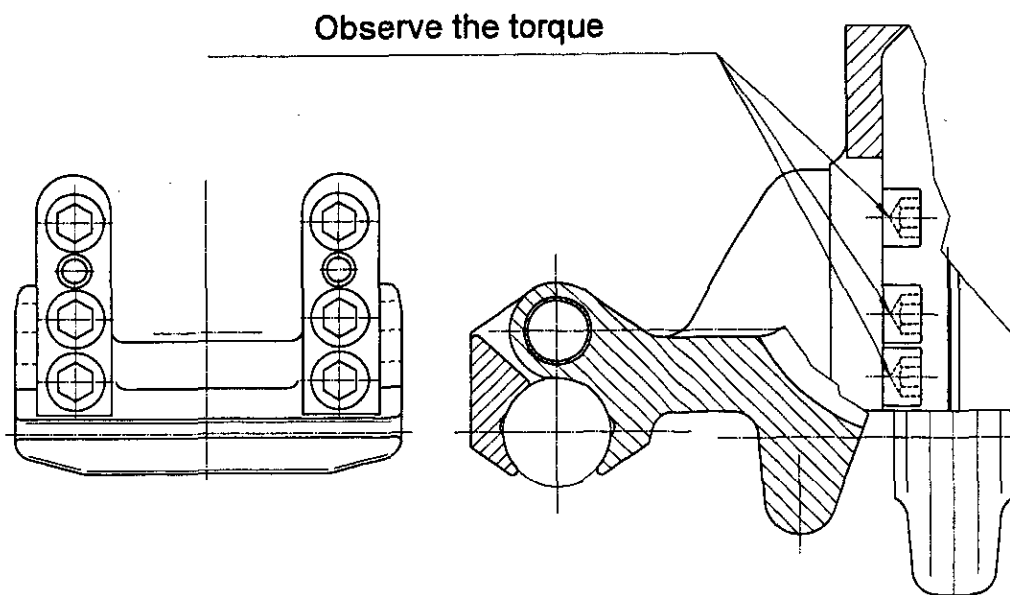
On detachable DS grips, the fixed grip jaw is mounted on the grip housing by means of 6 Allen bolts. On some installations, some of these bolts have been found broken.

- Check all grips before each season and once during the season for the completeness of the bolts.
- During the annual grip maintenance check the bolts for correct torque by means of a torque wrench (check on the grips to be stripped down). The required torque is 300 Nm unless a different torque applies for your specific installation.
- If the fixed grip jaw needs to be replaced, use new bolts for reassembly.
- If one of the bolts is broken on a grip, all bolts of this grip must be replaced immediately (before resuming operation).

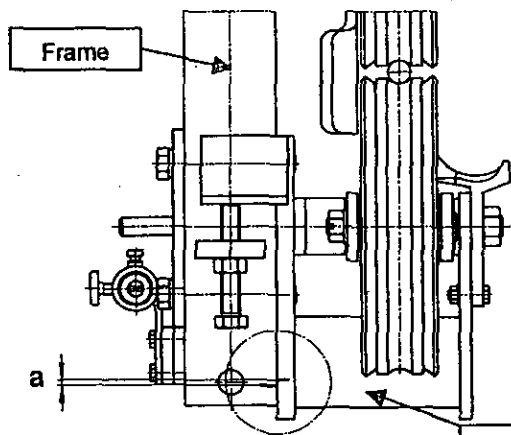
Adjustment of 2T/2N, 4T/2N, 4N/2T, 8T/4N and 8N/4T sheave assemblies of type A, C and OE

In addition, please also check the setting of the adjustable 2-wheeler evener frames of the combined sheave assemblies and readjust them if need be. For correct adjustment refer to the sketch.

Adjust the sheave assembly by relocating the support bracket of the 2-wheeler evener frame:

1. Relocate the adjustable 2-wheeler evener frame until all sheaves contact the rope.
2. Mark the position on the frame and on the support bracket of the 2-wheeler evener frame with a coloured pen.
3. Adjust the 2-wheeler evener frame at dimension "a" to increase the sheave pressure.

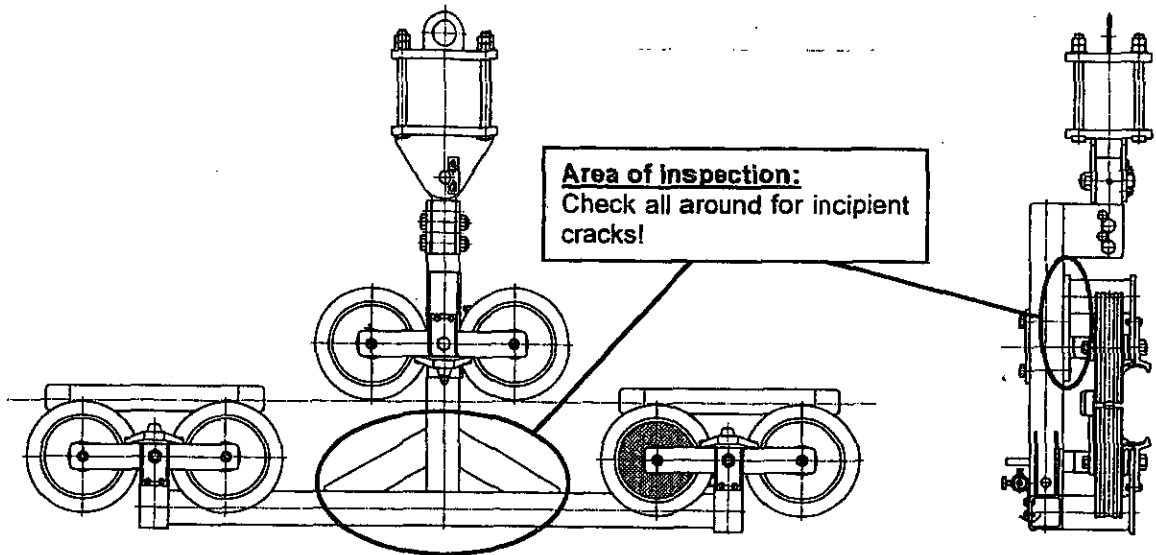
4T/2N resp. 8T/4N sheave assembly

If you find any incipient cracks during the check or obvious vibrations during operation, please inform Doppelmayr immediately so that we can decide the further measures to be taken.

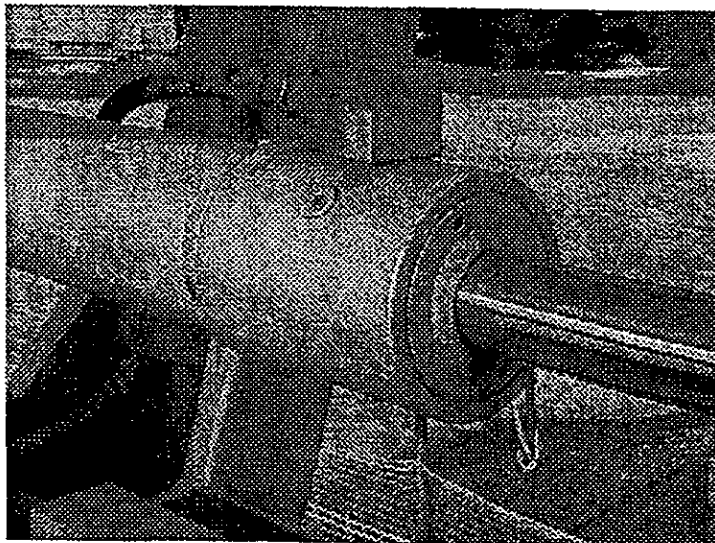
The problem may affect installations built prior to 1987. Since then, pipe failure lock valves are generally fitted with steel bodies.

Should you require such conversion sets, please contact our After-Sales Service in Wolfurt.

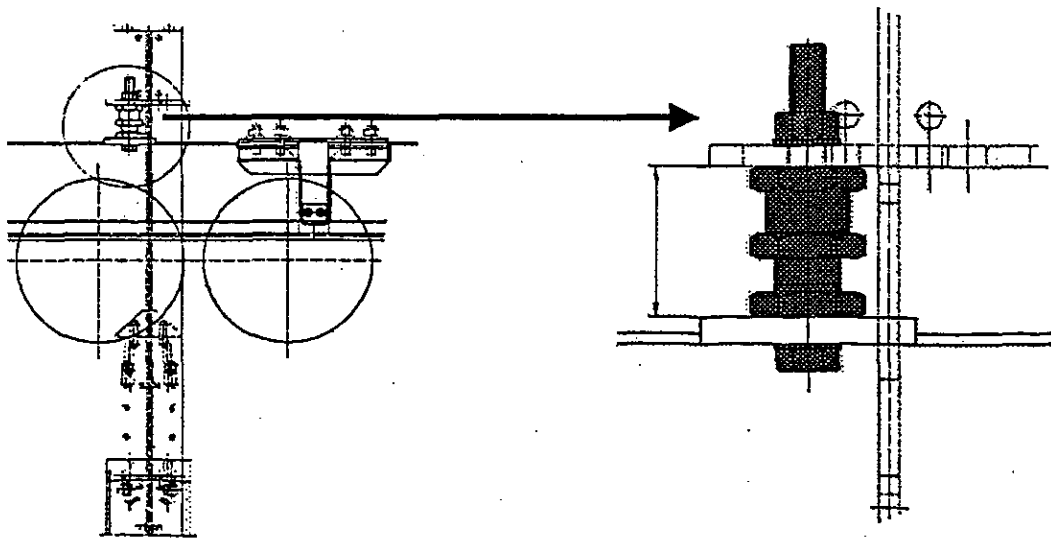
- As of 2002, adjustable spacer sleeves (see below) are used for UNIG station equipment to enable pretensioning of the suspension bolts with a specific torque (see table of torques for M 20).

This solution may also be applicable on older UNI installations but must be discussed with the technical department for every individual case (different length of UNI and UNIG). Please address your inquiries to our After-Sales Service department.

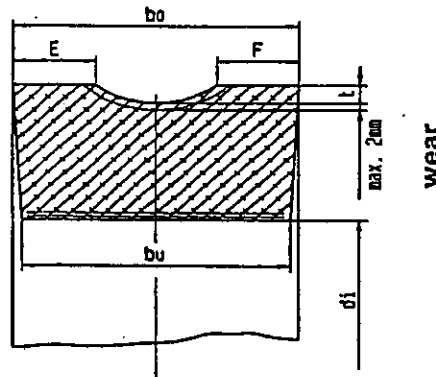
Max. permissible wear in the groove
2 mm

Max. permissible eccentricity of
groove 2 mm

The permissible wear of 2 mm indicated in the latest operation manuals assures that in the most unfavorable case (crosswinds, unevenly loaded carriers, etc.) the required swing clearances are being met and no contact of the grip main body on the sheave side plate exists.

In any case, it is this contact which is the decisive removal criteria for sheave liners for fixed and detachable installations.

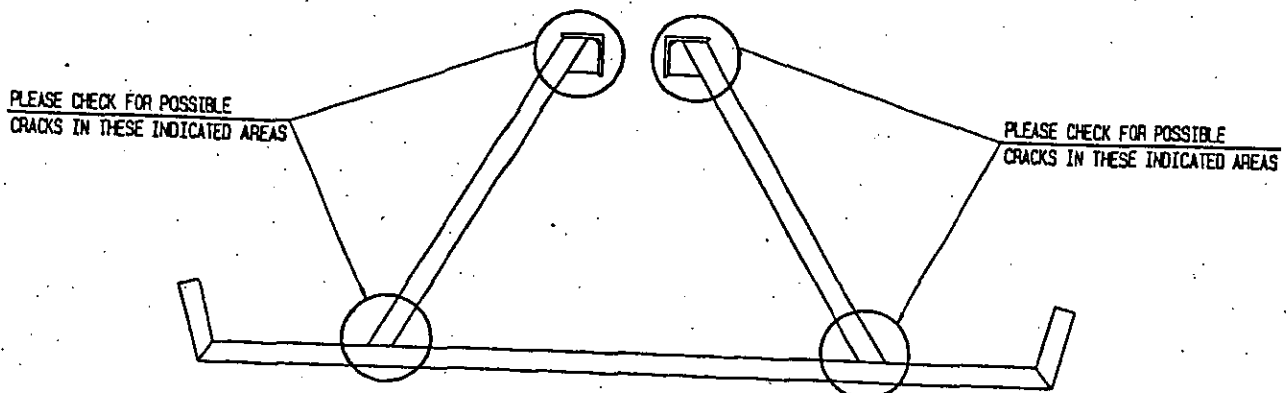
CATWALK 4T/4D

During the last season, one of our customers found indication of cracks on a 4T/4D catwalk during his periodic visual inspection. The catwalk failed by natural vibration at the end of the season. According to our records, you have these types of catwalks on your Doppelmayr 4T/4D sheave assemblies. Therefore, we kindly ask you to inspect your catwalks in the areas as described in drawing below. In case of doubt, perform a non-destructive test by magnetic particles. If any indication of cracks is found, remove the catwalk and report immediately to your Doppelmayr CTEC representative. We thank you in advance for your collaboration on this matter.

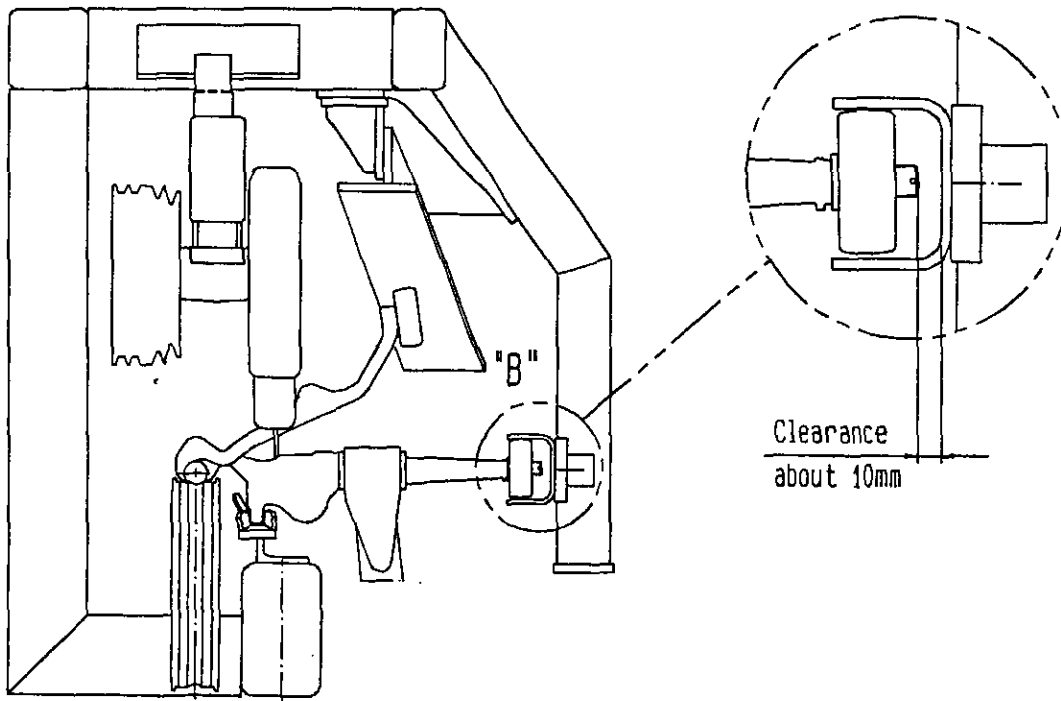
Detail "B"

Please refer to enclosed drawing # 60006044NCE001301 and drawing #60006412NCE001301 drawing. These drawings should also be added to section 17 in the maintenance manual. Particular attention should be given to the trumpet/guide rail adjustments at bracket "0" and "Section A-A" for the hanger axle clearances: Bracket "0" = max. 20mm and "Section A-A" about 10mm, when making these adjustments please consider the play in vertical trumpet guide. The entrance trumpet should be able to move up and down freely and the shock absorber work properly.

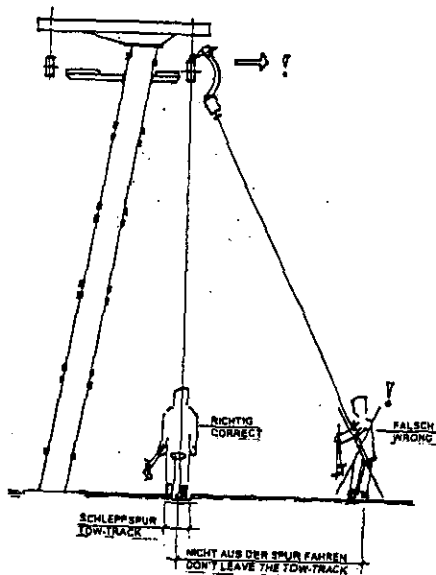
- 1) When a lift user leaves the tow track to the side away from the tower shaft, there is a risk that the resulting transverse pull leads to rope derailment from the sheave assembly. This can result in complete rope derailment.

- Post the Terms and Conditions of Transport and/or the 6 point information sign including the information "Stay in track when riding the lift".
- Put up the information sign "Stay in track" (Zigzagging prohibited).
- Do not groom the track too broad and provide for a tow track.
- An additional measure may be to remove the ladder eyes on the downhill side of the tower shafts.

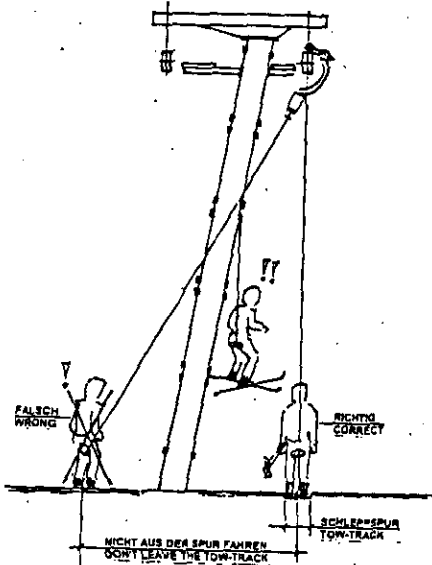
- 2) When a lift user leaves the tow track to the side towards the tower shaft or beyond, there is a risk of rope derailment as well.
 If the towing cable becomes entangled on one of the ladder eyes on the downhill side of the tower, the lift user may be lifted up and as a result fall down from a height of several metres.

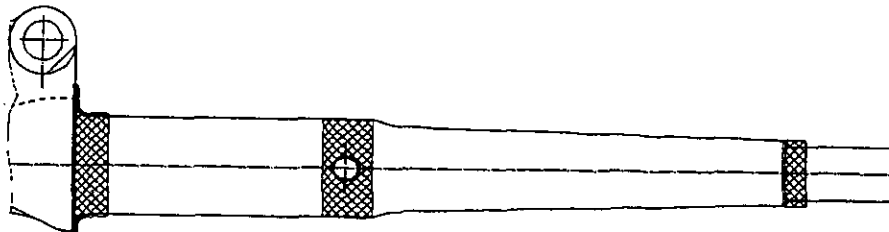
Graph 3: Critical areas for MT- inspection, hanger axle

- **Linear indications with a length > 1 mm**
 - Exception:** - The indication is exactly parallel to the longitudinal axis
 - A penetration test performed to confirm the MT-indications shows no indications
- Unacceptable indications must be further treated according to D4.3

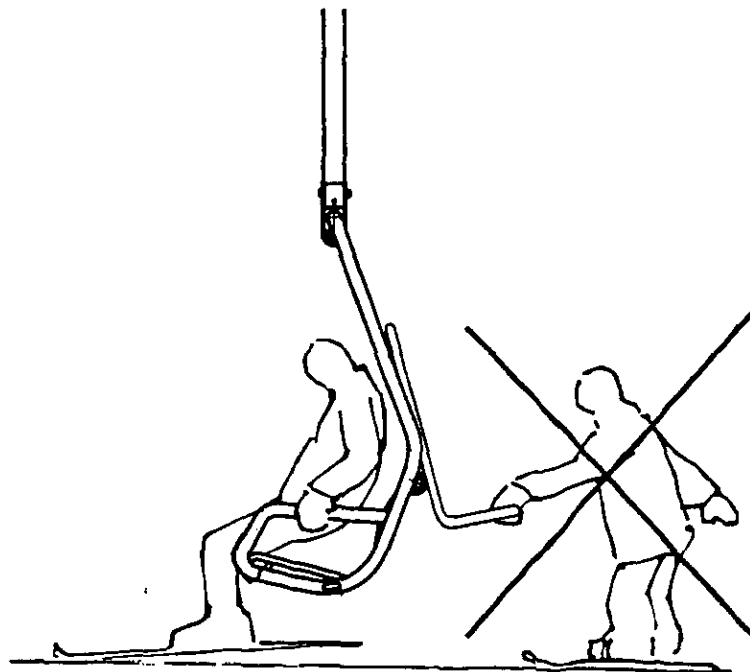
This notification bulletin is a reminder. It is strictly forbidden for skiers, snowboarders, etc. to hold on the restraining bar frame of the preceding chair to be towed to the loading point because the carriers and conveyor are not designed for this and could cause important damage. This can also be dangerous for injuries to the users.

We recommend to install a visible notice at all waiting point of terminals for detachable chairs.

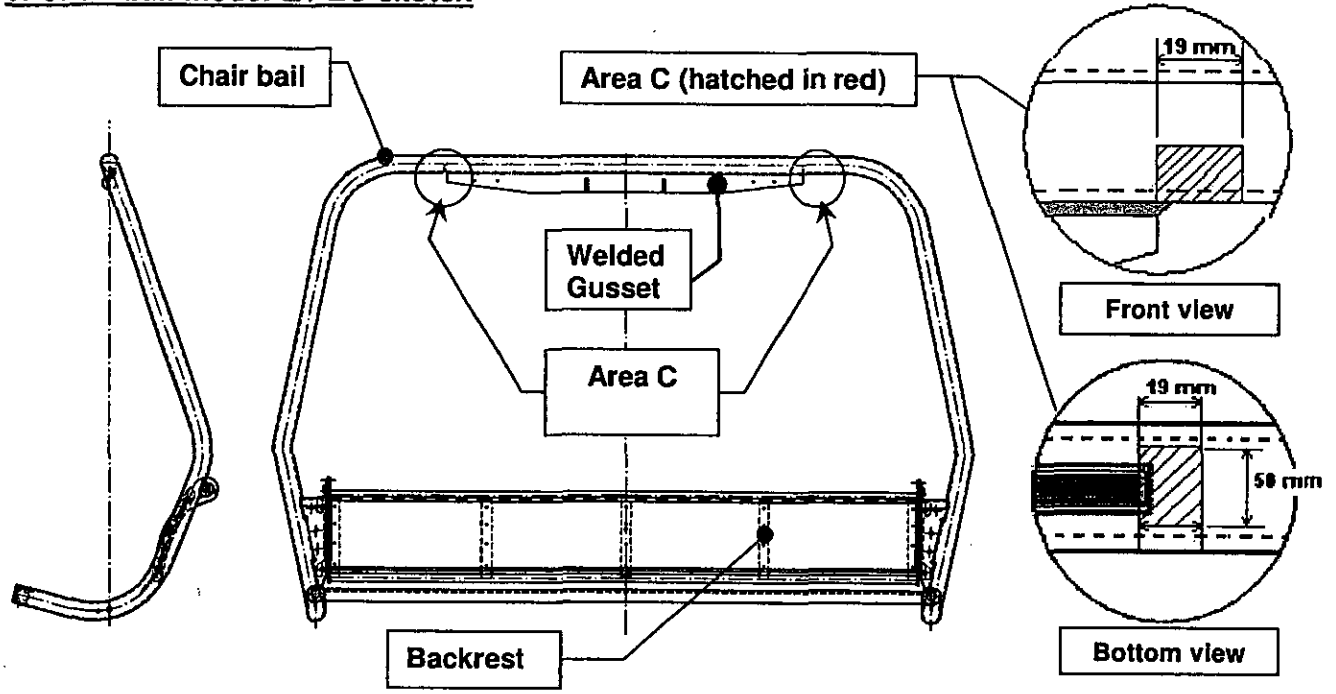
5. Chair bail model E / EC sketch

To determine if the chair bail is deformed :

- Measure the camber of the angle bar in the front. If the camber is less than or equal to **5 mm (3/16")** the chair bail is considered to be "conforming"
- If the camber exceeds **5 mm (3/16")** remove the seat back and measure the dimensions **A** and **B**.
- If dimensions **A** or **B** are less than **2002 mm**, the bail is considered as "deformed"
- If dimensions **A** or **B** are equal or greater than **2002 mm**, the bail is considered as "conforming".
