OCTOPUS-SPIDER INSPECTION CHECK LIST

SWEEP SUPPORT ROD BULLETIN			
DRAWN BY: TMCQ	SCALE:	NO. REQ'D.:	MATERIAL:
DATE: 9-25-78	NEXT ASSY.:	BDS. NO.: 0-41-76	EFF. W/SN:
		SDD. BY NO.:	EFF. W/SN:

DATE: 3-30-74
 DRAWN BY: NEA
 SCALE: NONE
 NEXT ASSY:
 NO. REQ'D:
 MATERIAL:
 SDS NO.:
 SDD BY NO.:
 SPIDER
 BULLETIN O-39-74

Octo./Spider Sweep Support Rod Bulletin

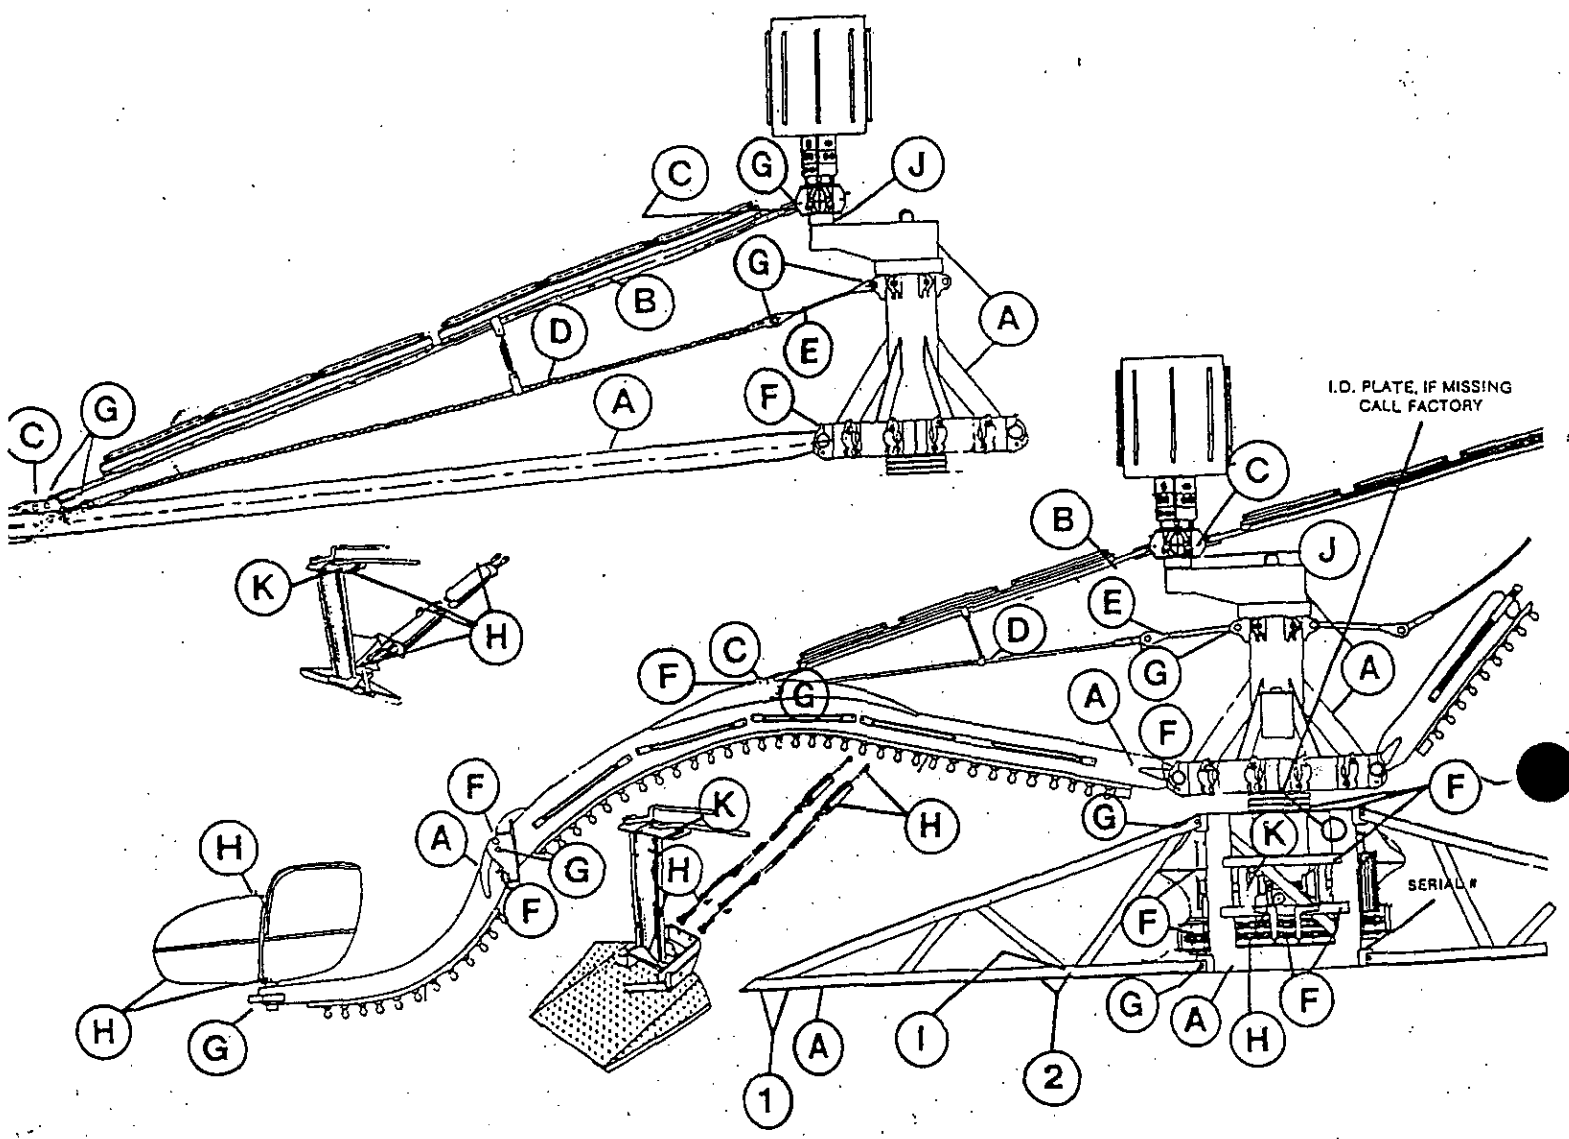
- A. Inspect for weld cracks, structural damage.
- E. Check support rod, if bent replace rod. (See Spider Bulletin #0-41-76). Inspect pin hole and pin rotating retainer. Replace retainer if pin can rotate.

- C. Check swivel block, mono ball for movement:
 1. Swivel block should be replaced if wear exceeds 1/16" (.0625).
 2. Mono ball bolt should be removed, inspected and replaced along with adapter if worn.

- D. Check safety cable for condition; broken strands—corrosion; adjustments. Cable should not bear weight of arm when extended. Attaching points should move freely (if cable has been stretched—replace. Factory specifications center line of hole to end of thread 89½" plus ½" minus ¼").

- E. Check safety cable link for twist—replace (also means cable stretched).
- F. Check bolts for condition and tightness. If movement is detectable, or bolts damaged, replace or tighten. Check condition of pillow block and block pin, if loose or block damaged—replace.

- G. Check pins and fastener. Do not use hair pins in mudsill pins—pins rotate and push keep out. Inspect for hole enlargement and repair.
- H. Check for wear in bushing, linkage and joints and hinges.

- I. Check condition of tie rod for wear due to contact with bearing lock collar, etc.
- J. Check Eccentric Hub for play and rough bearings. Tighten or replace as necessary.

- K. Check ratchet for condition and control handle lug—check condition of brakes.
- L. General Information:
 - Maximum weight per car 400 lbs. Maximum RPM is 7ccw.

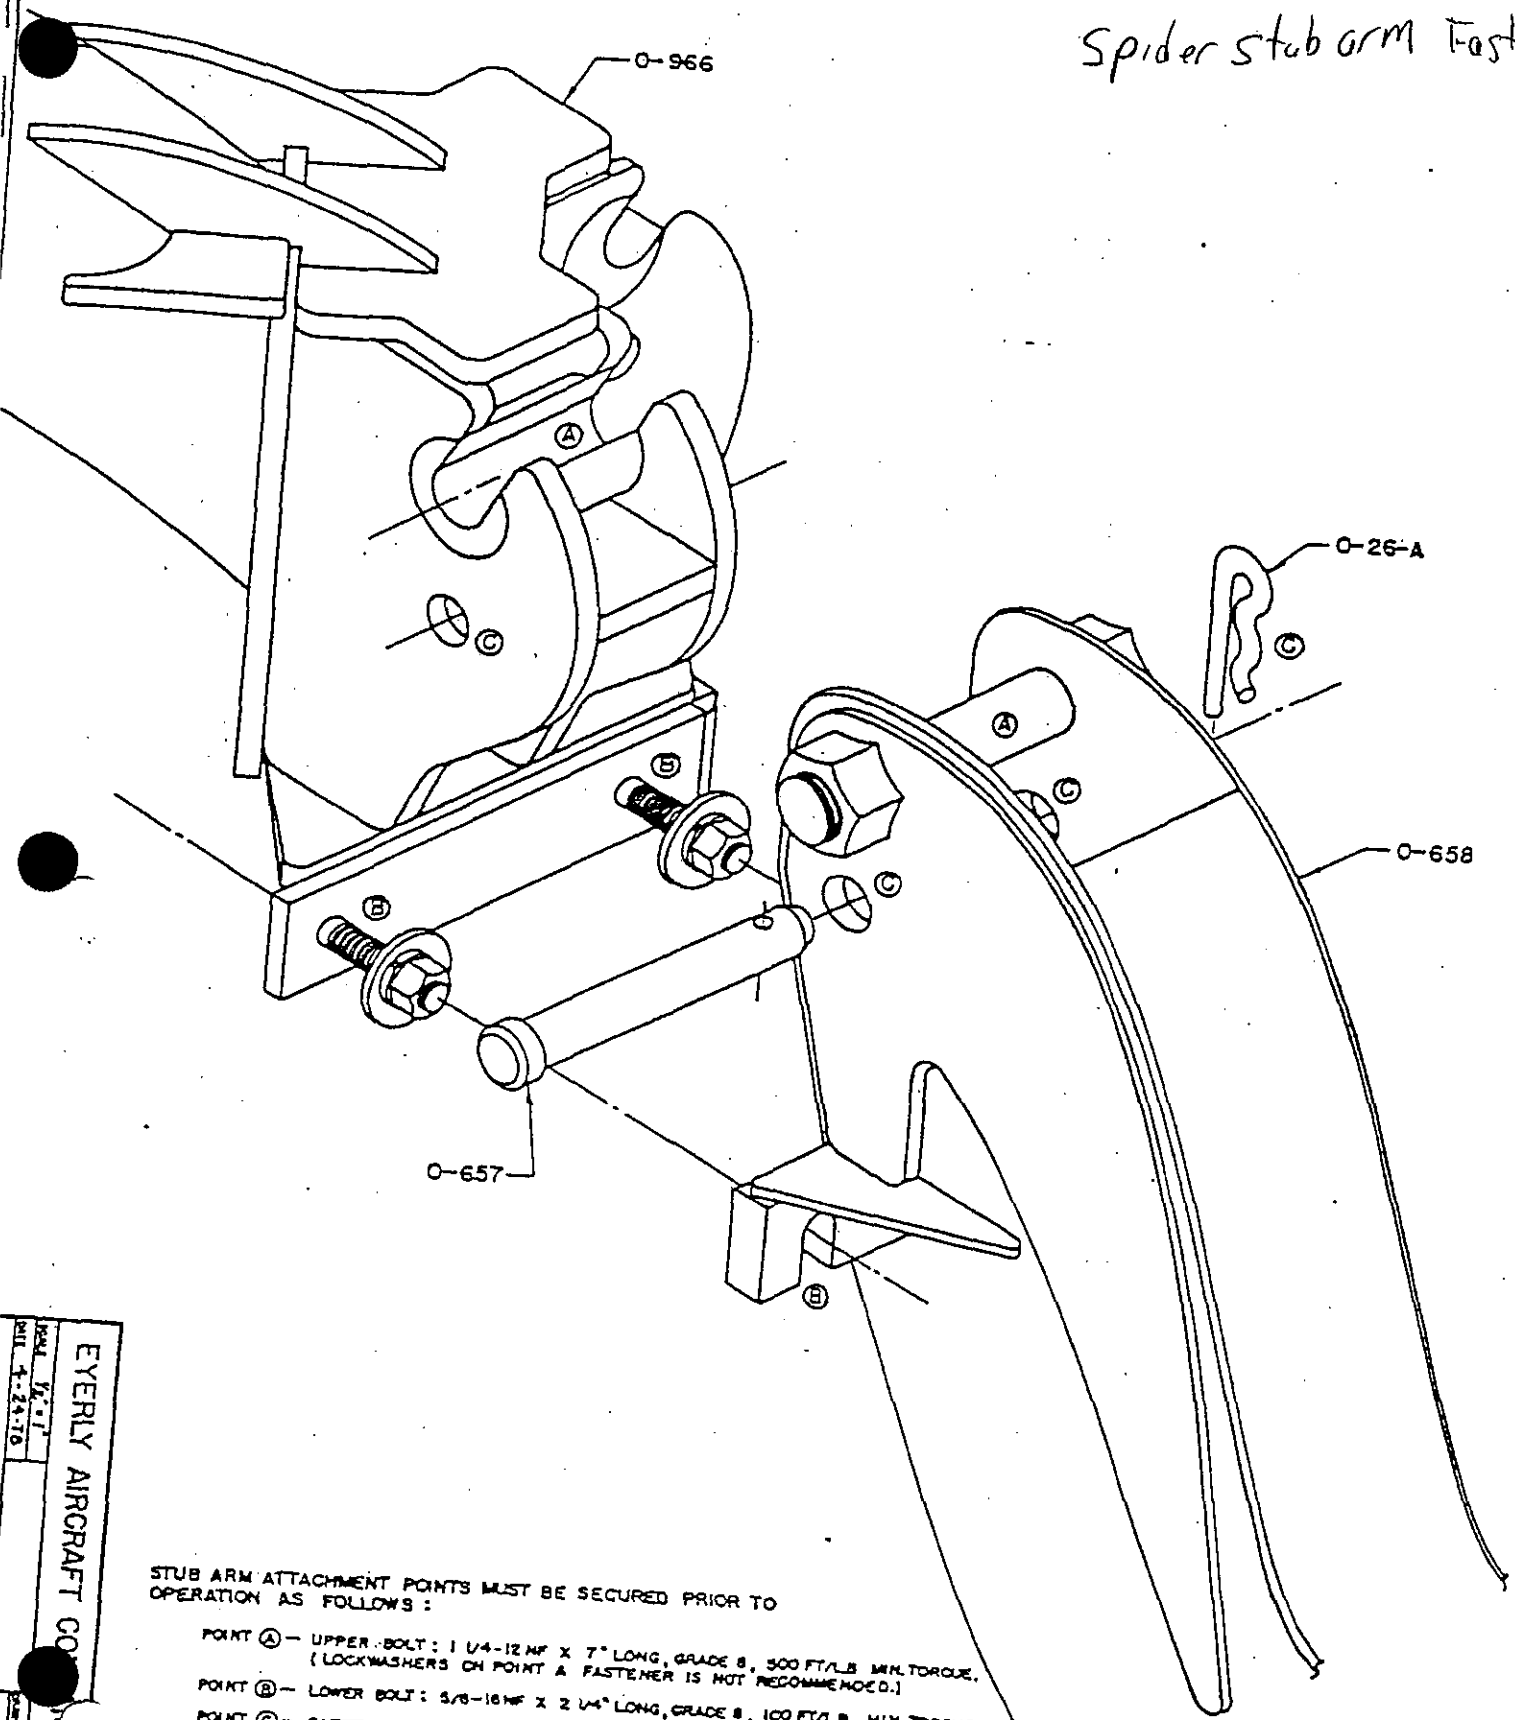
DWG. NO. 0-43-78
 Spider stub arm Fastener

WARNING: IF SAFETY PIN IS REMOVED, OPERATION OF RIDE WITH BOLTS IN LOOSENED CONDITION MAY PERMIT STUB ARM TO DISENGAGE AND FALL.

STUB ARM ATTACHMENT POINTS MUST BE SECURED PRIOR TO OPERATION AS FOLLOWS:

- POINT A - UPPER BOLT: 1/4-12NF X 7" LONG, GRADE 8, 500 FT./LB. MIN. TORQUE. (LOCKWASHERS ON POINT A FASTENER IS NOT RECOMMENDED.)
- POINT B - LOWER BOLT: 5/8-18NF X 2 1/4" LONG, GRADE 8, 100 FT./LB. MIN. TORQUE.
- POINT C - SAFETY PIN (0-657): 15/16" X 6 1/4" LONG. HAIR PIN (0-26-A): 1/4".

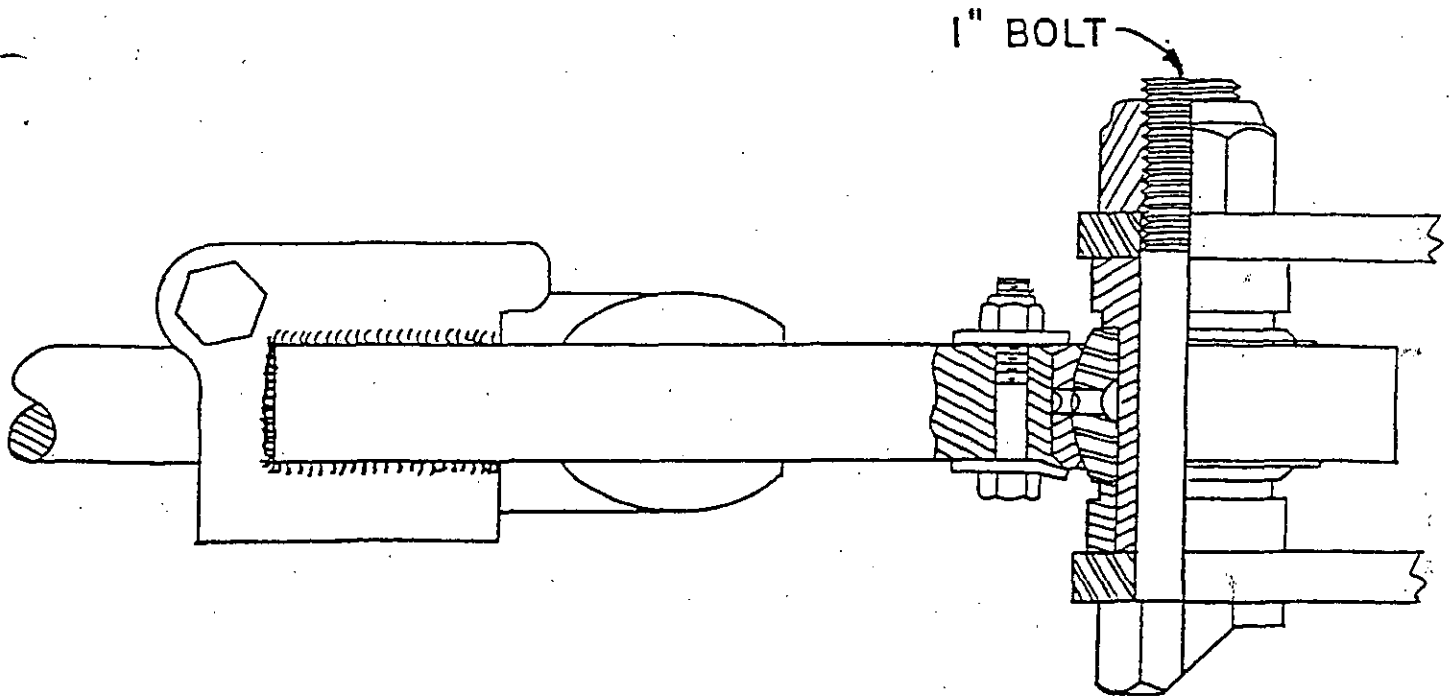
ANY LOOSNESS HERE CAN ALLOW THE ASSEMBLY TO TURN ON THE BOLT, CAUSING IT TO WEAR THROUGH IN A SHORT TIME.

IT IS VERY IMPORTANT THAT THE ONE INCH BOLT PASSING THROUGH THE BALL JOINT SUPPORT ROD ENDS BE KEPT TIGHT.

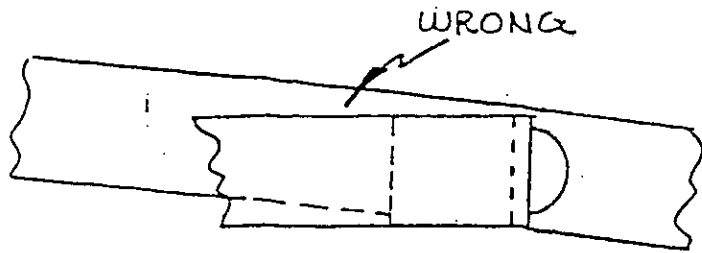
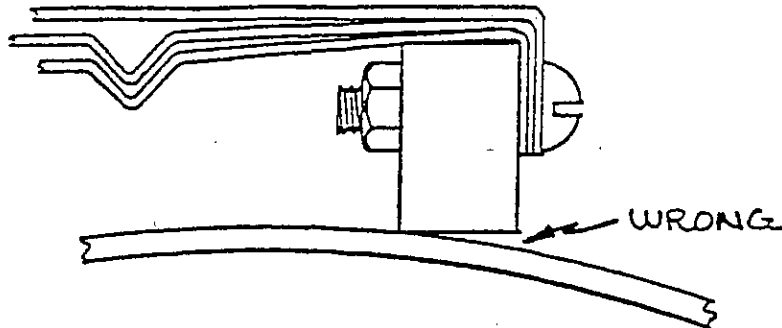
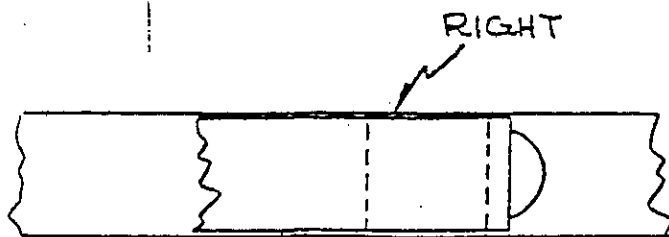
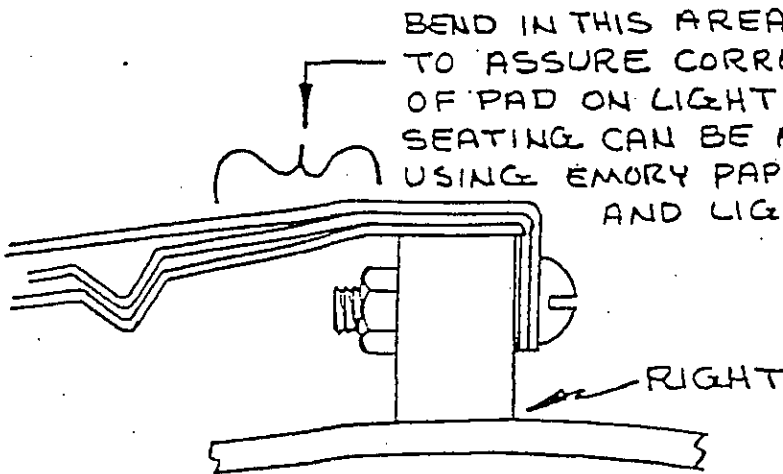
Drg. No. 0-30

MISALIGNMENT WILL SHORTEN LIFE OF BRUSH PADS.

BRUSHES SHOULD BE INSPECTED REGULARLY FOR WEAR. EXCESSIVE WEAR WILL CAUSE ARCING IF METAL SPRING TOUCHES LIGHT RING. LIGHT RING COULD BE DAMAGED BEYOND REPAIR.

BRUSH PADS MUST BE PARALLEL WITH LIGHT RING. CORRECT BY ELONGATING MOUNTING HOLES IN BRUSH INSULATING BLOCK WITH RATTAIL FILE.

BEND IN THIS AREA WITH PLIERS TO ASSURE CORRECT SEATING OF PAD ON LIGHT RING. FURTHER SEATING CAN BE ACCOMPLISHED BY USING EMORY PAPER BETWEEN PAD AND LIGHT RING.
