To: Pharoah's Fury Owners

From: Mark F. Mooney, Chief of Inspections – Mechanical

RE: Internal Lap Bar Corrosion – Rev.2

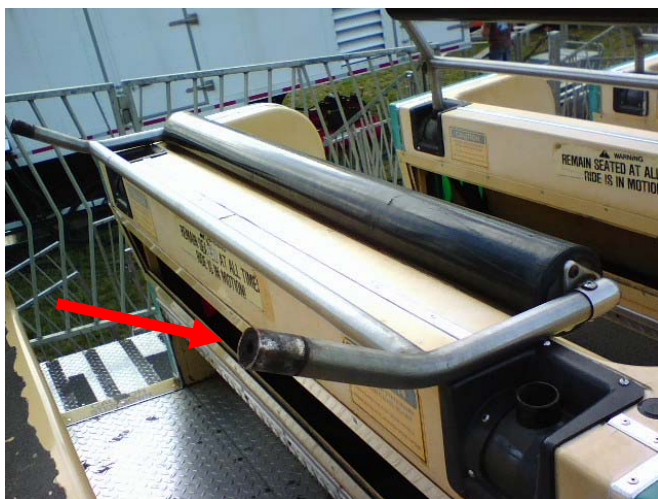
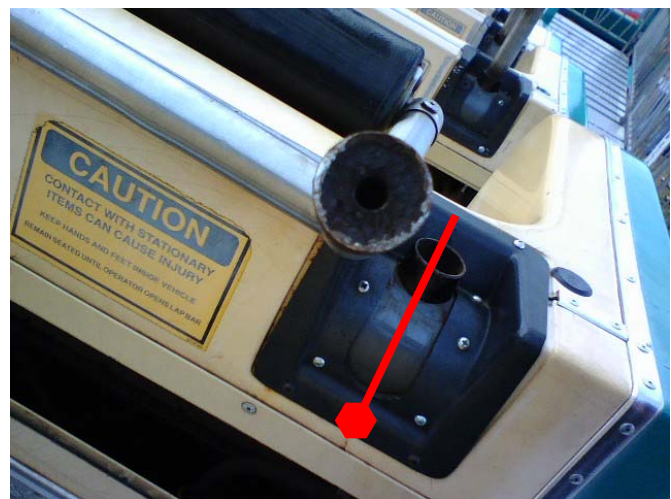
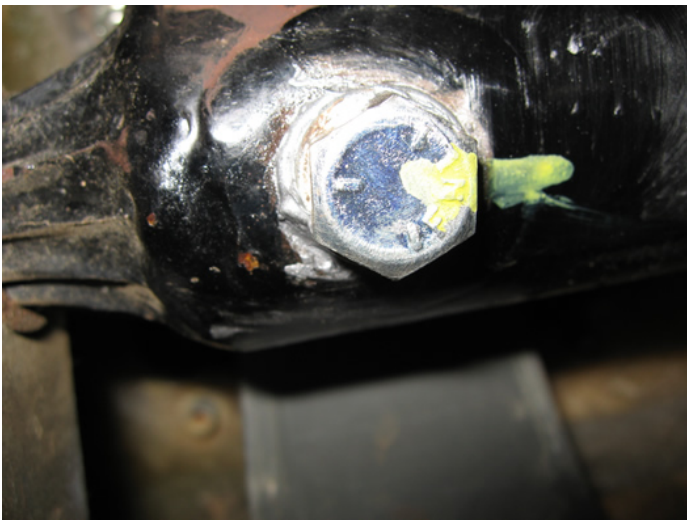
A recent inspection revealed severe corrosion of the bolts holding the lap bars to the frame of the Chance Pharoah's Fury. This was detected after an inspector noted excessive play in the restraint when the device was in the "locked" position. The corrosion of the bolts was not easily seen and the extent of the corrosion was not recognized until the bolts were removed and examined.

The bolts are not easy to view. You must remove the fiberglass panel and look up at the bolt, as shown in the photo on the next page (courtesy of Rockwell Amusements). The bolts screw up into the center of the restraint. The initial photo did not make this clear.

You are directed to immediately inspect all the bolts that connect each lap bar to the frame (as shown) and to replace the bolts as necessary. The required bolts are grade 5, 3/8"-16 x 2 3/4" with lock washers.
